CIRCULAR DOOR KNOCKER STRIKING PLATE - CU ALLOY - MODERN TIMES - SWITZERLAND

Artefact name	Circular door knocker striking plate
Authors	Marianne. Senn (EMPA, Dübendorf, Zurich, Switzerland) & Christian. Degriigny (HE-Arc CR, Neuchâtel, Neuchâtel, Switzerland)
Url	/artefacts/396/

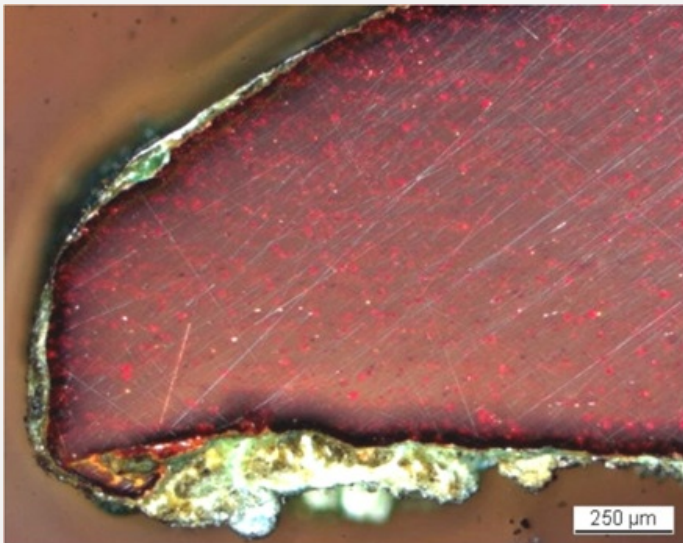
red (Figs. 5 and 8) while with SEM in BSE-mode they look light-grey (Fig. 9). Heavy metals inclusions appear white with SEM (BSE-mode, Fig. 9). Due to the rolling process the copper oxide inclusions are parallel to the longitudinal orientation of the sample (Figs. 5 and 6). They were identified as cuprite by Raman spectroscopy (Fig. 7). The etched alloy shows a structure of polygonal grains with annealing twins (Fig. 6). The grain size is variable. The average hardness of the alloy is HV1 80, which is quite high compared to the average hardness of a pure annealed copper of around HV1 40-50 (Schumann 1991, 627).

Fig. 5: Micrograph of the metal sample from Fig. 3 (reversed picture), unetched, polarised light. The red copper oxide inclusions form rows in the copper alloy matrix.,

The average thickness of the corrosion crust is about 90µm, but may be thinner or thicker depending on the area of origin (Fig. 5). Under polarized light, we observe a multilayer system with a dense and thin inner red corrosion layer (CP2, probably cuprite/Cu₂O) on the metal (Fig. 8) containing chlorides (Fig. 9 and Table 3). This is followed by bands of heterogeneous green corrosion products (CP1, possibly copper chloride / sulphate / carbonate). This outer corrosion layer is contaminated with atmospheric components (Si, Al, Cl, C and O and perhaps gypsum particles (CaSO₄)) (Fig. 9).

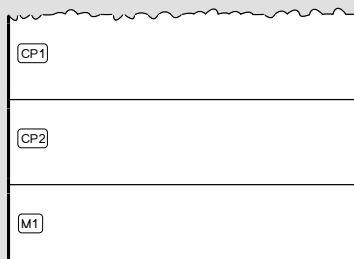
Fig. 4: Stratigraphic representation of the object in cross-section using the MiCorr application. This representation can be compared to Fig. 8, Credit HE-Arc CR.
