TANG FRAGMENT OF A KNIFE HR-6246 - TIN BRONZE - LATE BRONZE AGE - SWITZERLAND

Artefact name	Tang fragment of a knife HR-6246
Authors	Marianne. Senn (EMPA, Dübendorf, Zurich, Switzerland) & Christian. Degriigny (HE-Arc CR, Neuchâtel, Neuchâtel, Switzerland)
Url	/artefacts/398/

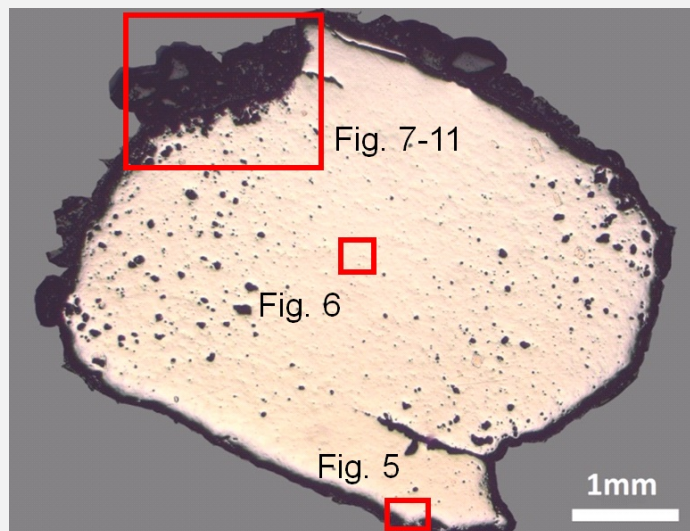
Fig. 3: Micrograph of the cross-section showing the location of Figs. 5 to 11,

The cross-section corresponds to a lateral cut (Fig. 2). The surface is covered with a thick corrosion crust (Fig. 3).

The remaining metal is a tin bronze (Table 1) with high porosity and large cracks both on the left and right edges of the sample (Fig. 3). The metal contains small, elongated copper sulphide (Table 2) and Pb inclusions that are oriented parallel to the cracks. Near the metal surface, slip lines are outlined by the development of intergranular corrosion (Fig. 5). The etched metal shows small, elongated grains with slip lines (Fig. 6). Annealing is visible in areas near the surface. The average hardness of the metal is HV1 145, but significant variations are observed, depending on where the measurements are taken.

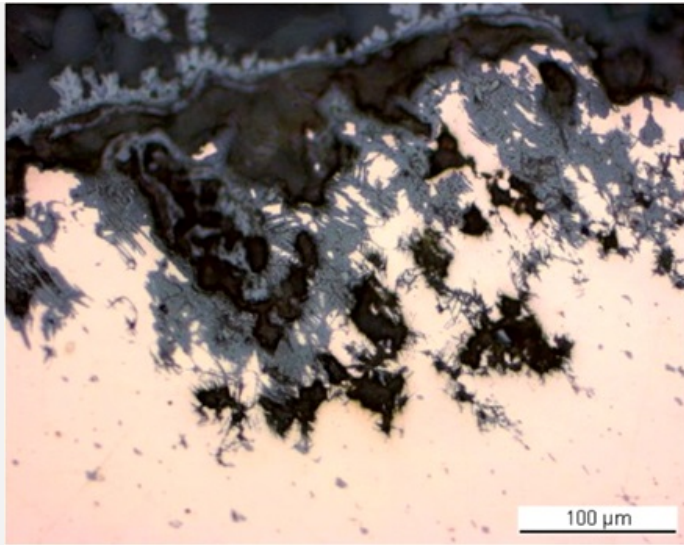
Fig. 5: Micrograph of the metal sample from Fig. 3 (inverted and reversed picture, detail), unetched, bright field. Corrosion products are in dark-grey whereas the metal is in pink. Slip lines are outlined by the development of intergranular corrosion,

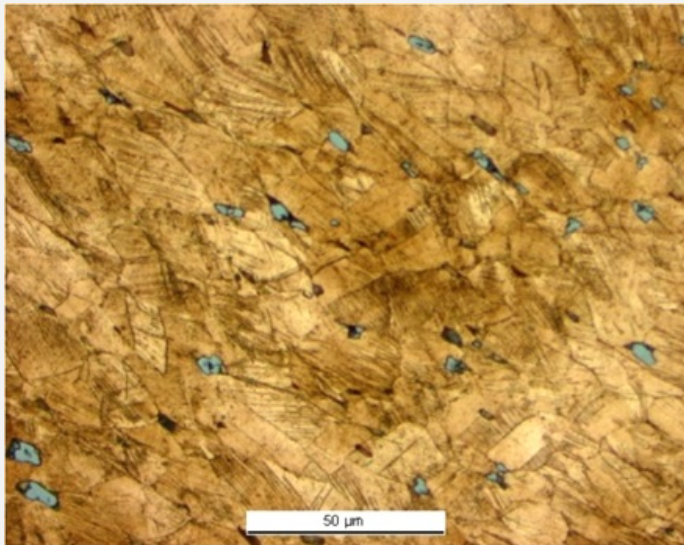
Fig. 6: Micrograph of the metal sample from Fig. 3 (detail), etched, bright field. We observe elongated grains with slip lines as well as grey copper sulphide inclusions,

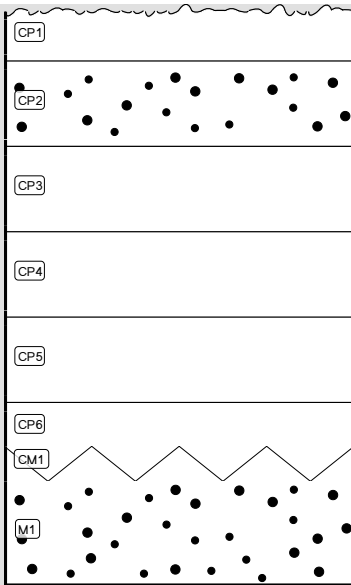
Fig. 4: Stratigraphic representation of the object in cross-section using the MiCorr application. This representation can be compared to Fig. 8, Credit HE-Arc CR.
