TANG FRAGMENT OF A KNIFE HR-6246 - TIN BRONZE - LATE BRONZE AGE - SWITZERLAND

Artefact name Tang fragment of a knife HR-6246

Authors Marianne. Senn (EMPA, Dübendorf, Zurich, Switzerland) & Christian. Degrigny (HE-Arc CR, Neuchâtel, Neuchâtel,

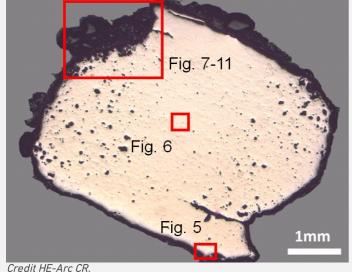
Fig. 3: Micrograph of the cross-section showing the location of Figs. 5 to 11, $\,$

Description of sampleThe cross-section corresponds to a lateral cut (Fig. 2). The surface is covered with a thick corrosion crust

(Fig. 3).

The remaining metal is a tin bronze (Table 1) with high porosity and large cracks both on the left and right edges of the sample (Fig. 3). The metal contains small, elongated copper sulphide (Table 2) and Pb inclusions that are oriented parallel to the cracks. Near the metal surface, slip lines are outlined by the development of intergranular corrosion (Fig. 5). The etched metal shows small, elongated grains with slip lines (Fig. 6). Annealing is visible in areas near the surface. The average hardness of the metal is HV1 145, but significant variations are observed, depending on where the measurements are taken.

The corrosion crust has a thickness between 0.1mm and 0.7mm (Fig. 3). In bright field (Fig. 7), one can observe that the metal has been replaced by light-grey corrosion products. Adjacent to the metal is a thick, heterogeneous, dark-grey layer with a band of light-grey corrosion products. In polarised light (Fig. 8), all corrosion products which were previously light-grey appear brown-orange, the dark-grey layer turquoise. The elemental chemical distribution of the SEM images (Figs. 9 and 10) reveals that the inner corrosion products are Sn-rich whereas the adjacent band is Cu and S-rich (Fig. 11). The outer layer contains large inclusions (quartz and others, Si, Al and Na, see Figs. 10-11) and is most probably composed of malachite/Cu2(CO3)(OH)2 (only Cu and O are detected – Fig. 11). S is distributed throughout this layer. XRD analyses indicated the presence of posnjakite/Cu4SO4(OH)6H2O, chalcocite/CuS and djurleïte/Cu1.93S (Schweizer 1994).

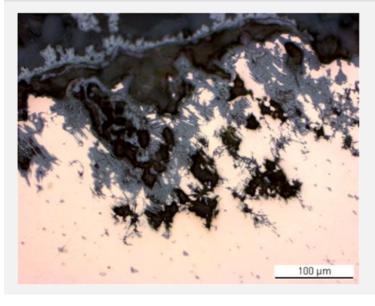
Fig. 5: Micrograph of the metal sample from Fig. 3 (inverted and reversed picture, detail), unetched, bright field. Corrosion products are in dark-grey whereas the metal is in pink. Slip lines are outlined by the development of intergranular corrosion,

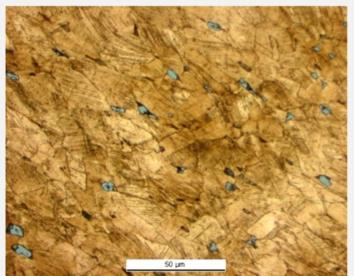
Fig. 6: Micrograph of the metal sample from Fig. 3 (detail), etched, bright field. We observe elongated grains with slip lines as well as grey copper sulphide inclusions,

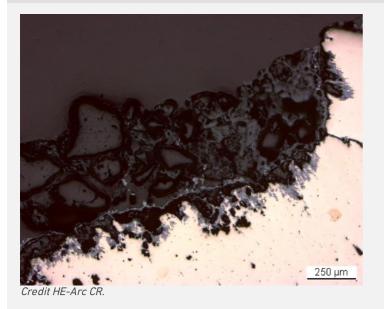
Fig. 7: Micrograph of the metal sample from Fig. 3 (detail), unetched, bright field. The inner light-grey corrosion products extend into the metal surface (in pink) and appear as a line within the dark-grey corrosion layer,

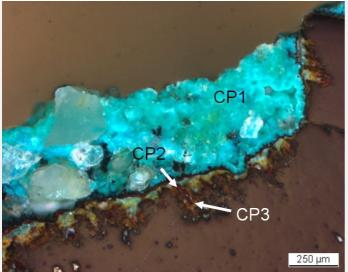
Fig. 8: Micrograph similar to Fig. 7 and corresponding to the stratigraphy of Fig. 4, polarized light. One can see that large mineral features are incorporated only in the corrosion layers above the brown-orange corrosion band,

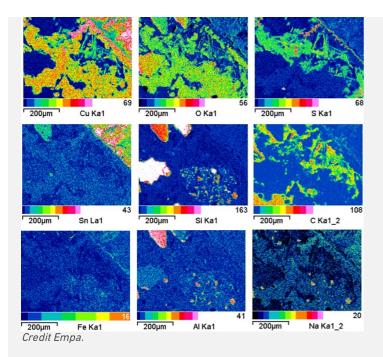
Fig. 11: EDS elemental chemical distribution of the SEM image of Fig. 9. Method of examination: SEM/EDS, Laboratory of Analytical
