# TANG FRAGMENT OF A KNIFE HR-6246 - TIN BRONZE - LATE BRONZE AGE - SWITZERLAND

Artefact name	Tang fragment of a knife HR-6246
Authors	Marianne. Senn (EMPA, Dübendorf, Zurich, Switzerland) & Christian. Degriigny (HE-Arc CR, Neuchâtel, Neuchâtel, Switzerland)
Url	/artefacts/398/

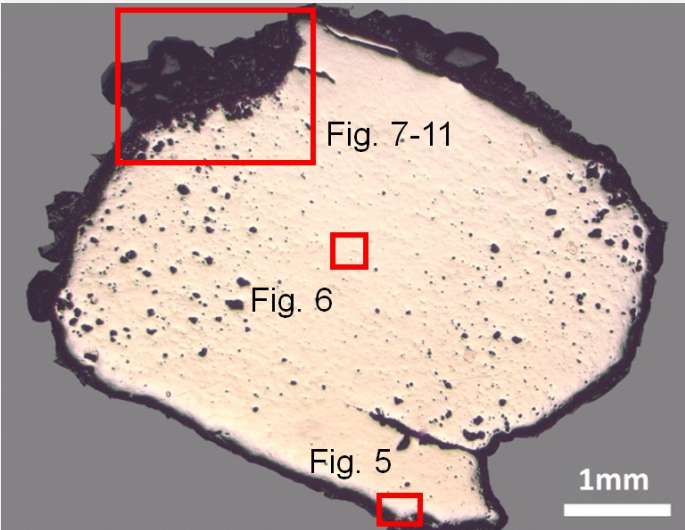
Fig. 3: Micrograph of the cross-section showing the location of Figs. 5 to 11,

Description of sample	The cross-section corresponds to a lateral cut (Fig. 2). The surface is covered with a thick corrosion crust (Fig. 3).
Alloy	Tin Bronze
Technology	Cold worked after annealing
Lab number of sample	MAH 87-197
Sample location	Musées d'art et d'histoire, Genève, Geneva

The remaining metal is a tin bronze (Table 1) with high porosity and large cracks both on the left and right edges of the sample (Fig. 3). The metal contains small, elongated copper sulphide (Table 2) and Pb inclusions that are oriented parallel to the cracks. Near the metal surface, slip lines are outlined by the development of intergranular corrosion (Fig. 5). The etched metal shows small, elongated grains with slip lines (Fig. 6). Annealing is visible in areas near the surface. The average hardness of the metal is HV1 145, but significant variations are observed, depending on where the measurements are taken.

The corrosion crust has a thickness between 0.1mm and 0.7mm (Fig. 3). In bright field (Fig. 7), one can observe that the metal has been replaced by light-grey corrosion products. Adjacent to the metal is a thick, heterogeneous, dark-grey layer with a band of light-grey corrosion products. In polarised light (Fig. 8), all corrosion products which were previously light-grey appear brown-orange, the dark-grey layer turquoise. The elemental chemical distribution of the SEM images (Figs. 9 and 10) reveals that the inner corrosion products are Sn-rich whereas the adjacent band is Cu and S-rich (Fig. 11). The outer layer contains large inclusions (quartz and others, Si, Al and Na, see Figs. 10-11) and is most probably composed of malachite/ $\text{Cu}_2(\text{CO}_3)(\text{OH})_2$  (only Cu and O are detected – Fig. 11). S is distributed throughout this layer. XRD analyses indicated the presence of posnjakite/ $\text{Cu}_4\text{SO}_4(\text{OH})_6\text{H}_2\text{O}$ , chalcocite/ $\text{Cu}_2\text{S}$  and djurleite/ $\text{Cu}_{1.93}\text{S}$  (Schweizer 1994).

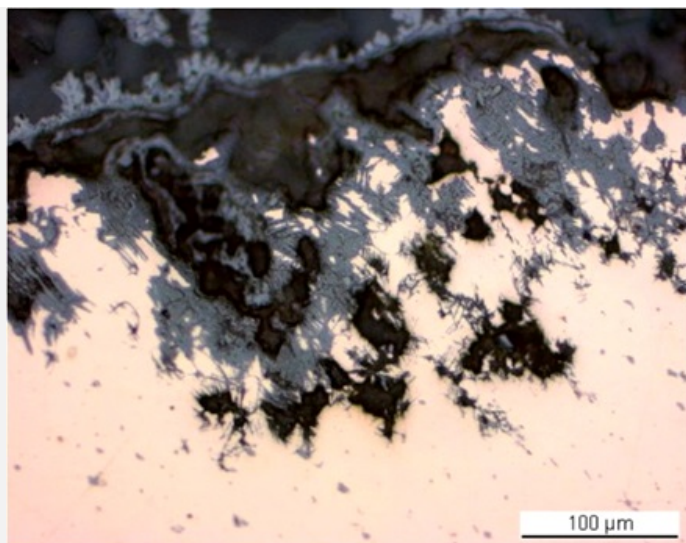
Fig. 5: Micrograph of the metal sample from Fig. 3 (inverted and reversed picture, detail), unetched, bright field. Corrosion products are in dark-grey whereas the metal is in pink. Slip lines are outlined by the development of intergranular corrosion,

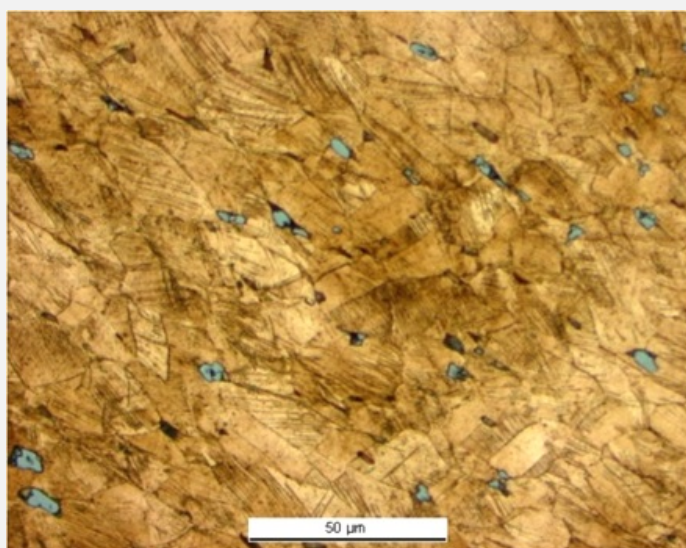
Fig. 6: Micrograph of the metal sample from Fig. 3 (detail), etched, bright field. We observe elongated grains with slip lines as well as grey copper sulphide inclusions,

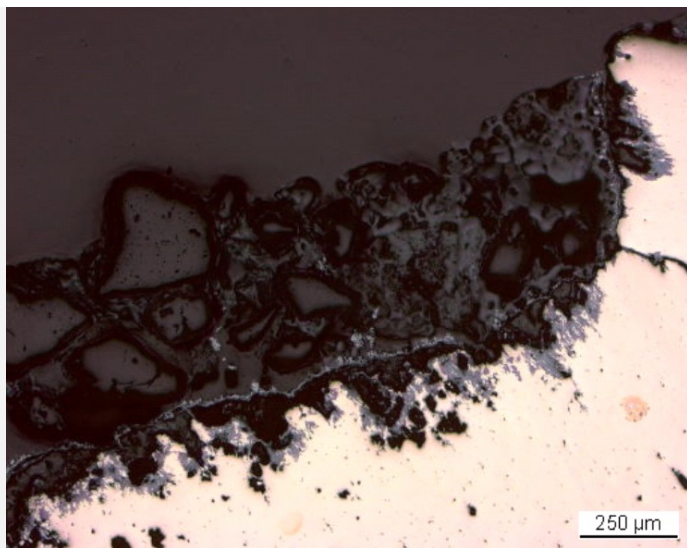
Fig. 7: Micrograph of the metal sample from Fig. 3 (detail), unetched, bright field. The inner light-grey corrosion products extend into the metal surface (in pink) and appear as a line within the dark-grey corrosion layer,

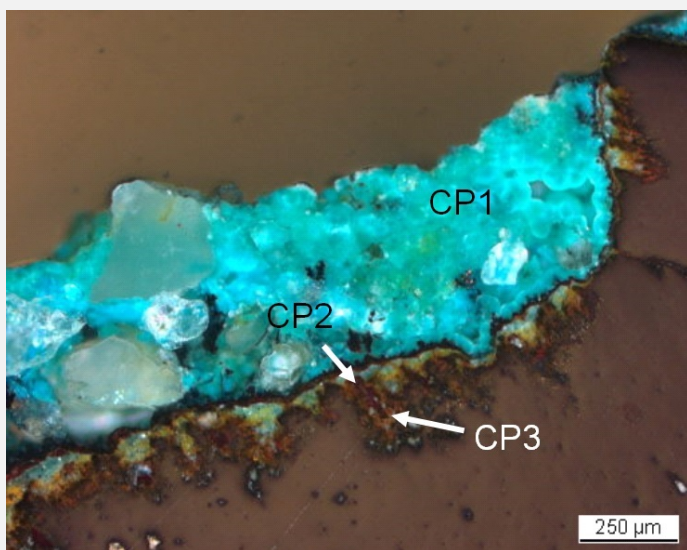
Fig. 8: Micrograph similar to Fig. 7 and corresponding to the stratigraphy of Fig. 4, polarized light. One can see that large mineral features are incorporated only in the corrosion layers above the brown-orange corrosion band,

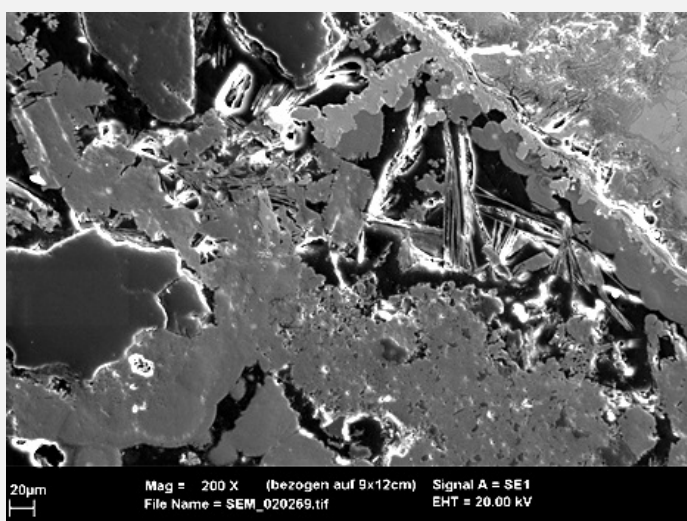
Fig. 9: SEM image (detail of Fig. 7), SE-mode. From bottom to top right: the thick, porous outer corrosion layer, the light-grey band and the remaining metal,

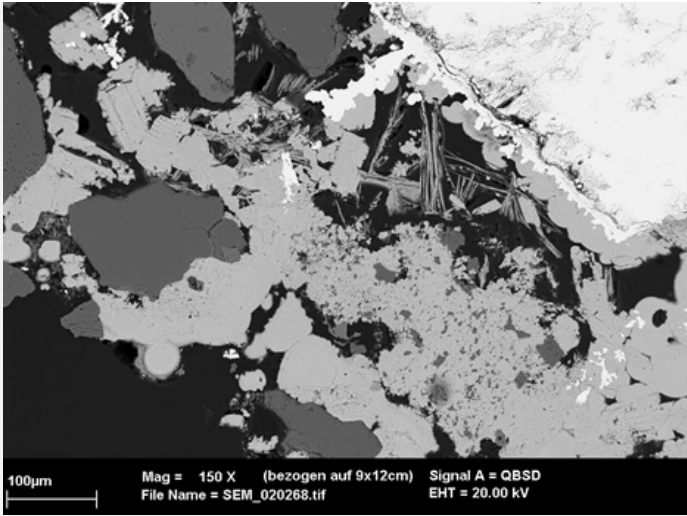
Fig. 10: SEM image, similar to Fig. 9, BSE-mode,

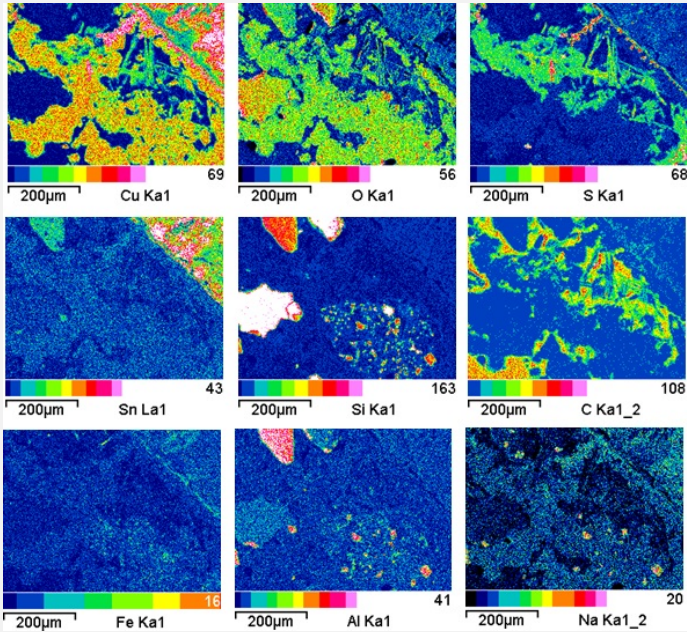
Fig. 11: EDS elemental chemical distribution of the SEM image of Fig. 9. Method of examination: SEM/EDS, Laboratory of Analytical Chemistry, Empa,

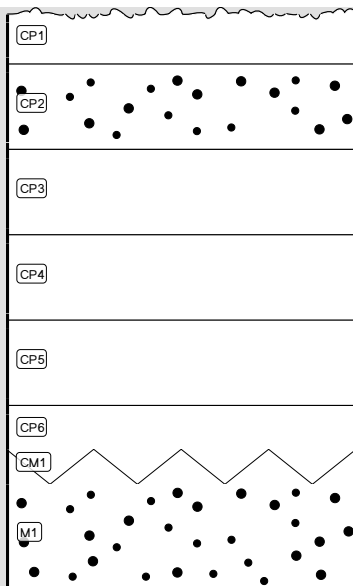
Fig. 4: Stratigraphic representation of the object in cross-section using the MiCorr application. This representation can be compared to Fig. 8, Credit HE-Arc CR.
