TANG FRAGMENT OF A KNIFE HR-6246 - TIN BRONZE - LATE BRONZE AGE - SWITZERLAND

Artefact name	Tang fragment of a knife HR-6246
Authors	Marianne. Senn (EMPA, Dübendorf, Zurich, Switzerland) & Christian. Degriigny (HE-Arc CR, Neuchâtel, Neuchâtel, Switzerland)
Url	/artefacts/398/

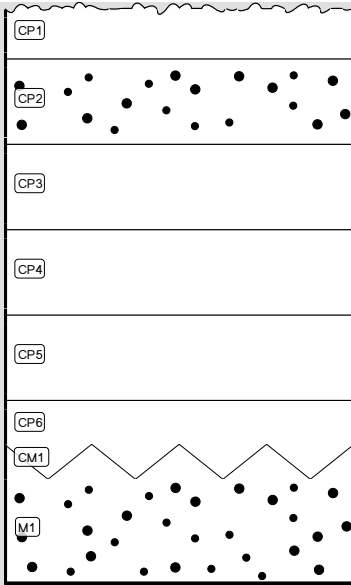
Fig. 4: Stratigraphic representation of the object in cross-section using the MiCorr application. This representation can be compared to Fig. 8, Credit HE-Arc CR.
