# TANG FRAGMENT OF A KNIFE HR-6246 - TIN BRONZE - LATE BRONZE AGE - SWITZERLAND

<b>Artefact name</b>	Tang fragment of a knife HR-6246
<b>Authors</b>	Marianne. Senn (EMPA, Dübendorf, Zurich, Switzerland) & Christian. Degriigny (HE-Arc CR, Neuchâtel, Neuchâtel, Switzerland)
<b>Url</b>	/artefacts/398/

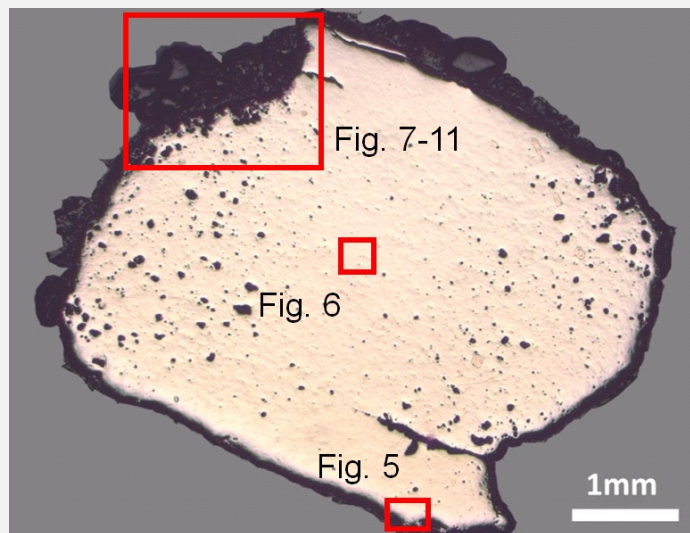
Fig. 3: Micrograph of the cross-section showing the location of Figs. 5 to 11,

The cross-section corresponds to a lateral cut (Fig. 2). The surface is covered with a thick corrosion crust (Fig. 3).

The remaining metal is a tin bronze (Table 1) with high porosity and large cracks both on the left and right edges of the sample (Fig. 3). The metal contains small, elongated copper sulphide (Table 2) and Pb inclusions that are oriented parallel to the cracks. Near the metal surface, slip lines are outlined by the development of intergranular corrosion (Fig. 5). The etched metal shows small, elongated grains with slip lines (Fig. 6). Annealing is visible in areas near the surface. The average hardness of the metal is HV1 145, but significant variations are observed, depending on where the measurements are taken.

The corrosion crust has a thickness between 0.1mm and 0.7mm (Fig. 3). In bright field (Fig. 7), one can observe that the metal has been replaced by light-grey corrosion products. Adjacent to the metal is a thick, heterogeneous, dark-grey layer with a band of light-grey corrosion products. In polarised light (Fig. 8), all corrosion products which were previously light-grey appear brown-orange, the dark-grey layer turquoise. The elemental chemical distribution of the SEM images (Figs. 9 and 10) reveals that the inner corrosion products are Sn-rich whereas the adjacent band is Cu and S-rich (Fig. 11). The outer layer contains large inclusions (quartz and others, Si, Al and Na, see Figs. 10-11) and is most probably composed of malachite/ $\text{Cu}_2(\text{CO}_3)(\text{OH})_2$  (only Cu and O are detected – Fig. 11). S is distributed throughout this layer. XRD analyses indicated the presence of posnjakite/ $\text{Cu}_4\text{SO}_4(\text{OH})_6\text{H}_2\text{O}$ , chalcocite/ $\text{Cu}_2\text{S}$  and djurleite/ $\text{Cu}_{1.93}\text{S}$  (Schweizer 1994).

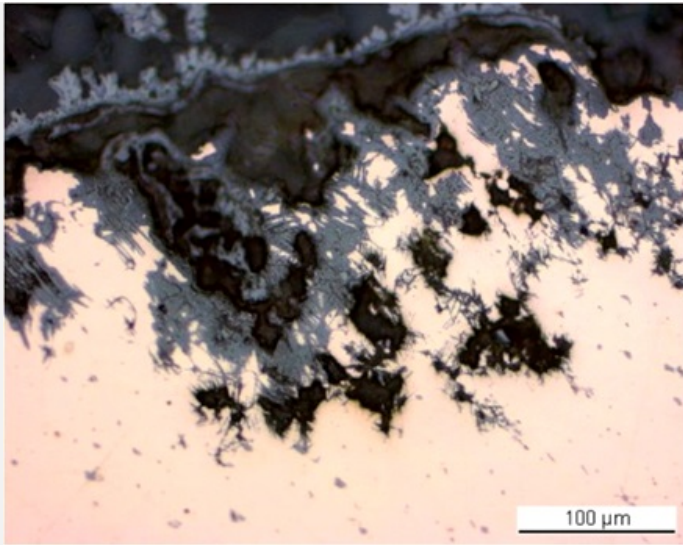
Fig. 5: Micrograph of the metal sample from Fig. 3 (inverted and reversed picture, detail), unetched, bright field. Corrosion products are in dark-grey whereas the metal is in pink. Slip lines are outlined by the development of intergranular corrosion,

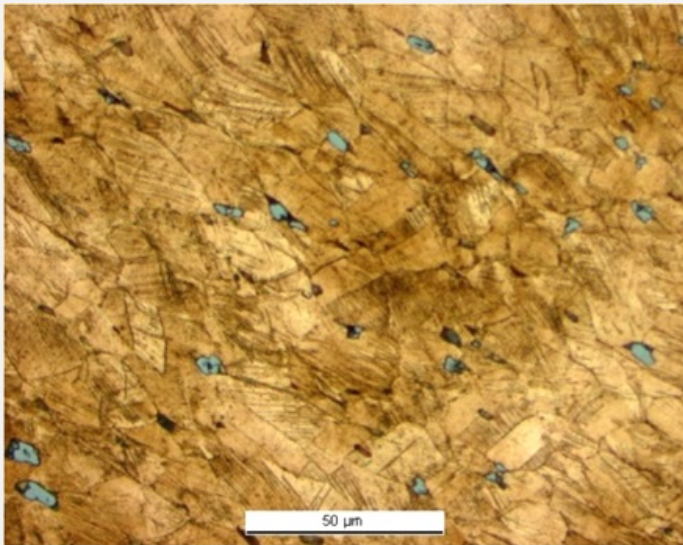
Fig. 6: Micrograph of the metal sample from Fig. 3 (detail), etched, bright field. We observe elongated grains with slip lines as well as grey copper sulphide inclusions,

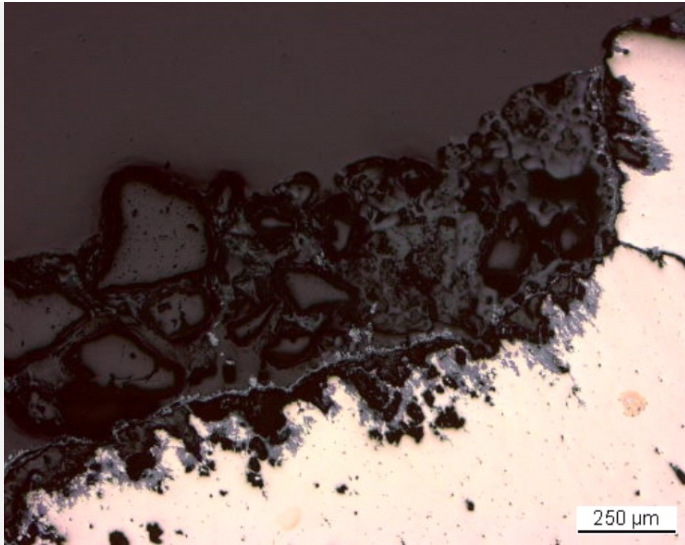
Fig. 7: Micrograph of the metal sample from Fig. 3 (detail), unetched, bright field. The inner light-grey corrosion products extend into the metal surface (in pink) and appear as a line within the dark-grey corrosion layer,

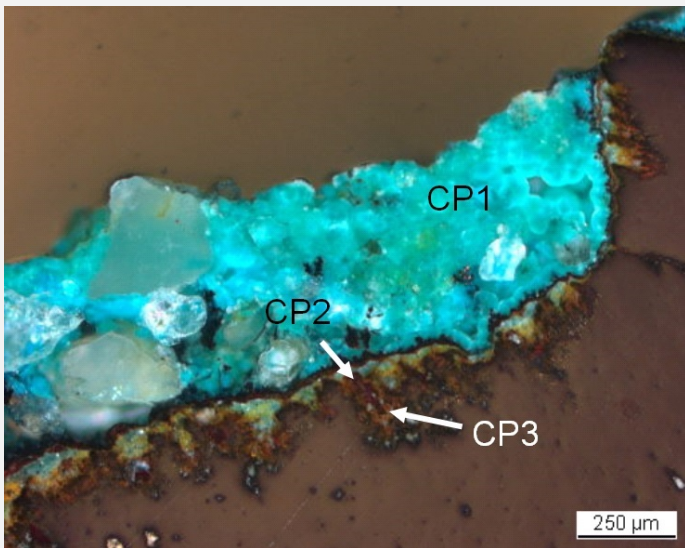
Fig. 8: Micrograph similar to Fig. 7 and corresponding to the stratigraphy of Fig. 4, polarized light. One can see that large mineral features are incorporated only in the corrosion layers above the brown-orange corrosion band,

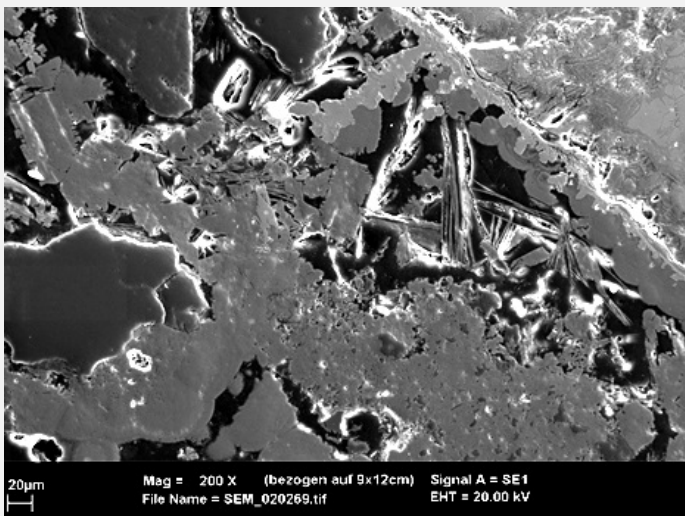
Fig. 9: SEM image (detail of Fig. 7), SE-mode. From bottom to top right: the thick, porous outer corrosion layer, the light-grey band and the remaining metal,

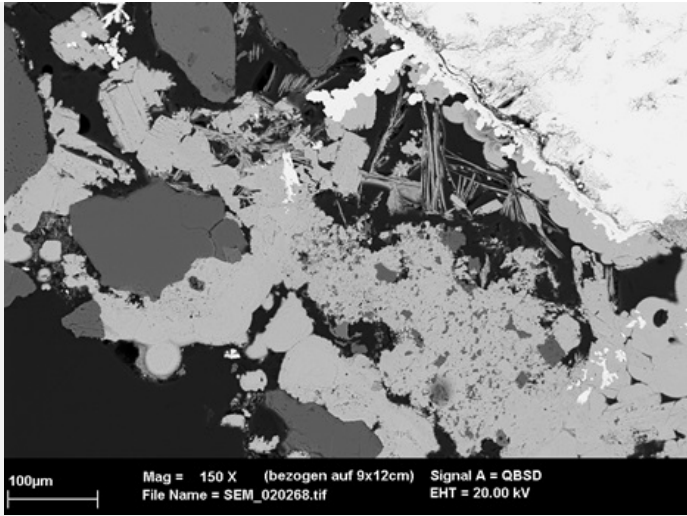
Fig. 10: SEM image, similar to Fig. 9, BSE-mode,

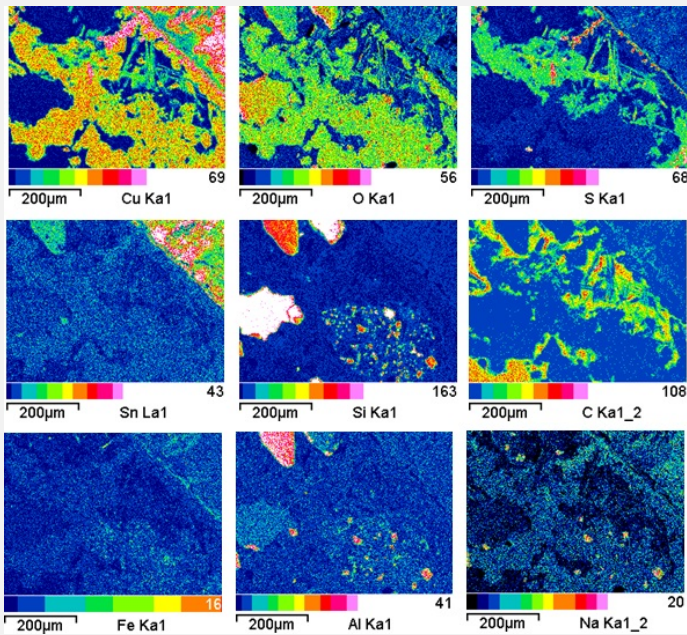
Fig. 11: EDS elemental chemical distribution of the SEM image of Fig. 9. Method of examination: SEM/EDS, Laboratory of Analytical Chemistry, Empa,

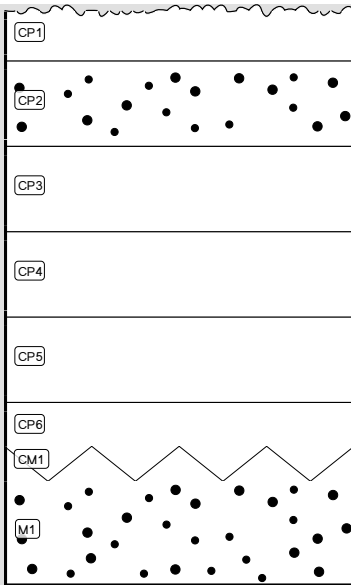
Fig. 4: Stratigraphic representation of the object in cross-section using the MiCorr application. This representation can be compared to Fig. 8, Credit HE-Arc CR.
