FUNERAL MASK IVC 11595 – CU/AG, WITH SURFACE ENRICHMENT (AG)

Artefact name Funeral mask Ivc 11595

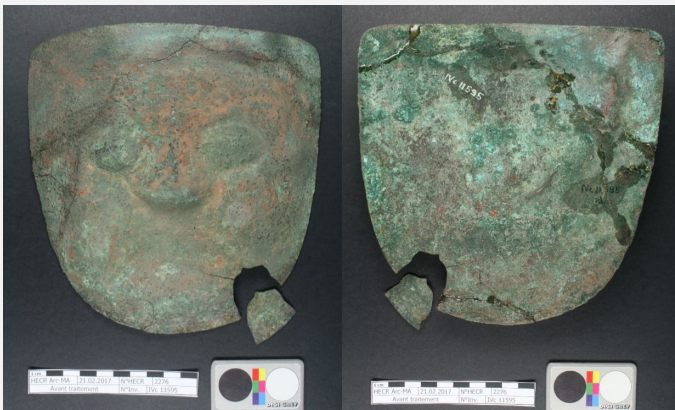
Fig. 1: Funeral mask, front and back face to the left and right respectively,

Description of the artefact	The object is a funeral mask made from a copper alloy (Fig. 1). There are remains of red pigment and of a mineralised textile on the both sides of the object. It is heavily corroded in green and red corrosion layers. It is deformed and broken. Dimensions: Length = 180mm; Width = 170mm; Height = 20 mm; WT = 158,6g.
Type of artefact	Funeral mask
Origin	Peru, north coast
Recovering date	Date of excavation unknown, acquisition in 1967
Chronology category	None
chronology tpq	<input type="text" value=""/> ---- ▾
chronology taq	<input type="text" value="1500"/> A.D. ▾
Chronology comment	Tpq (earliest): unknown, Taq (latest): 1500

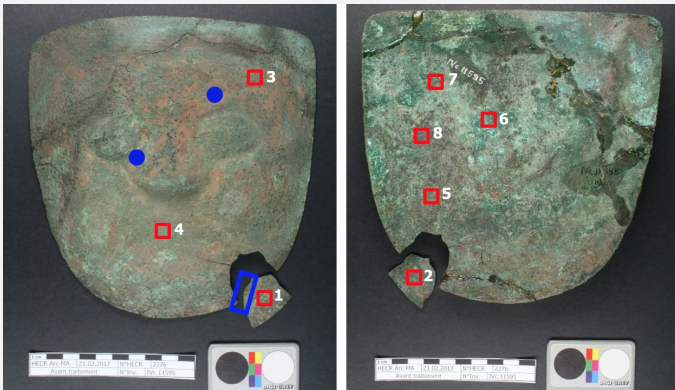
Fig. 2: Location of XRF analyses (red squares), cross-section area (blue square) and sampling areas for SEM-EDS (blue points),

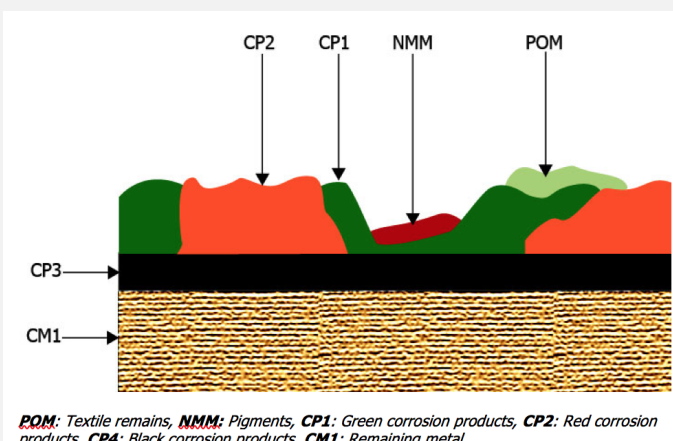
Fig. 3a: Stratigraphic representation of the artefact in cross-section by macroscopic observation, face of the object,

Fig. 3b: Stratigraphic representation of the artefact in cross-section by macroscopic observation, back of the object,

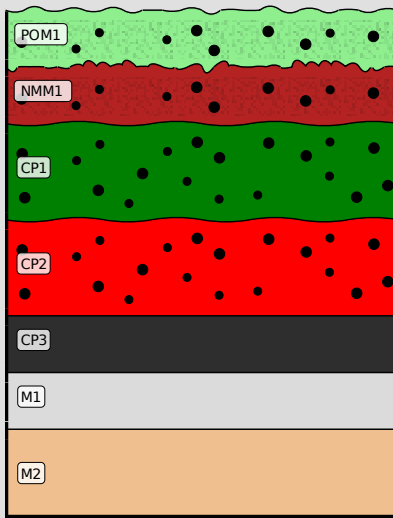
Fig. 5a: Schematic interpretation of the cross-section from 3a (front of the object), Credit HE-Arc CR, N. Gutknecht.

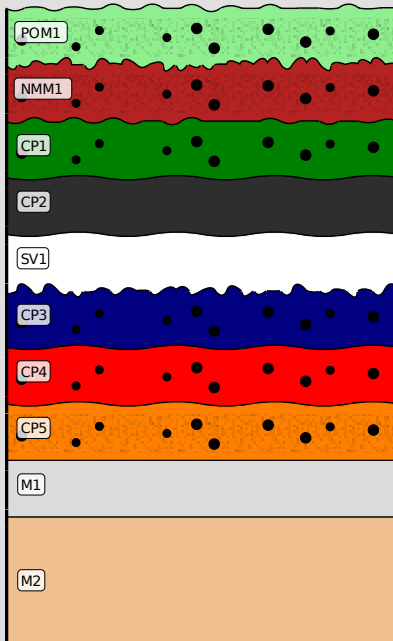
Fig. 5b: Schematic interpretation of the cross-section from 3b (back of the object), Credit HE-Arc CR, N. Gutknecht.
