FUNERAL MASK IVC 11595 – CU/AG, WITH SURFACE ENRICHMENT (AG)

Artefact name Funeral mask Ivc 11595

Url /artefacts/400/

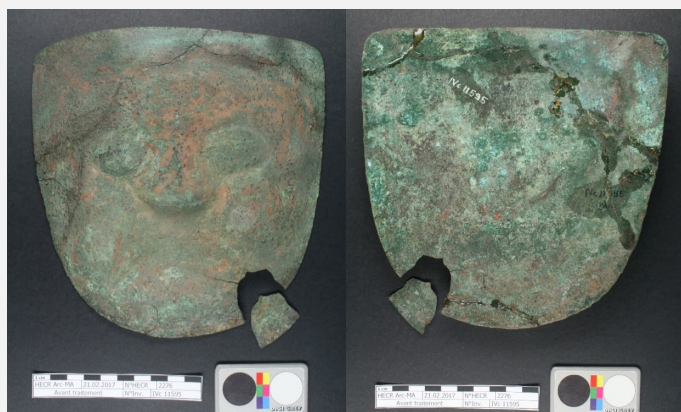
Fig. 1: Funeral mask, front and back face to the left and right respectively,

The object is a funeral mask made from a copper alloy (Fig. 1). There are remains of red pigment and of a mineralised textile on the both sides of the object. It is heavily corroded in green and red corrosion layers. It is deformed and broken.
Dimensions: Length = 180mm; Width = 170mm; Height = 20 mm; WT = 158,6g.

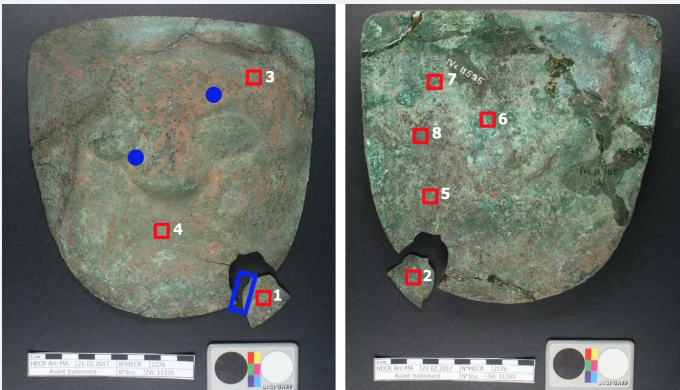
Fig. 2: Location of XRF analyses (red squares), cross-section area (blue square) and sampling areas for SEM-EDS (blue points),

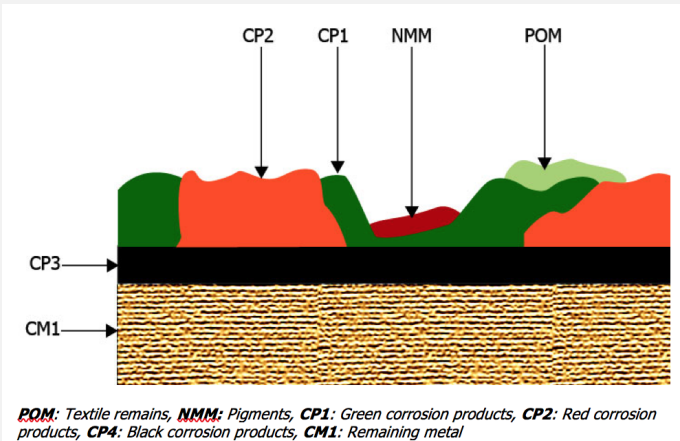
Fig. 3a: Stratigraphic representation of the artefact in cross-section by macroscopic observation, face of the object,

Fig. 3b: Stratigraphic representation of the artefact in cross-section by macroscopic observation, back of the object,

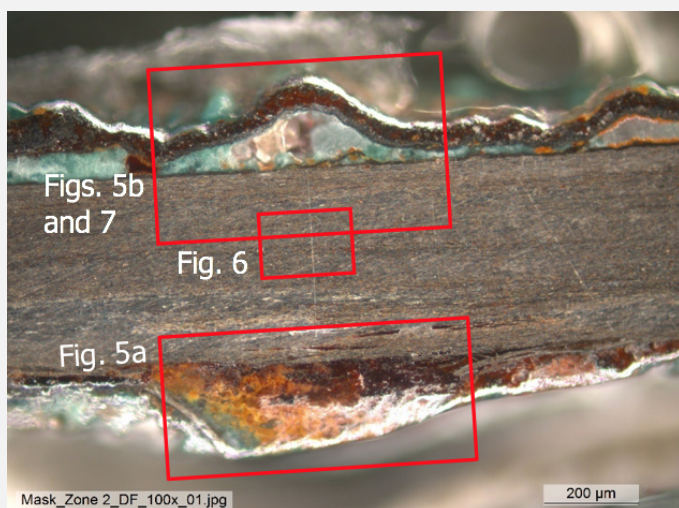
Fig. 4: Micrograph of the cross-section showing the locations of Figs. 5a (corresponding to the front of the object), Fig. 5b (back of the object), Figs. 6 and 7,

A polished section was made from an already detached fragment that was temporarily embedded in resin (Fig. 2). On Fig. 4 the upper part of the sample corresponds to the exterior (front) face of the object. Both sides have developed subsequent layers of corrosion. In areas, these have buckled and become detached.

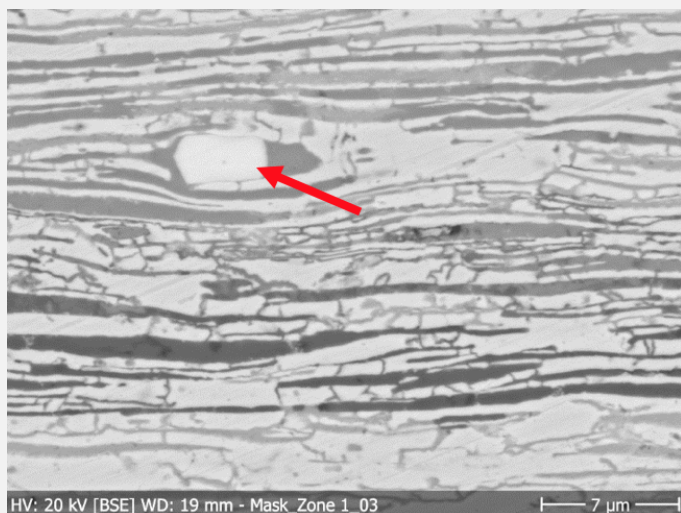
The XRF analysis is a surface analysis that was done without any removal of the copper corrosion products. The proportions are given for the oxide on the surface. The SEM/EDS analysis shows that there are Cu-rich phases alternating with Ag-rich phases. There are inclusions of Pb and As (Fig. 6). Cl has been detected throughout the entire corroded metal, most likely in the form of Cu and Ag corrosion products.

Fig. 6: SEM image (BSE-mode) of a selected area in the middle of the cross-section from Fig. 4 (detail), the elongated grains are the result of repeated hammering. Absence of strain lines indicates that the metal is annealed. The darker areas are Cu-rich phases and the lighter areas are Ag-rich phases. The arrow shows an As- and Pb inclusion,

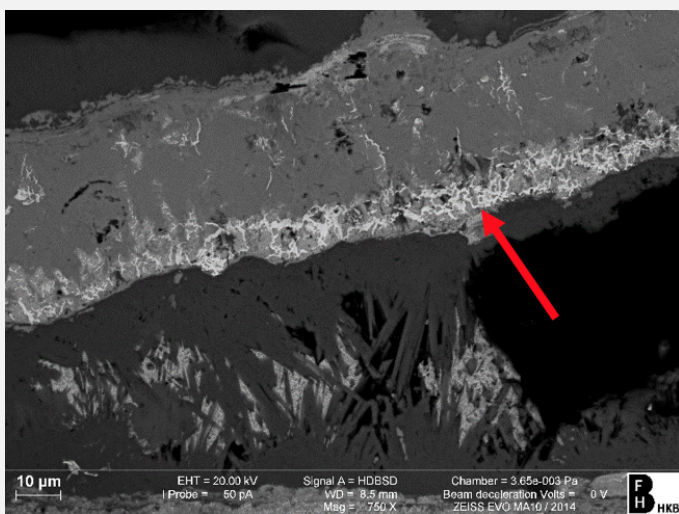
Fig. 8: SEM image of a partially refilled structural void with a silver-, copper- and mercury-rich layer (red arrow),

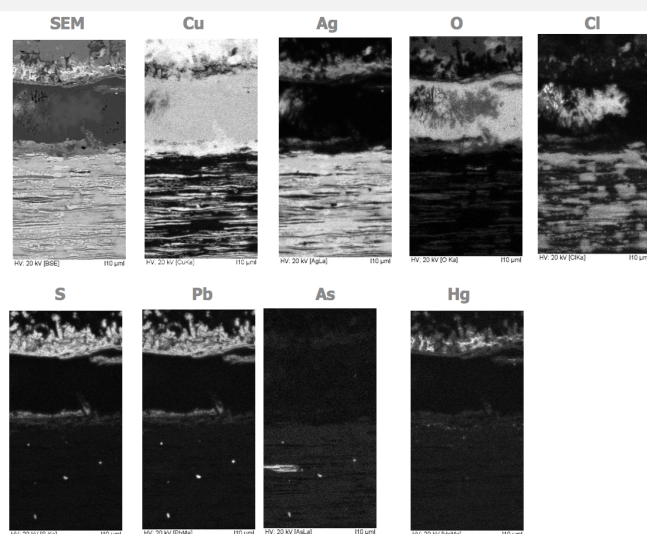
The remaining metal shows a preferential corrosion of copper and a presence of chlorides (Fig. 9, Table 1). There is a preferential corrosion of copper that has fragilized the structure of the sheet metal.

Fig. 9: SEM image (BSE-mode) and elemental chemical distribution of the selected area on Fig. 7. Method of examination: SEM/EDS,

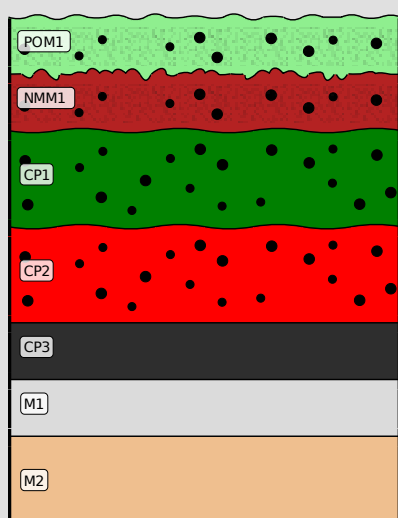
Fig. 5a: Schematic interpretation of the cross-section from 3a (front of the object), Credit HE-Arc CR, N. Gutknecht.

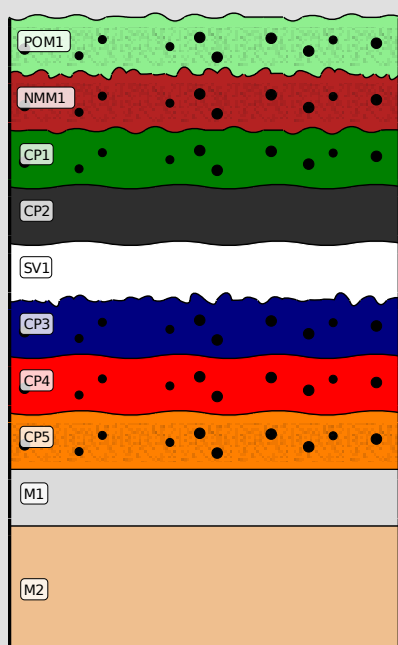
Fig. 5b: Schematic interpretation of the cross-section from 3b (back of the object), Credit HE-Arc CR, N. Gutknecht.

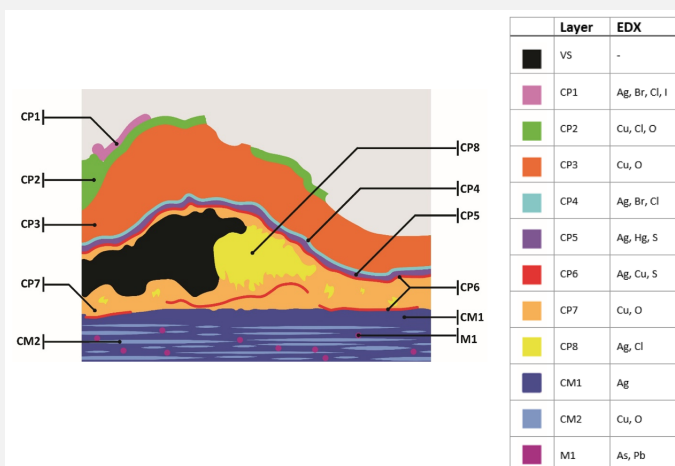
Fig. 16: Stratigraphic representation of Fig. 7 based on the results from the SEM-EDS analysis,

Close to the enriched silver surface and below the cuprite layer a silver- and mercury-rich stratum has formed. Only one publication mentions the reaction of cinnabar with a gold-enriched tumbaga surface but does not go into details about the possible mechanism involved (Masuda, S. (ed.) (1997)).

The presence of a silver-sulphur compound below this silver-mercury stratum could indicate that the cinnabar was reduced by electrochemical processes to mercury, releasing sulphur that reacted with the silver enriched surface. The mercury itself formed a silver-mercury layer above the latter. More research is needed to fully comprehend this phenomenon.
