VOTIVE FIGURE OF A BAT IVB4168 – GILDED BRASS

Artefact name Votive figure of a bat IVb4168

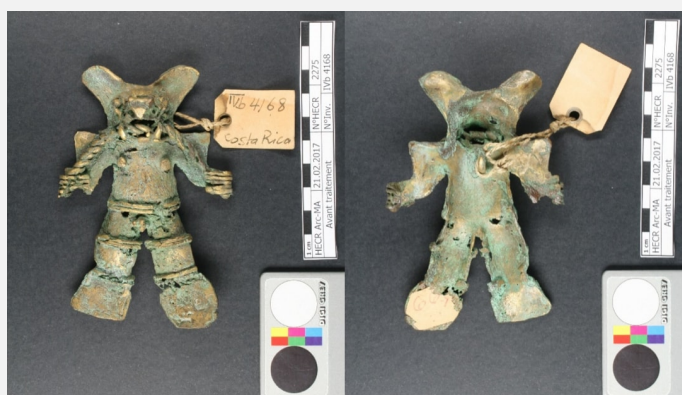
Fig. 1: Votive figure of a bat consisting of a Cu-alloy, front and back view,

The object represents a bat-like figure holding and chewing a rope (Fig. 1). The copper alloy was most likely cast using the lost wax process. There are remains of a surface gilding. The object has a red-brown adherent layer where the gold has flaked off with a heterogenous green and white loosely bound layer on top.

The metal seems to have been heavily attacked (acid dissolution). There are several perforations on the lower part of the object, and where the gold layer is absent the surface is unevenly pitted by corrosion (Figs. 1, 2 and 7). The submetallic core is not visible from the surface.

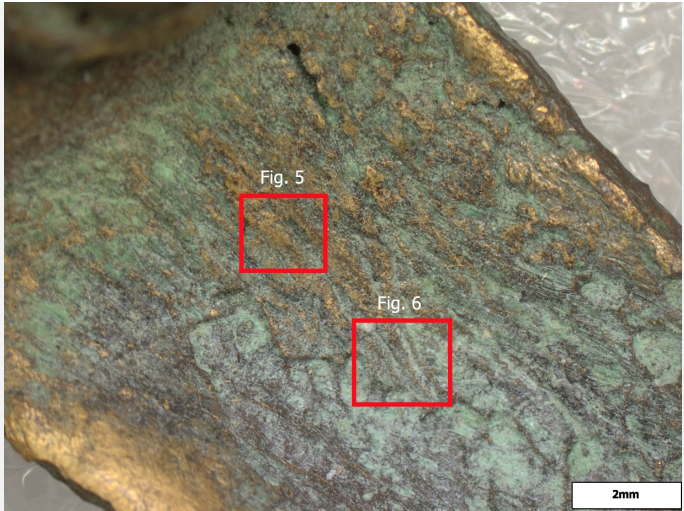
Fig. 4: Location of the areas used to build the MiCorr stratigraphies of figures 5 and 6,

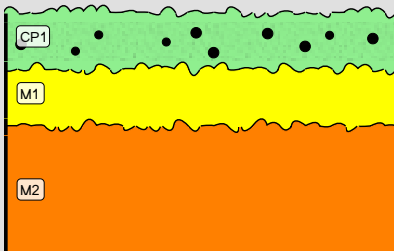
Fig 5: MiCorr stratigraphy 1 from Fig. 4, Credit HE-Arc CR, N.Gutknecht.

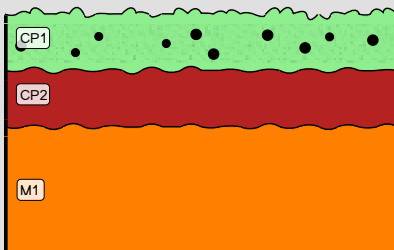
Fig. 6: MiCorr stratigraphy 2 from Fig. 4, Credit HE-Arc CR, N.Gutknecht.
