# VOTIVE FIGURE OF A BAT IVB4168 – GILDED BRASS

**Artefact name** Votive figure of a bat IVb4168

**Authors** Christian. Degriigny (HE-Arc CR, Neuchâtel, Neuchâtel, Switzerland) & Naima. Gutknecht (HE-Arc CR, Neuchâtel, Neuchâtel, Switzerland) & Valentin. Boissonnas (HE-Arc CR, Neuchâtel, Neuchâtel, Switzerland)

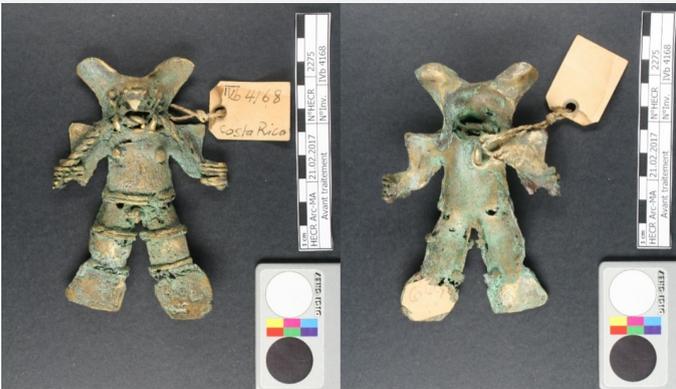
Fig. 1: Votive figure of a bat consisting of a Cu-alloy, front and back view,

**Description of the artefact** The object represents a bat-like figure holding and chewing a rope (Fig. 1). The copper alloy was most likely cast using the lost wax process. There are remains of a surface gilding. The object has a red-brown adherent layer where the gold has flaked off with a heterogenous green and white loosely bound layer on top.  
 Dimensions: Length = 110 mm; Width = 73mm; Height = 25mm; WT = 60g.

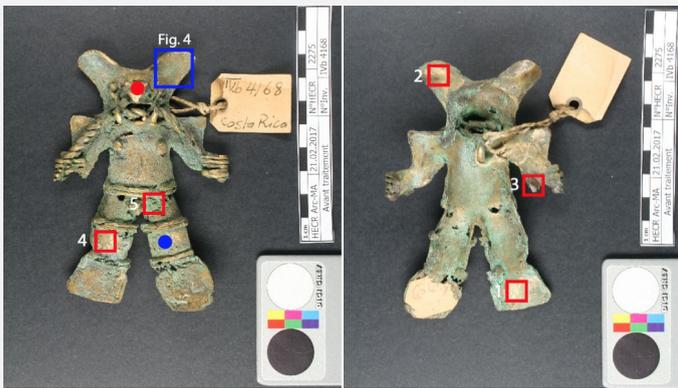
Fig. 2: Bat figure, front and back view. Location of XRF analyses (red squares), FTIR analysis (blue point) and SEM-EDS analyses (red point),

The metal seems to have been heavily attacked (acid dissolution). There are several perforations on the lower part of the object, and where the gold layer is absent the surface is unevenly pitted by corrosion (Figs. 1, 2 and 7). The submetallic core is not visible from the surface.

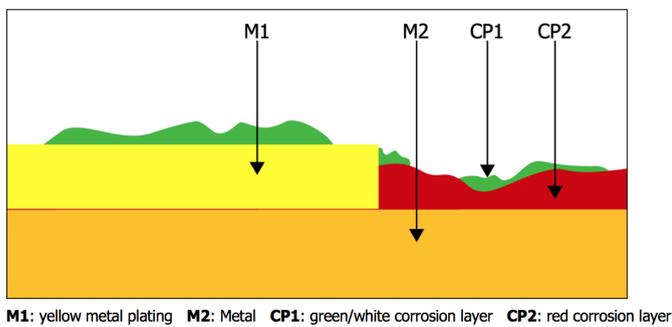
**M1:** yellow metal plating **M2:** Metal **CP1:** green/white corrosion layer **CP2:** red corrosion layer  
Credit HE-Arc CR, N.Gutknecht.

Fig. 3: Stratigraphic representation of the artefact in cross-section by macroscopic observation,

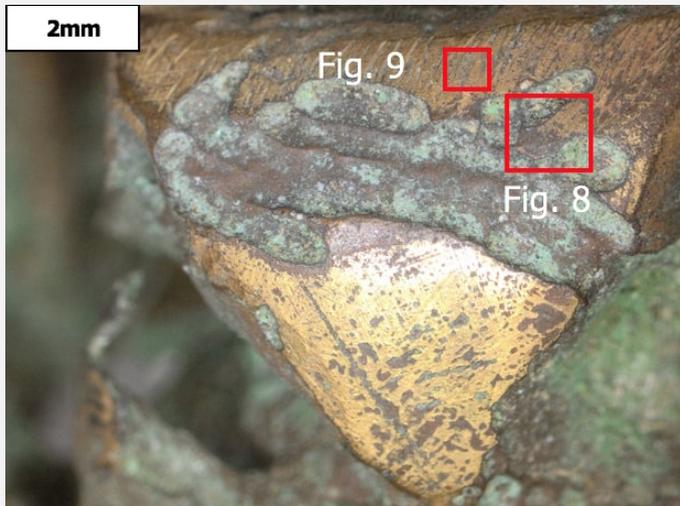
There are two corrosion products (Figs. 7, 8 and 9). The red one (CP2) has a submetallic brightness and is opaque, non-magnetic, compact, hard and adherent. It is very thin (less than a few microns thick) and only appears where the gold layer has been lost. The EDX spectrum (Fig. 10) shows that it is a Cu- and O rich product, probably cuprite (Cu<sub>2</sub>O).

Fig. 7: Binocular image of the metal showing details of Figs. 8 and 9,

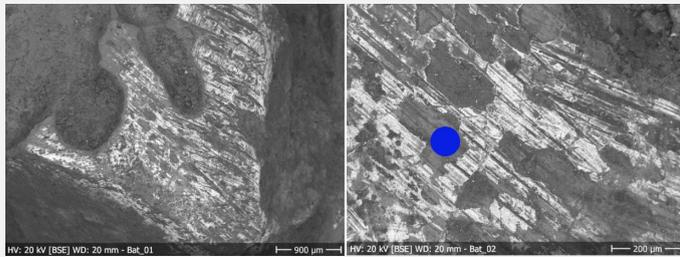
Figs. 8 and 9: SEM images of the metal on the nose of the object as indicated on Fig. 2. The blue point represents the area for the EDS point analysis (Fig. 10),

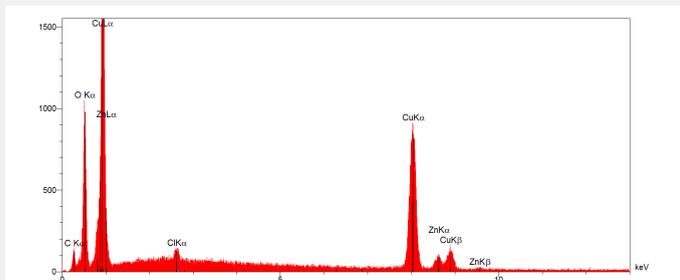
Fig. 10: EDS analysis of the red corrosion product. Method of analysis: SEM-EDS, Lab of Electronic Microscopy and Microanalysis, Néode, HEI Arc,

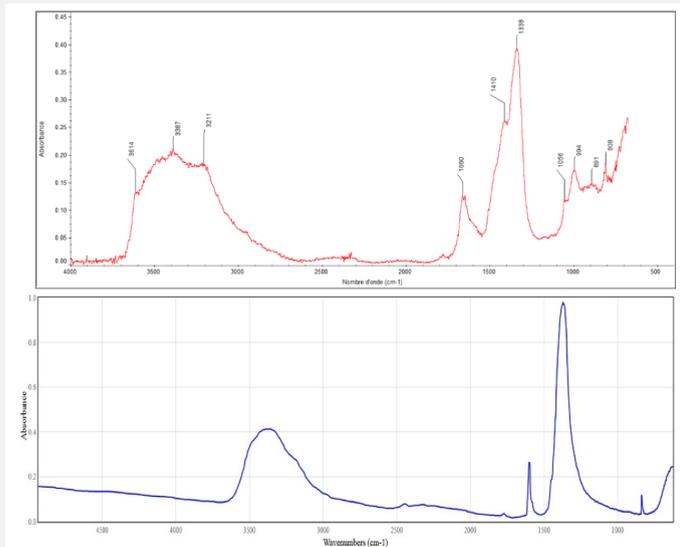
The light green to white corrosion product (CP1) has a waxy consistency and is thin, translucent, non-magnetic, powdery and very soft. It is very loosely bound. It is distributed on the whole object (front and back) as disparate clumps. It is mainly located on the cavities and irregularities of the surface. Its FTIR analysis (ATR mode) (Fig. 11) was performed on green and white areas of CP1. The two compounds have similar spectra and were identified as copper nitrate (Fig. 11b).

Fig. 11: FTIR spectrum (ATR mode) of the white corrosion product (top), and of synthesized copper nitrate (Cu(NO<sub>3</sub>)<sub>2</sub> \* 3H<sub>2</sub>O) (bottom),

FTIR analysis of the green/white corrosion product suggests that it is a copper nitrate, a highly water soluble corrosion product that cannot be found in an archaeological context. However, it has been recorded on artificially patinated copper alloys (Scott, D. (2000) p. 250-251 ; Craddock, P. (2009) p. 365).
