DOMED CAP NUT – ZN AL SN CU ALLOY – MODERN TIMES – FRANCE

Artefact name Domed cap nut

Authors Christian. Degriigny (HE-Arc CR, Neuchâtel, Neuchâtel, Switzerland) & Mathea. Hovind (University of Oslo, Department of archaeology, conservation and history (IAKH-UiO), Oslo, Oslo, Norway)

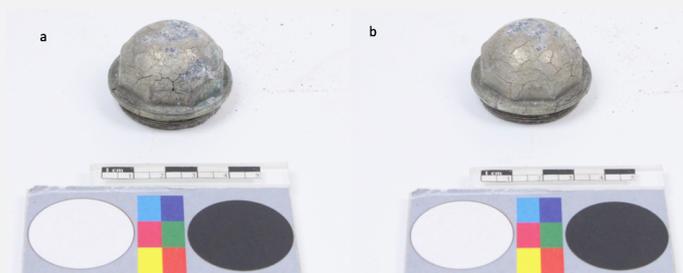
Fig. 1: Domed, threaded fitting, consisting of a Zn/Al/Pb/Cu/Sn alloy. Profile «a» and «b», to the left and right, respectively.

Description of the artefact	A domed, threaded fitting, consisting of a cast alloy with a metallic plating (Fig. 1). Its shape is octagonal and the inside is hollow. The plating is heavily cracked, leading to surface flaking. The metal appears to be consumed by some kind of internal corrosion. Dimensions: L (∅) = 40mm; H = 28mm; T = 5mm; WT = 49g.
Type of artefact	Cap
Origin	Château de Germolles, Mellecey, Bourgogne, France
Recovering date	Date unknown
Chronology category	Modern Times
chronology tpq	<input type="text" value="1801"/> A.D. ▾
chronology taq	<input type="text" value="2000"/> A.D. ▾
Chronology comment	19th - 20th century
Burial conditions / environment	Outdoor atmosphere

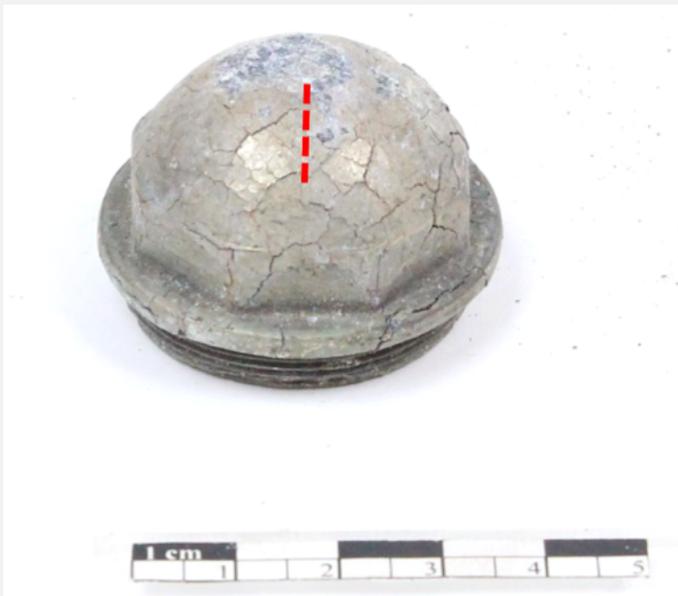
Fig. 2: Zones of the artefact submitted to visual observation and location of sampling area (a cross-section of the metal marked by the stippled line),

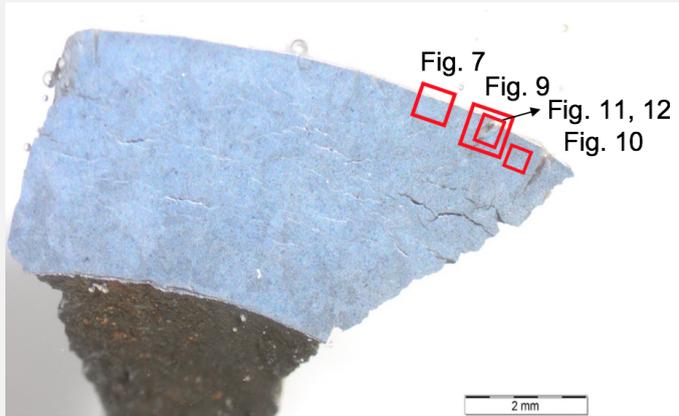
Fig. 4: Micrograph of the cross-section showing the locations of Figs. 7 and 9-12,

Description of sample	The sample is a cross section of the metal, representative of the head of the fitting. It shows external cracks extending from the metal surface and into its structure in addition to internal cracks, visible as thin lines along its longitudinal axis (Fig. 4).
Alloy	Zn Al Sn Cu Alloy
Technology	None
Lab number of sample	NZC2018 (Ni/Zn Cap, sampled in 2018)
Sample location	HE-Arc CR, Neuchâtel, Neuchâtel
Responsible institution	Haute Ecole Arc Conservation-Restoration
Date and aim of sampling	March 2018, study of corrosion stratigraphy and chemical analyses

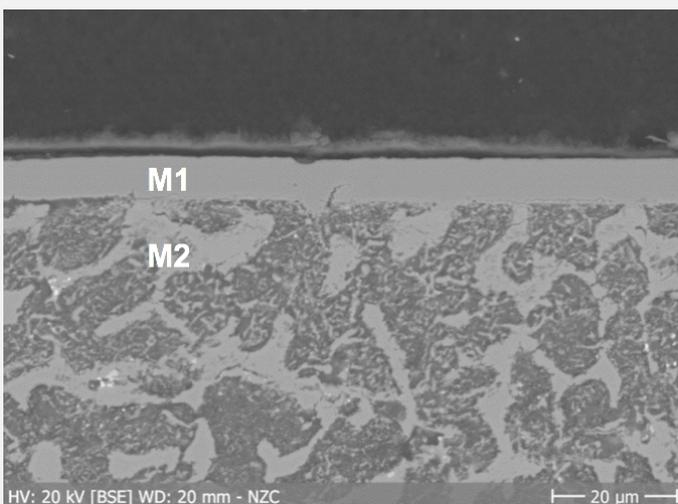
The metal of the domed fitting (M2) consists of a Zn/Al/Pb/Cu/Sn alloy (Table 1) externally covered by a nickel-based plating (M1) (Figs. 7 and 8). The bulk metal (M2) has a dendritic microstructure appearing light grey in bright field, while the interdendritic phase appears white (Fig. 9). The latter is Zn-rich, while the dendritic phase consists of approximately equal amounts of Zn and Al (Table 2, Fig. 11). Observation in SEM (BSE-mode) reveals the presence of Pb-nodules, visible as white irregular spots with a scattered distribution, in addition to opaque grey patches which are rich in Al and Fe (Fig. 10).

Fig. 7: SEM-image (BSE-mode) of a selected area from Fig. 4 (detail), showing the metal plating (M1) and the bulk metal (M2),

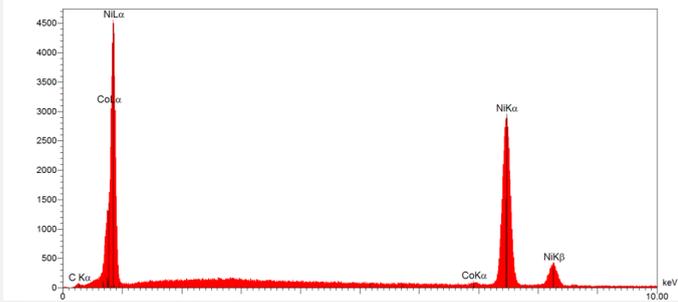
Fig. 8: EDS-spectrum showing the chemical composition of the metal plating (M1). Method of analysis: SEM-EDS. Lab. of Electronic Microscopy and and Microanalysis, Néode, HEI Arc,

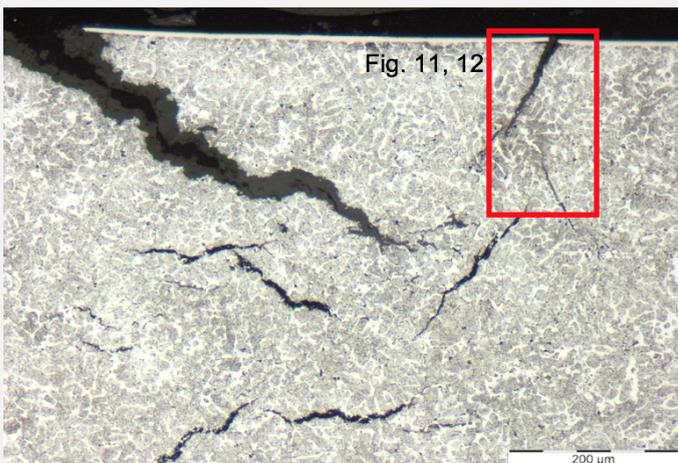
Fig. 9: Micrograph of the metal sample from Fig. 4 (detail), unetched, bright field. The dendrites appear light to dark grey while the interdendritic phase appears white. The metal is characterized by surface cracks as well as internal cracks. The upper red square corresponds to the area selected for elementary mapping by SEM-EDS (Figs. 11 and 12),

The dendritic phase is heavily oxidized compared to the interdendritic phase (Table 2 and Fig. 12). The corrosion has developed throughout the entire metal body, generating cracks (Fig. 9). The cracks are Zn and O-rich (Fig. 12) and could be composed of zinc carbonate. It could be a case of zinc pest, an intergranular corrosion phenomenon known to cause disintegration in poor quality alloys (Selwyn 2004:155-156, Zhang 2011:890).

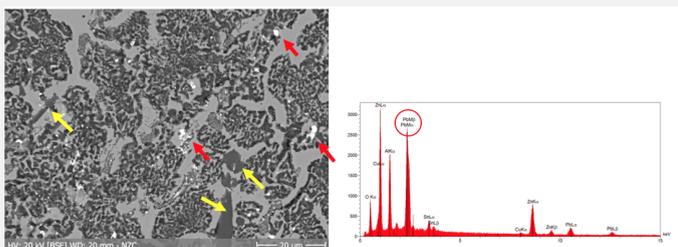
Fig. 10: SEM-image in BSE-mode (left) and EDS-spectrum (right), showing the appearance and the chemical composition of the Pb inclusions (red arrows). The inclusions appear white, the dendrites appear dark grey/black and the interdendritic phase appears grey. Grey opaque patches (yellow arrows) are Fe- and Al-rich phases,

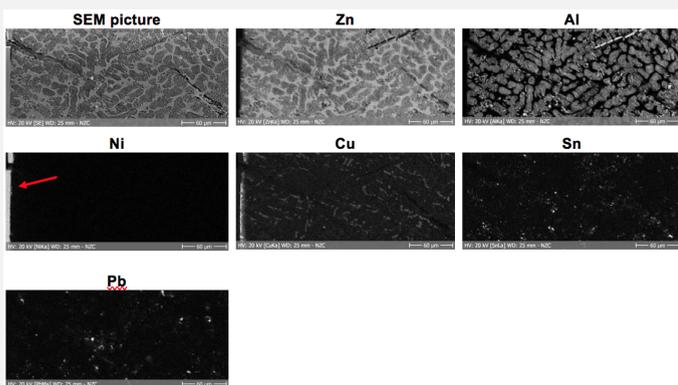
Fig. 11: SEM image and elemental chemical distribution of the selected area from Fig. 9 (rotated 270° and inverted). Method of analysis: SEM-EDS. Lab. of Electronic Microscopy and Microanalysis, Néode, HEI Arc,

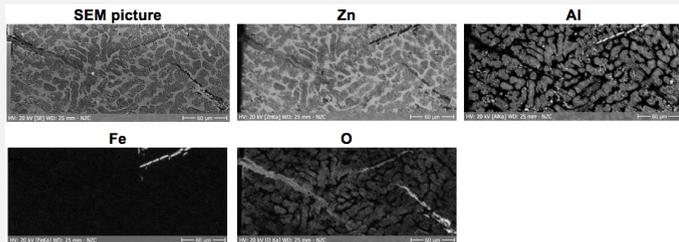
Fig. 12: SEM image and elemental chemical distribution of the selected area from Fig. 9 (rotated 270° and inverted). Method of analysis: SEM-EDS. Lab. of Electronic Microscopy and Microanalysis, Néode, HEI Arc,

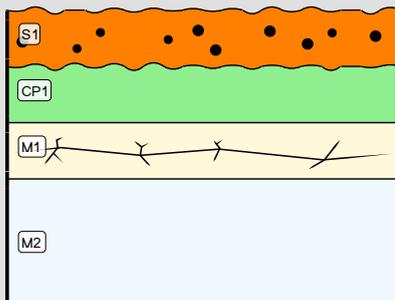
Fig. 5: A MiCorr stratigraphy representative of an area with intact metal plating (M1). S1 represents Fe-polluted soil while CP1 is a green translucent corrosion product, Credit UiO-IAKH, M.Hovind.

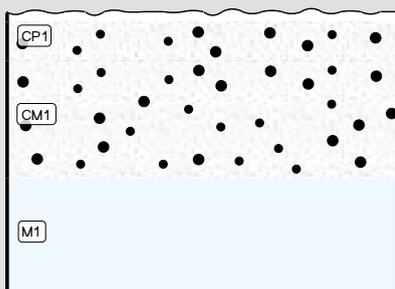
Fig. 6: A MiCorr stratigraphy representative of an area where the metal plating is missing. CP1 corresponds to CP2 in Fig. 3, CM1 represents the corroded metal phase, while M1 corresponds to the bulk metal (M2 in Fig. 3), Credit UiO-IAKH, M.Hovind.
