DOMED CAP NUT – ZN AL SN CU ALLOY – MODERN TIMES – FRANCE

Artefact name	Domed cap nut
Authors	Christian. Degriigny (HE-Arc CR, Neuchâtel, Neuchâtel, Switzerland) & Mathea. Hovind (University of Oslo, Department of archaeology, conservation and history (IAKH-UiO), Oslo, Oslo, Norway)
Url	/artefacts/402/

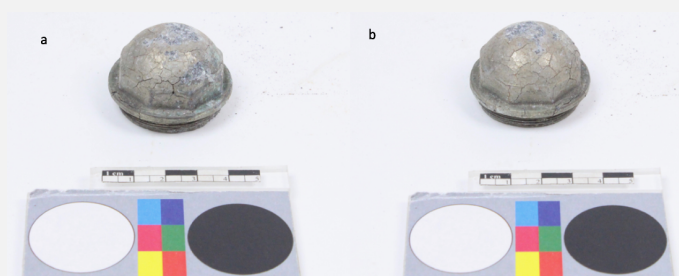
Fig. 1: Domed, threaded fitting, consisting of a Zn/Al/Pb/Cu/Sn alloy. Profile «a» and «b», to the left and right, respectively,

Description of the artefact	A domed, threaded fitting, consisting of a cast alloy with a metallic plating (Fig. 1). Its shape is octagonal and the inside is hollow. The plating is heavily cracked, leading to surface flaking. The metal appears to be consumed by some kind of internal corrosion. Dimensions: L (ø) = 40mm; H = 28mm; T = 5mm; WT = 49g.
Type of artefact	Cap
Origin	Château de Germolles, Mellecey, Bourgogne, France
Recovering date	Date unknown
Chronology category	Modern Times
chronology tpq	1801 A.D. ▼
chronology taq	2000 A.D. ▼
Chronology comment	19th - 20th century
Burial conditions / environment	Outdoor atmosphere
Artefact location	Haute Ecole Arc Conservation-Restaurations

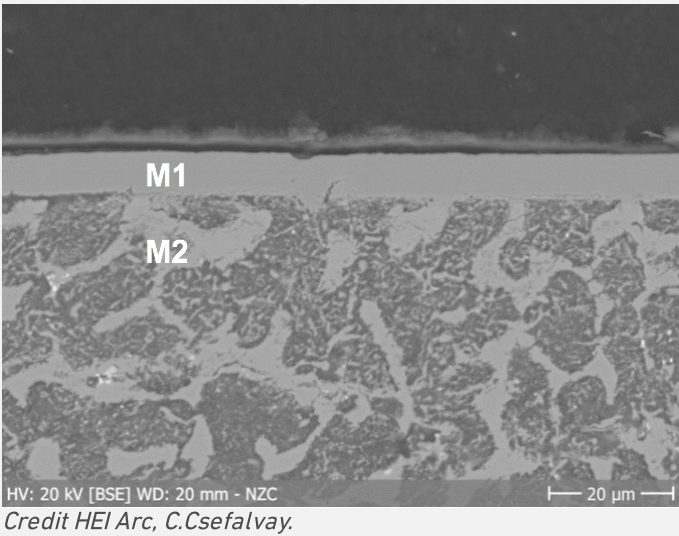
The metal of the domed fitting (M2) consists of a Zn/Al/Pb/Cu/Sn alloy (Table 1) externally covered by a nickel-based plating (M1) (Figs. 7 and 8). The bulk metal (M2) has a dendritic microstructure appearing light grey in bright field, while the interdendritic phase appears white (Fig. 9). The latter is Zn-rich, while the dendritic phase consists of approximately equal amounts of Zn and Al (Table 2, Fig. 11). Observation in SEM (BSE-mode) reveals the presence of Pb-nodules, visible as white irregular spots with a scattered distribution, in addition to opaque grey patches which are rich in Al and Fe (Fig. 10).

Fig. 7: SEM-image (BSE-mode) of a selected area from Fig. 4 (detail), showing the metal plating (M1) and the bulk metal (M2),

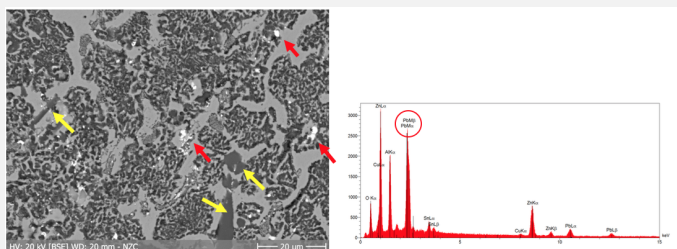
Fig. 10: SEM-image in BSE-mode (left) and EDS-spectrum (right), showing the appearance and the chemical composition of the Pb inclusions (red arrows). The inclusions appear white, the dendrites appear dark grey/black and the interdendritic phase appears grey. Grey opaque patches (yellow arrows) are Fe- and Al-rich phases,

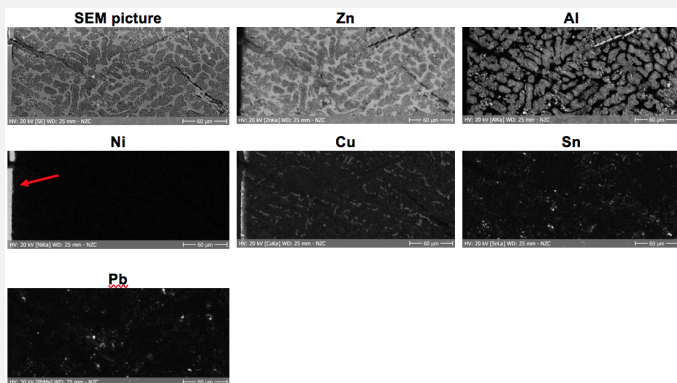
Fig. 11: SEM image and elemental chemical distribution of the selected area from Fig. 9 (rotated 270° and inverted). Method of analysis: SEM-EDS. Lab. of Electronic Microscopy and Microanalysis, Néode, HEI Arc,

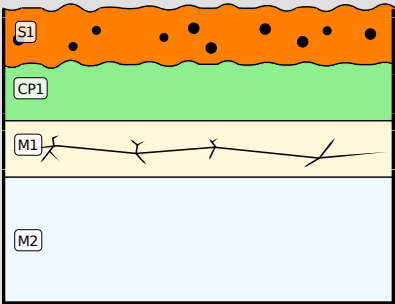
Fig. 5: A MiCorr stratigraphy representative of an area with intact metal plating (M1). S1 represents Fe-polluted soil while CP1 is a green translucent corrosion product, Credit UiO-IAKH, M.Hovind.

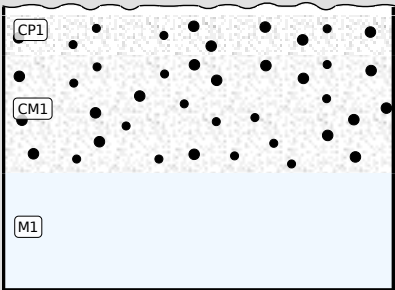
Fig. 6: A MiCorr stratigraphy representative of an area where the metal plating is missing. CP1 corresponds to CP2 in Fig. 3, CM1 represents the corroded metal phase, while M1 corresponds to the bulk metal (M2 in Fig. 3), Credit UiO-IAKH, M.Hovind.
