DOMED CAP NUT – ZN AL SN CU ALLOY – MODERN TIMES – FRANCE

Artefact name	Domed cap nut
Authors	Christian. Degriigny (HE-Arc CR, Neuchâtel, Neuchâtel, Switzerland) & Mathea. Hovind (University of Oslo, Department of archaeology, conservation and history (IAKH-UiO), Oslo, Oslo, Norway)
Url	/artefacts/402/

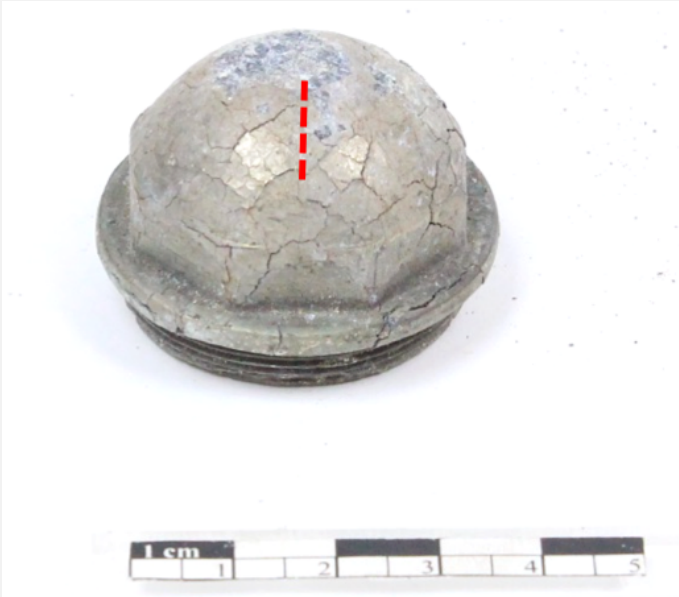
Fig. 2: Zones of the artefact submitted to visual observation and location of sampling area (a cross-section of the metal marked by the stippled line),

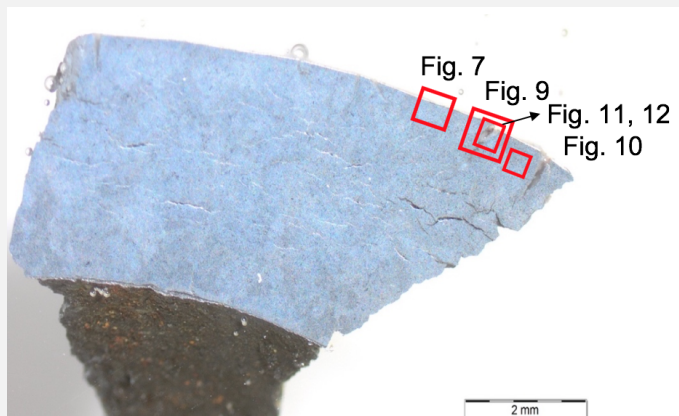
Fig. 4: Micrograph of the cross-section showing the locations of Figs. 7 and 9-12,

The sample is a cross section of the metal, representative of the head of the fitting. It shows external cracks extending from the metal surface and into its structure in addition to internal cracks, visible as thin lines along its longitudinal axis (Fig. 4).

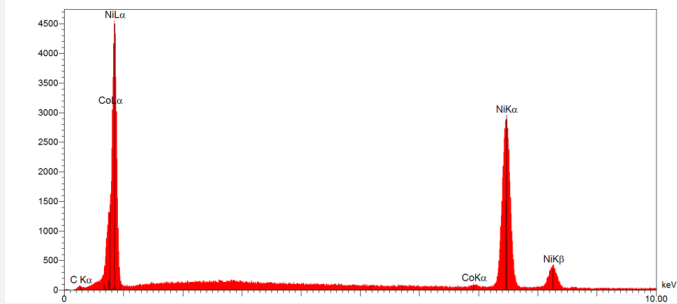
Fig. 8: EDS-spectrum showing the chemical composition of the metal plating (M1). Method of analysis: SEM-EDS. Lab. of Electronic Microscopy and and Microanalysis, Néode, HEI Arc,

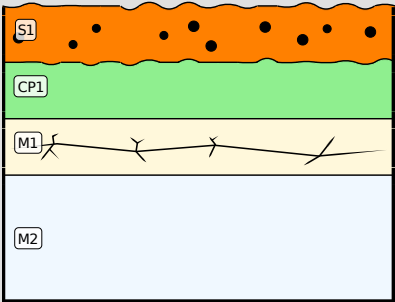
Fig. 5: A MiCorr stratigraphy representative of an area with intact metal plating (M1). S1 represents Fe-polluted soil while CP1 is a green translucent corrosion product, Credit UiO-IAKH, M.Hovind.

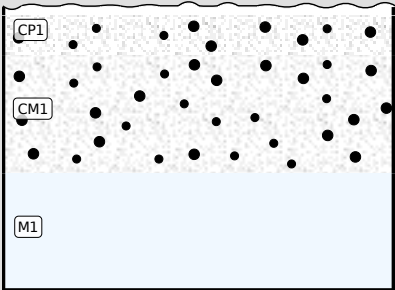
Fig. 6: A MiCorr stratigraphy representative of an area where the metal plating is missing. CP1 corresponds to CP2 in Fig. 3, CM1 represents the corroded metal phase, while M1 corresponds to the bulk metal (M2 in Fig. 3), Credit UiO-IAKH, M.Hovind.
