DOMED CAP NUT – ZN AL SN CU ALLOY – MODERN TIMES – FRANCE

Artefact name	Domed cap nut
Authors	Christian. Degriigny (HE-Arc CR, Neuchâtel, Neuchâtel, Switzerland) & Mathea. Hovind (University of Oslo, Department of archaeology, conservation and history (IAKH-UiO), Oslo, Oslo, Norway)
Url	/artefacts/402/

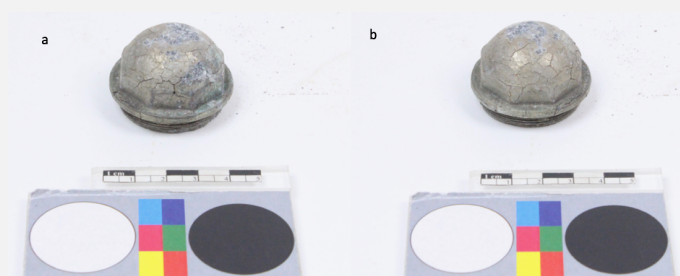
Fig. 1: Domed, threaded fitting, consisting of a Zn/Al/Pb/Cu/Sn alloy. Profile «a» and «b», to the left and right, respectively,

Description of the artefact	A domed, threaded fitting, consisting of a cast alloy with a metallic plating (Fig. 1). Its shape is octagonal and the inside is hollow. The plating is heavily cracked, leading to surface flaking. The metal appears to be consumed by some kind of internal corrosion. Dimensions: L (ø) = 40mm; H = 28mm; T = 5mm; WT = 49g.
Type of artefact	Cap
Origin	Château de Germolles (14th century), Mellecey, Bourgogne, France
Recovering date	Date unknown
Chronology category	Modern Times
chronology tpq	1801 A.D. ▼
chronology taq	2000 A.D. ▼
Chronology comment	19th - 20th century
Burial conditions / environment	Outdoor atmosphere
Artefact location	Haute Ecole Arc Conservation-Restauration

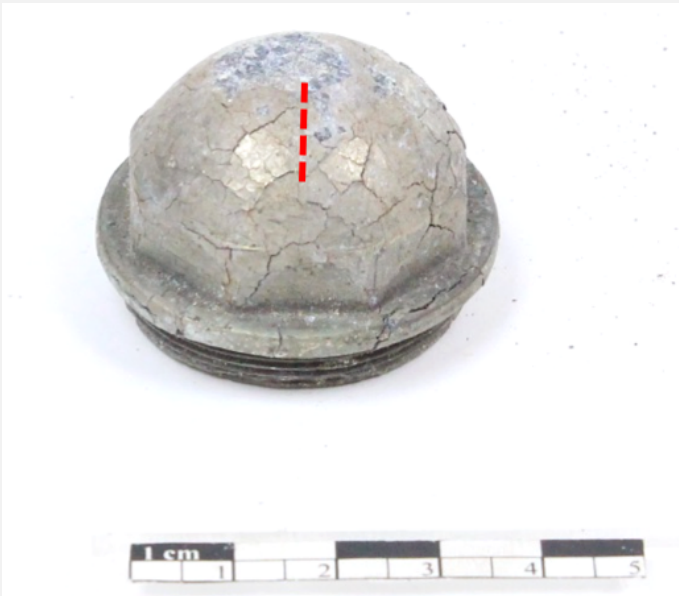
Fig. 2: Zones of the artefact submitted to visual observation and location of sampling area (a cross-section of the metal marked by the stippled line),

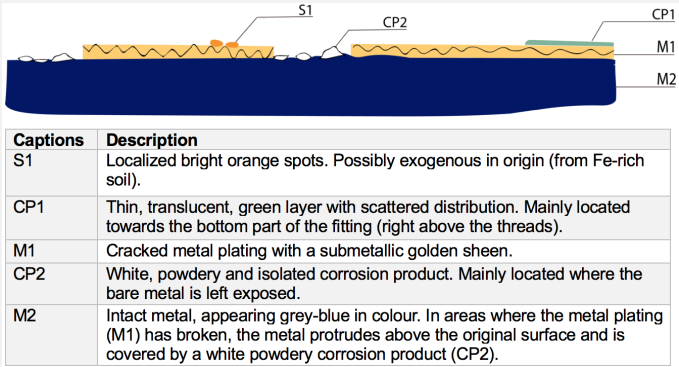
Fig. 3: Preliminary stratigraphy corresponding to the overall surface of the artefact. CP = Corrosion Product, S = Soil, M = Metal,

The external corrosion products and deposits (Fig. 3) were documented but not analyzed as they were considered to be mainly exogenous in origin and not the main reason behind the deterioration of the object. The orange deposit (S1) is probably soil from Fe-rich environment, while the thin green layer (CP1) is most likely consisting of an oxide of Ni from the metal plating (M1). The white corrosion product (CP2) can either be a salt from the environment, or corrosion products of Zn/Al.

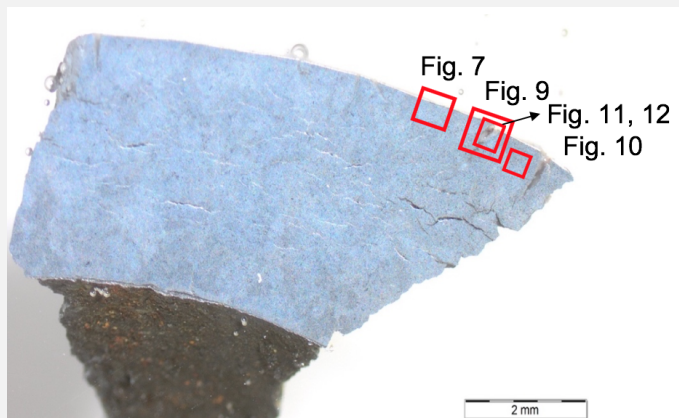
Fig. 4: Micrograph of the cross-section showing the locations of Figs. 7 and 9-12,

The sample is a cross section of the metal, representative of the head of the fitting. It shows external cracks extending from the metal surface and into its structure in addition to internal cracks, visible as thin lines along its longitudinal axis (Fig. 4).

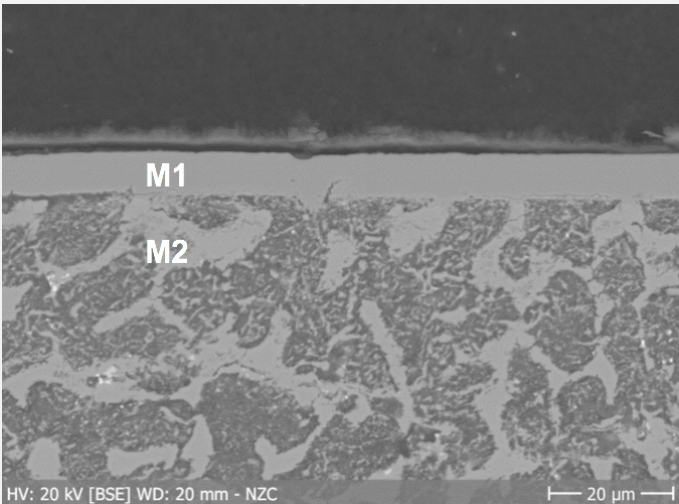
The metal of the domed fitting (M2) consists of a Zn/Al/Pb/Cu/Sn alloy (Table 1) externally covered by a nickel-based plating (M1) (Figs. 7 and 8). The bulk metal (M2) has a dendritic microstructure appearing light grey in bright field, while the interdendritic phase appears white (Fig. 9). The latter is Zn-rich, while the dendritic phase consists of approximately equal amounts of Zn and Al (Table 2, Fig. 11). Observation in SEM (BSE-mode) reveals the presence of Pb-nodules, visible as white irregular spots with a scattered distribution, in addition to opaque grey patches which are rich in Al and Fe (Fig. 10).

Fig. 7: SEM-image (BSE-mode) of a selected area from Fig. 4 (detail), showing the metal plating (M1) and the bulk metal (M2),

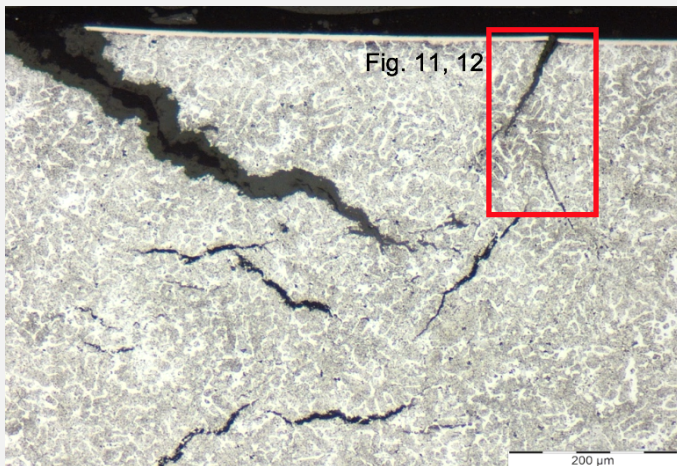
Fig. 9: Micrograph of the metal sample from Fig. 4 (detail), unetched, bright field. The dendrites appear light to dark grey while the interdendritic phase appears white. The metal is characterized by surface cracks as well as internal cracks. The upper red square corresponds to the area selected for elementary mapping by SEM-EDS (Figs. 11 and 12),

The dendritic phase is heavily oxidized compared to the interdendritic phase (Table 2 and Fig. 12). The corrosion has developed throughout the entire metal body, generating cracks (Fig. 9). The cracks are Zn and O-rich (Fig. 12) and could be composed of zinc carbonate. It could be a case of zinc pest, an intergranular corrosion phenomenon known to cause disintegration in poor quality alloys (Selwyn 2004:155-156, Zhang 2011:890).

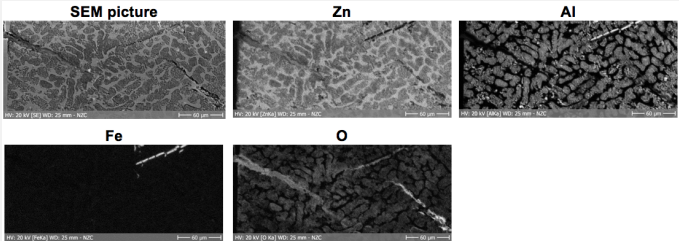
Fig. 12: SEM image and elemental chemical distribution of the selected area from Fig. 9 (rotated 270° and inversed). Method of analysis: SEM-EDS. Lab. of Electronic Microscopy and Microanalysis, Néode, HEI Arc,

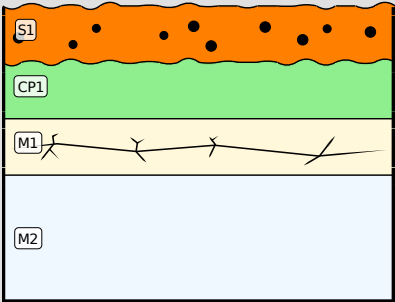
Fig. 5: A MiCorr stratigraphy representative of an area with intact metal plating (M1). S1 represents Fe-polluted soil while CP1 is a green translucent corrosion product, Credit UiO-IAKH, M.Hovind.

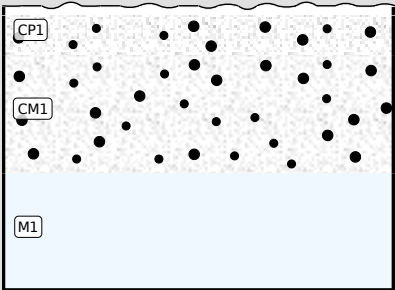
Fig. 6: A MiCorr stratigraphy representative of an area where the metal plating is missing. CP1 corresponds to CP2 in Fig. 3, CM1 represents the corroded metal phase, while M1 corresponds to the bulk metal (M2 in Fig. 3), Credit UiO-IAKH, M.Hovind.
