# DOMED CAP NUT – ZN AL SN CU ALLOY – MODERN TIMES – FRANCE

<b>Artefact name</b>	Domed cap nut
<b>Authors</b>	Christian. Degriigny (HE-Arc CR, Neuchâtel, Neuchâtel, Switzerland) & Mathea. Hovind (University of Oslo, Department of archaeology, conservation and history (IAKH-UiO), Oslo, Oslo, Norway)
<b>Url</b>	/artefacts/402/

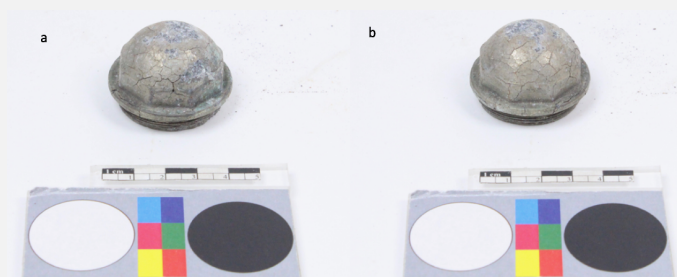
Fig. 1: Domed, threaded fitting, consisting of a Zn/Al/Pb/Cu/Sn alloy. Profile «a» and «b», to the left and right, respectively,

<b>Description of the artefact</b>	A domed, threaded fitting, consisting of a cast alloy with a metallic plating (Fig. 1). Its shape is octagonal and the inside is hollow. The plating is heavily cracked, leading to surface flaking. The metal appears to be consumed by some kind of internal corrosion. Dimensions: L (∅) = 40mm; H = 28mm; T = 5mm; WT = 49g.
<b>Type of artefact</b>	Cap
<b>Origin</b>	Château de Germolles (14th century), Mellecey, Bourgogne, France
<b>Recovering date</b>	Date unknown
<b>Chronology category</b>	Modern Times
<b>chronology tpq</b>	<input type="text" value="1801"/> A.D. ∨
<b>chronology taq</b>	<input type="text" value="2000"/> A.D. ∨
<b>Chronology comment</b>	19th - 20th century
<b>Burial conditions / environment</b>	Outdoor atmosphere
<b>Artefact location</b>	Haute Ecole Arc Conservation-Restoration

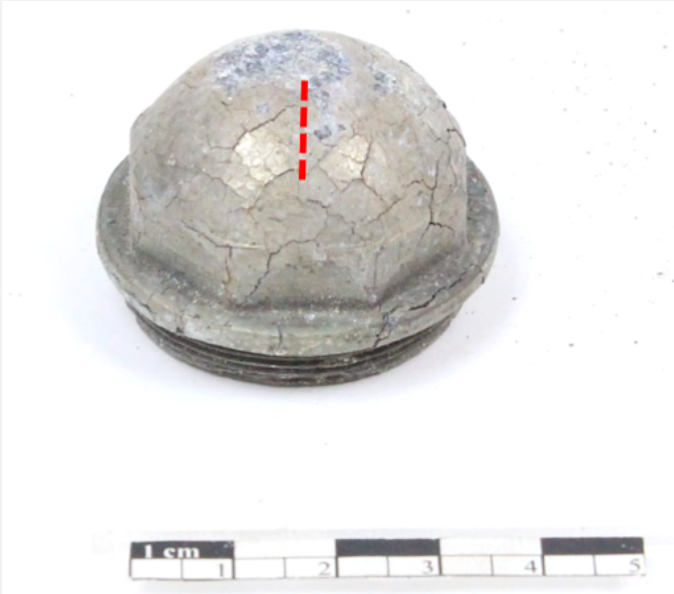
Fig. 2: Zones of the artefact submitted to visual observation and location of sampling area (a cross-section of the metal marked by the stippled line),

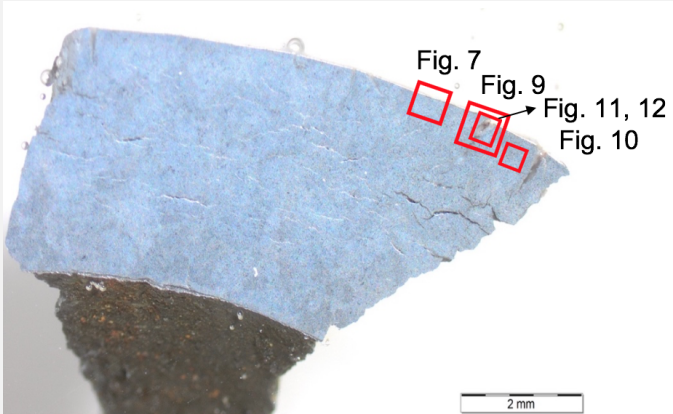
Fig. 4: Micrograph of the cross-section showing the locations of Figs. 7 and 9-12,

<b>Description of sample</b>	The sample is a cross section of the metal, representative of the head of the fitting. It shows external cracks extending from the metal surface and into its structure in addition to internal cracks, visible as thin lines along its longitudinal axis (Fig. 4).
<b>Alloy</b>	Zn Al Sn Cu Alloy
<b>Technology</b>	None
<b>Lab number of sample</b>	NZC2018 (Ni/Zn Cap, sampled in 2018)
<b>Sample location</b>	HE-Arc CR, Neuchâtel, Neuchâtel
<b>Responsible institution</b>	Haute Ecole Arc Conservation-Restauration
<b>Date and aim of sampling</b>	March 2018, study of corrosion stratigraphy and chemical analyses

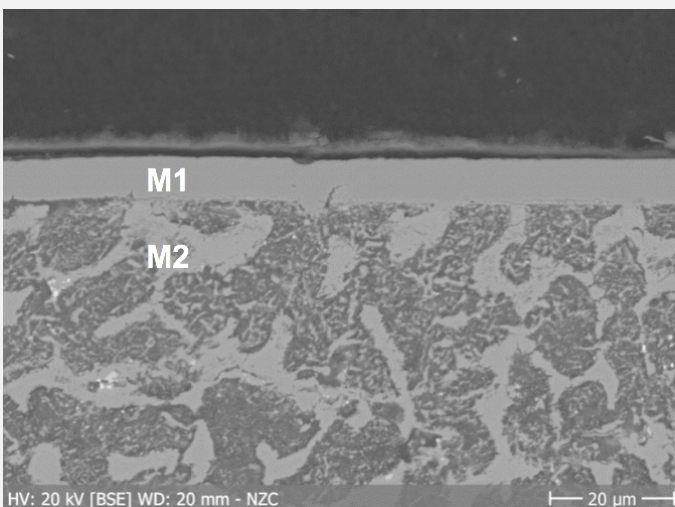
The metal of the domed fitting (M2) consists of a Zn/Al/Pb/Cu/Sn alloy (Table 1) externally covered by a nickel-based plating (M1) (Figs. 7 and 8). The bulk metal (M2) has a dendritic microstructure appearing light grey in bright field, while the interdendritic phase appears white (Fig. 9). The latter is Zn-rich, while the dendritic phase consists of approximately equal amounts of Zn and Al (Table 2, Fig. 11). Observation in SEM (BSE-mode) reveals the presence of Pb-nodules, visible as white irregular spots with a scattered distribution, in addition to opaque grey patches which are rich in Al and Fe (Fig. 10).

Fig. 7: SEM-image (BSE-mode) of a selected area from Fig. 4 (detail), showing the metal plating (M1) and the bulk metal (M2),

Fig. 8: EDS-spectrum showing the chemical composition of the metal plating (M1). Method of analysis: SEM-EDS. Lab. of Electronic Microscopy and and Microanalysis, Néode, HEI Arc,

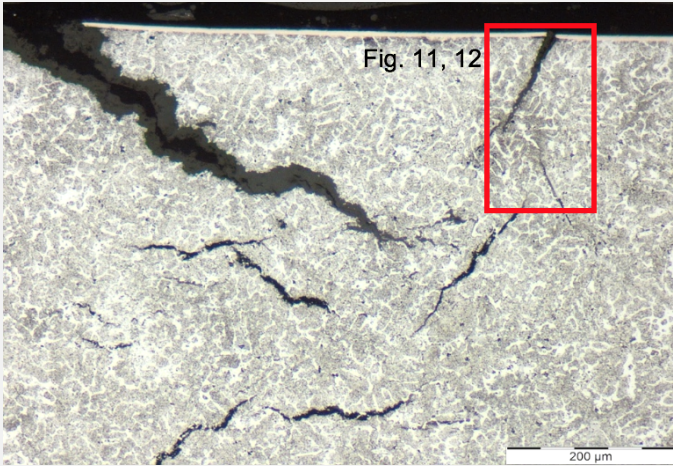
Fig. 9: Micrograph of the metal sample from Fig. 4 (detail), unetched, bright field. The dendrites appear light to dark grey while the interdendritic phase appears white. The metal is characterized by surface cracks as well as internal cracks. The upper red square corresponds to the area selected for elementary mapping by SEM-EDS (Figs. 11 and 12),

The dendritic phase is heavily oxidized compared to the interdendritic phase (Table 2 and Fig. 12). The corrosion has developed throughout the entire metal body, generating cracks (Fig. 9). The cracks are Zn and O-rich (Fig. 12) and could be composed of zinc carbonate. It could be a case of zinc pest, an intergranular corrosion phenomenon known to cause disintegration in poor quality alloys (Selwyn 2004:155-156, Zhang 2011:890).

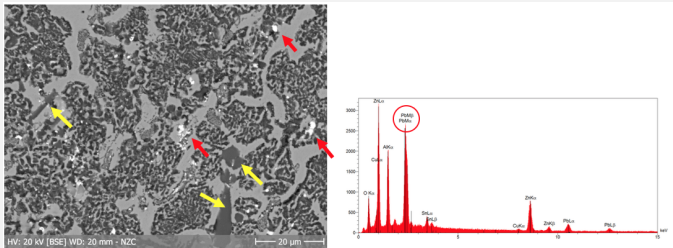
Fig. 10: SEM-image in BSE-mode (left) and EDS-spectrum (right), showing the appearance and the chemical composition of the Pb inclusions (red arrows). The inclusions appear white, the dendrites appear dark grey/black and the interdendritic phase appears grey. Grey opaque patches (yellow arrows) are Fe- and Al-rich phases,

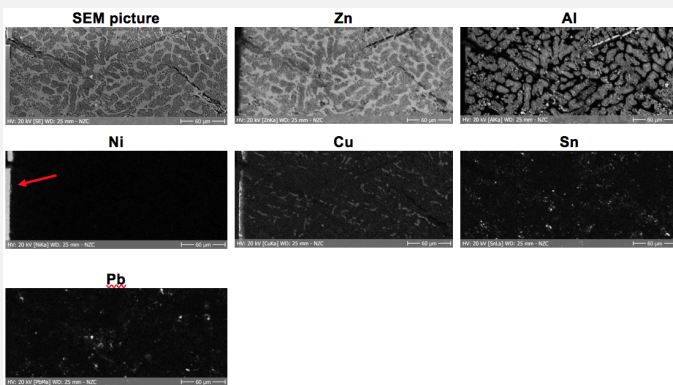
Fig. 11: SEM image and elemental chemical distribution of the selected area from Fig. 9 (rotated 270° and inverted). Method of analysis: SEM-EDS. Lab. of Electronic Microscopy and Microanalysis, Néode, HEI Arc,

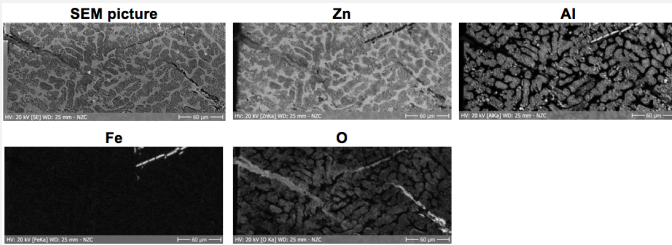
Fig. 12: SEM image and elemental chemical distribution of the selected area from Fig. 9 (rotated 270° and inverted). Method of analysis: SEM-EDS. Lab. of Electronic Microscopy and Microanalysis, Néode, HEI Arc,

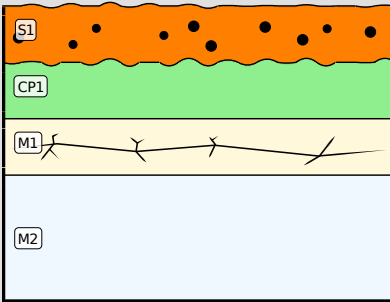
Fig. 5: A MiCorr stratigraphy representative of an area with intact metal plating (M1). S1 represents Fe-polluted soil while CP1 is a green translucent corrosion product, Credit UiO-IAKH, M.Hovind.

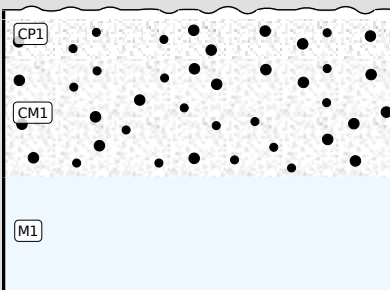
Fig. 6: A MiCorr stratigraphy representative of an area where the metal plating is missing. CP1 corresponds to CP2 in Fig. 3, CM1 represents the corroded metal phase, while M1 corresponds to the bulk metal (M2 in Fig. 3), Credit UiO-IAKH, M.Hovind.
