# ROOF GUTTER ELEMENT – ZN ALLOY – MODERN TIMES – FRANCE

Artefact name	Roof gutter element
Authors	Christian. Degriigny (HE-Arc CR, Neuchâtel, Neuchâtel, Switzerland) & Mathea. Hovind (University of Oslo, Department of archaeology, conservation and history (IAKH-UiO), Oslo, Oslo, Norway)
Url	/artefacts/403/

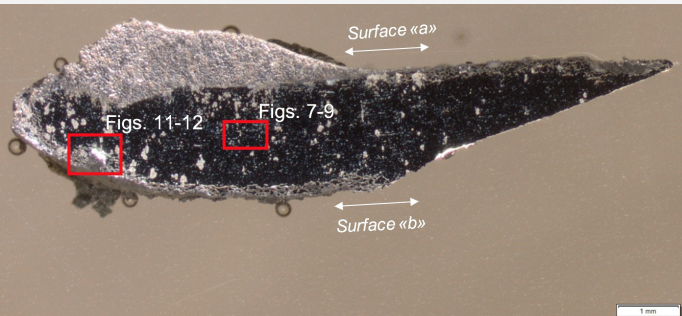
Fig. 4: Micrograph of the sample showing the locations of Figs. 7-9 and 11-12. The uppermost area (in white) is remains of solder, while the zinc metal appears dark grey to black (the white patches are due to secondary oxidation of the sample),

A cross-section (Fig. 4) was cut out where the metal is at an angle of approximately 90° to the flat surface. Its upper edge corresponds to surface "a" and contains remains of solder, while the lower edge corresponds to surface "b".

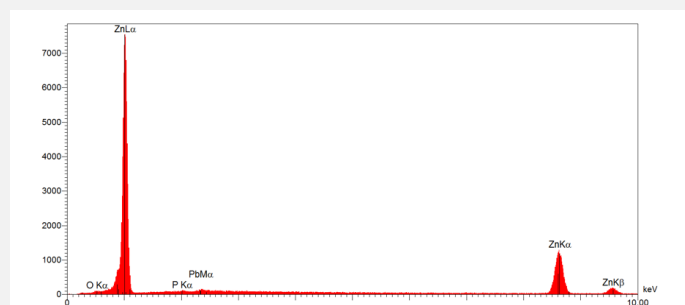
The flashing is composed of Zn with P and Pb (Fig. 6). The latter is probably originating from the solder that was applied to adjoin several metal sheets for the flashings.

Fig. 6: Chemical composition of the metal. Method of analysis: SEM-EDS. Lab. of Electronic Microscopy and Microanalysis, Néode, HEI Arc,

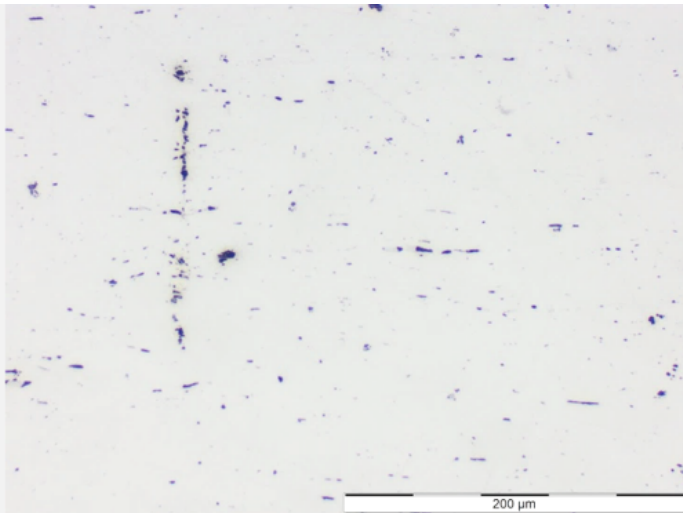
Fig. 7: Micrograph of the metal sample from Fig. 4 (detail). Unetched, bright field,

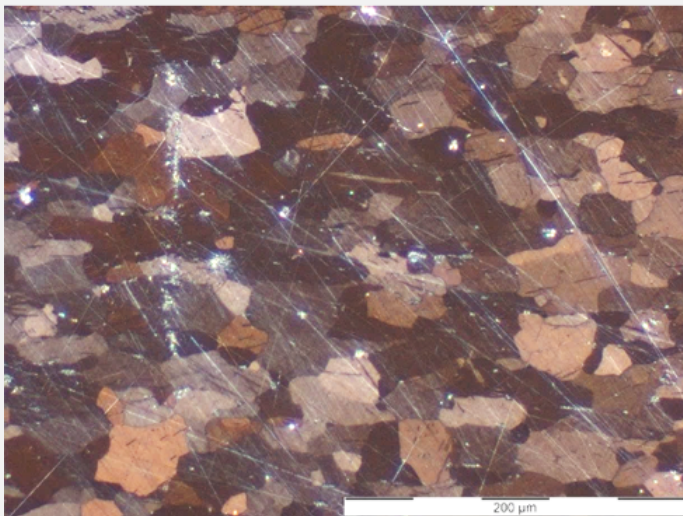
The metal appears white to light grey under bright field (Fig. 7). Under polarized light however (Fig. 8), the microstructure of the metal is visible as small polygonal grains appearing in various shades of brown, a coloured effect due to the anisotropic properties of the metal (Scott 1991: 49). In the SEM-image, white elongated inclusions are visible (Fig. 9) consisting mainly of Zn and Pb with some O (Fig. 10).

Fig. 8: Micrograph similar to Fig. 7, but under polarized light. The microstructure of the metal shows the presence of small and polygonal grains in shape,

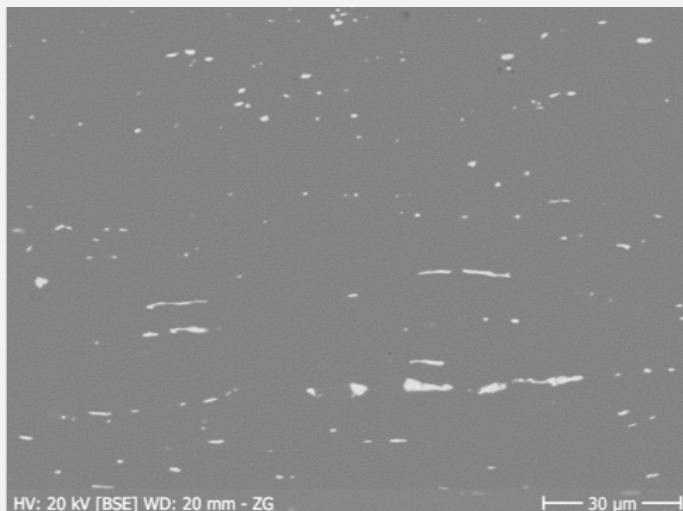
Fig. 9: SEM-image (BSE-mode) of the metal sample from Fig. 4 (detail) showing the white elongated inclusions,

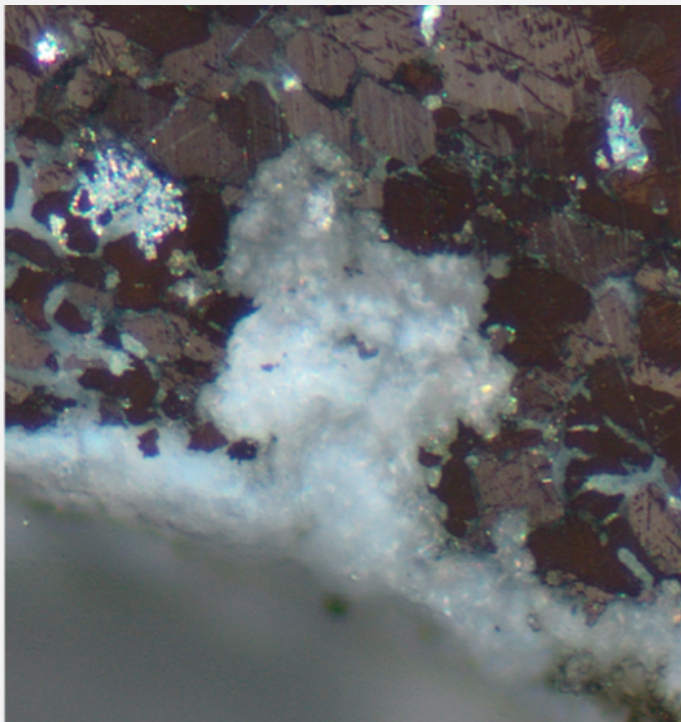
Fig. 12: Micrograph similar to Fig. 11 but under polarized light, the corrosion product (CP1) and the corroded metal (CM1) appear white,

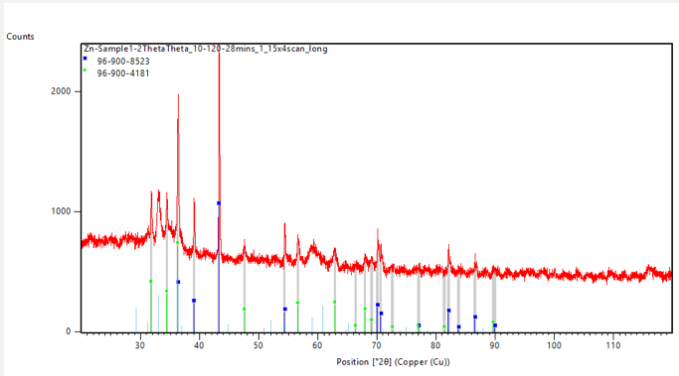
Table 2: Summary of the results from the crystallographic analysis of the white corrosion product (CP1). A representative spectrum is given in Fig. 13. Method of analysis: XRD. Center of X-ray Analytics, Empa-Swiss Federal Laboratories for Materials Science and Technology (Dübendorf), credit MiCorr\_Empa, Z.Balogh-Michels. \*The results are based on the analysis of two powder samples from different areas (see Fig. 2 for sample locations).

Fig. 13: XRD-spectrum for the analysis of powder sample 1. Ref. 96-900-8523 (in blue) corresponds to pure zinc and 96-900-4181 (in green) to zincite (ZnO),

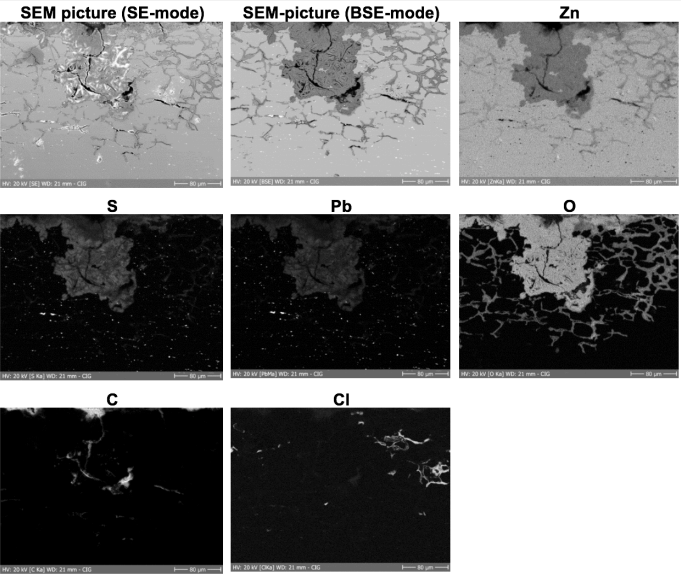
Fig. 14: SEM image and elemental chemical distribution of a selected area of Fig. 11 (rotated almost 180° and reversed). Method of analysis: SEM-EDS. Lab. of Electronic Microscopy and Microanalysis, Néode, HEI Arc,

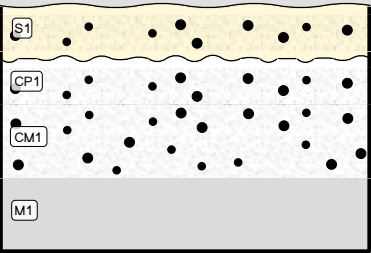
Fig. 5: MiCorr stratigraphy corresponding to the corrosion layers on surface "b" (Figs. 2 and 3). To be compared with Figs. 11 and 12, Credit UiO-IAKH, M.Hovind.
