ROOF GUTTER ELEMENT – ZN ALLOY – MODERN TIMES – FRANCE

Artefact name	Roof gutter element
Authors	Christian. Degrigny (HE-Arc CR, Neuchâtel, Neuchâtel, Switzerland) & Mathea. Hovind (University of Oslo, Department of archaeology, conservation and history (IAKH-UiO), Oslo, Oslo, Norway)
Url	/artefacts/403/

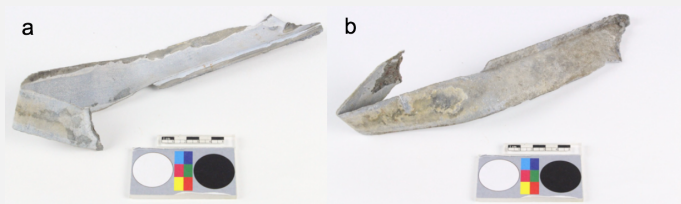
Fig. 1: Zn flashing, surface “a” and “b”, to the left and right, respectively,

Description of the artefact	A piece of zinc flashing with remains of lead solder (Fig. 1). Its surfaces are covered by a white, strongly adherent oxide layer. Surface “b” is slightly darker in colour than surface “a” due to the presence of soil particles. Dimensions: L = 265mm; W = 47mm; T = 1mm; WT = 93g.
Type of artefact	Architectural element
Origin	Château de Germolles (14th century), Mellecey, Bourgogne, France
Recovering date	Unknown
Chronology category	Modern Times
chronology tpq	<input type="text" value="1900"/> A.D. ▼
chronology taq	<input type="text" value="2000"/> A.D. ▼
Chronology comment	1900 AD/20th century
Burial conditions / environment	Outdoor atmosphere
Artefact location	Haute Ecole Arc Conservation-Restauration
Owner	Château de Germolles, Mellecey, Bourgogne
Inv. number	None
Recorded conservation data	Not conserved

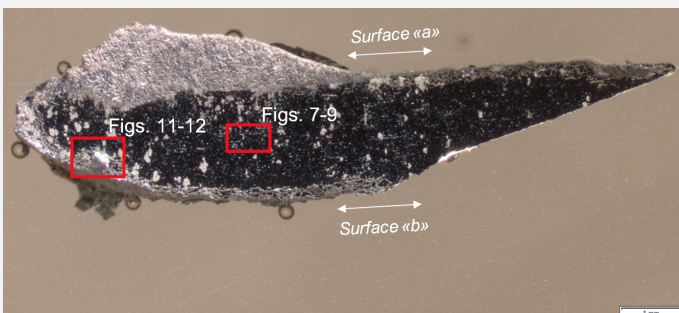
Fig. 4: Micrograph of the sample showing the locations of Figs. 7-9 and 11-12. The uppermost area (in white) is remains of solder, while the zinc metal appears dark grey to black (the white patches are due to secondary oxidation of the sample),

A cross-section (Fig. 4) was cut out where the metal is at an angle of approximately 90° to the flat surface. Its upper edge corresponds to surface "a" and contains remains of solder, while the lower edge corresponds to surface "b".

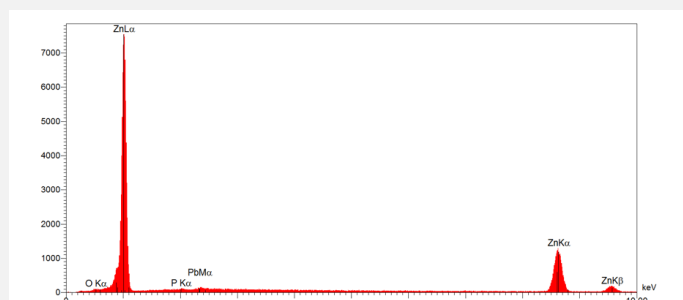
The flashing is composed of Zn with P and Pb (Fig. 6). The latter is probably originating from the solder that was applied to adjoin several metal sheets for the flashings.

Fig. 6: Chemical composition of the metal. Method of analysis: SEM-EDS. Lab. of Electronic Microscopy and Microanalysis, Néode, HEI Arc,

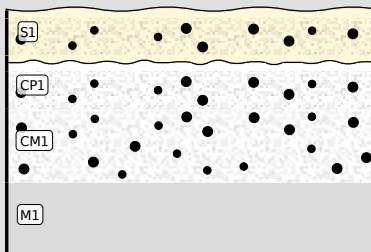
Fig. 5: MiCorr stratigraphy corresponding to the corrosion layers on surface "b" (Figs. 2 and 3). To be compared with Figs. 11 and 12, Credit UiO-IAKH, M.Hovind.
