ROOF GUTTER ELEMENT – ZN ALLOY – MODERN TIMES – FRANCE

Artifact name	Roof gutter element
Authors	Christian. Degriigny (HE-Arc CR, Neuchâtel, Neuchâtel, Switzerland) & Mathea. Hovind (University of Oslo, Department of archaeology, conservation and history (IAKH-UiO), Oslo, Oslo, Norway)
Url	/artefacts/403/

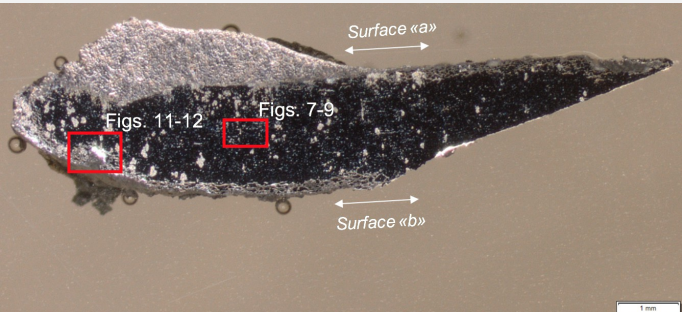
Fig. 4: Micrograph of the sample showing the locations of Figs. 7-9 and 11-12. The uppermost area (in white) is remains of solder, while the zinc metal appears dark grey to black (the white patches are due to secondary oxidation of the sample),

A cross-section (Fig. 4) was cut out where the metal is at an angle of approximately 90° to the flat surface. Its upper edge corresponds to surface "a" and contains remains of solder, while the lower edge corresponds to surface "b".

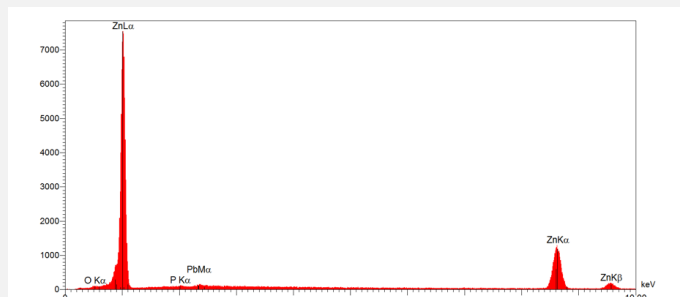
The flashing is composed of Zn with P and Pb (Fig. 6). The latter is probably originating from the solder that was applied to adjoin several metal sheets for the flashings.

Fig. 6: Chemical composition of the metal. Method of analysis: SEM-EDS. Lab. of Electronic Microscopy and Microanalysis, Néode, HEI Arc,

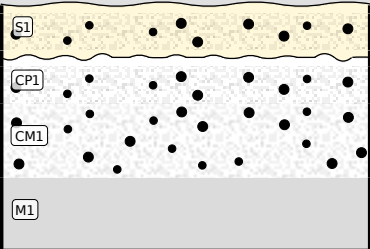
Fig. 5: MiCorr stratigraphy corresponding to the corrosion layers on surface "b" (Figs. 2 and 3). To be compared with Figs. 11 and 12, Credit UiO-IAKH, M.Hovind.
