# ROOF GUTTER ELEMENT – ZN ALLOY – MODERN TIMES – FRANCE

<b>Artefact name</b>	Roof gutter element
<b>Authors</b>	Christian. Degrigny (HE-Arc CR, Neuchâtel, Neuchâtel, Switzerland) & Mathea. Hovind (University of Oslo, Department of archaeology, conservation and history (IAKH-UiO), Oslo, Oslo, Norway)
<b>Url</b>	/artefacts/403/

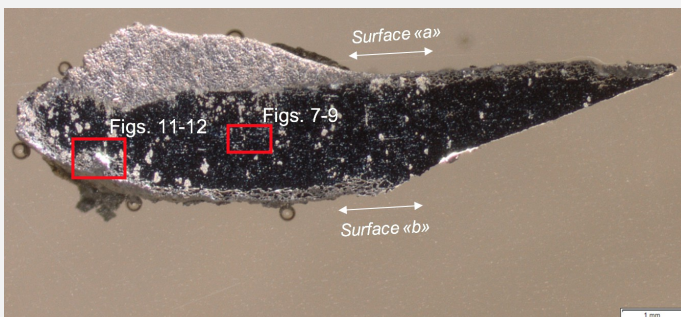
Fig. 4: Micrograph of the sample showing the locations of Figs. 7-9 and 11-12. The uppermost area (in white) is remains of solder, while the zinc metal appears dark grey to black (the white patches are due to secondary oxidation of the sample),

A cross-section (Fig. 4) was cut out where the metal is at an angle of approximately 90° to the flat surface. Its upper edge corresponds to surface "a" and contains remains of solder, while the lower edge corresponds to surface "b".

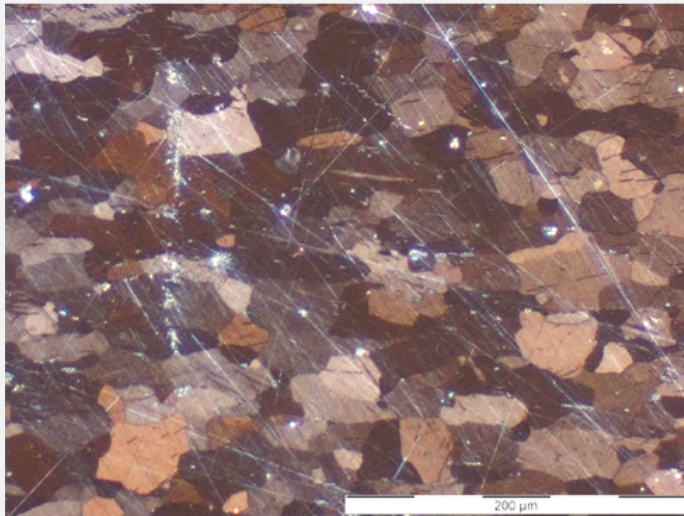
The metal appears white to light grey under bright field (Fig. 7). Under polarized light however (Fig. 8), the microstructure of the metal is visible as small polygonal grains appearing in various shades of brown, a coloured effect due to the anisotropic properties of the metal (Scott 1991: 49). In the SEM-image, white elongated inclusions are visible (Fig. 9) consisting mainly of Zn and Pb with some O (Fig. 10).

Fig. 8: Micrograph similar to Fig. 7, but under polarized light. The microstructure of the metal shows the presence of small and polygonal grains in shape,

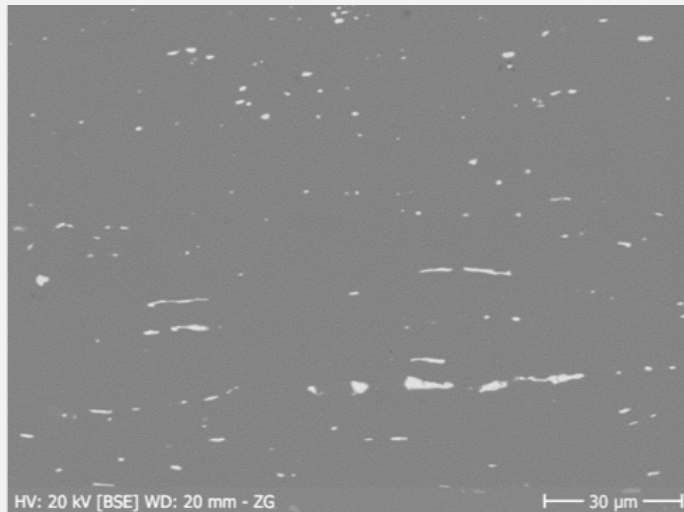
Fig. 9: SEM-image (BSE-mode) of the metal sample from Fig. 4 (detail) showing the white elongated inclusions,

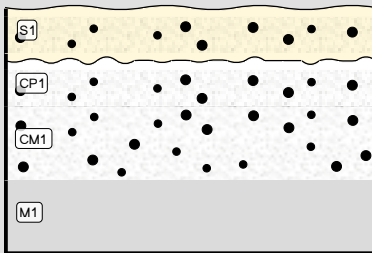
Fig. 5: MiCorr stratigraphy corresponding to the corrosion layers on surface "b" (Figs. 2 and 3). To be compared with Figs. 11 and 12, Credit UiO-IAKH, M.Hovind.
