ROOF GUTTER ELEMENT – ZN ALLOY – MODERN TIMES – FRANCE

Artefact name Roof gutter element

Authors Christian. Degrigny (HE-Arc CR, Neuchâtel, Neuchâtel, Switzerland) & Mathea. Hovind (University of Oslo, Department of archaeology, conservation and history (IAKH-UiO), Oslo, Oslo, Norway)

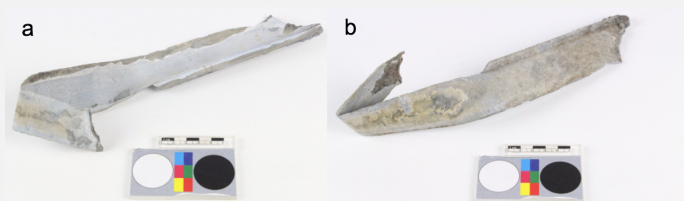
Fig. 1: Zn flashing, surface “a” and “b”, to the left and right, respectively,

Description of the artefact	A piece of zinc flashing with remains of lead solder (Fig. 1). Its surfaces are covered by a white, strongly adherent oxide layer. Surface “b” is slightly darker in colour than surface “a” due to the presence of soil particles. Dimensions: L = 265mm; W = 47mm; T = 1mm; WT = 93g.
Type of artefact	Architectural element
Origin	Château de Germolles, Mellecey, Bourgogne, France
Recovering date	Unknown
Chronology category	Modern Times
chronology tpq	<input type="text" value="1900"/> A.D. ▼
chronology taq	<input type="text" value="2000"/> A.D. ▼
Chronology comment	1900 AD/20th century
Burial conditions / environment	Outdoor atmosphere
Artefact location	Haute Ecole Arc Conservation-Restauration
Owner	Château de Germolles, Mellecey, Bourgogne
Inv. number	None
Recorded conservation data	Not conserved

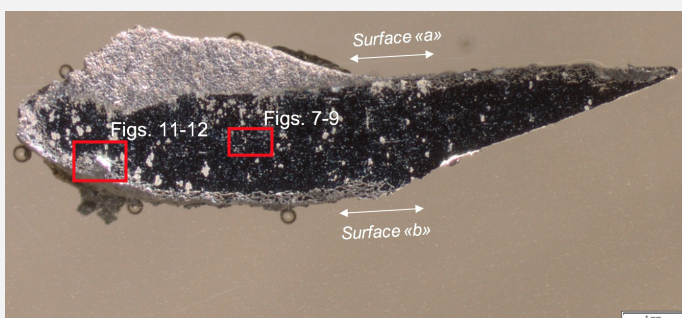
Fig. 4: Micrograph of the sample showing the locations of Figs. 7-9 and 11-12. The uppermost area (in white) is remains of solder, while the zinc metal appears dark grey to black (the white patches are due to secondary oxidation of the sample),

A cross-section (Fig. 4) was cut out where the metal is at an angle of approximately 90° to the flat surface. Its upper edge corresponds to surface "a" and contains remains of solder, while the lower edge corresponds to surface "b".

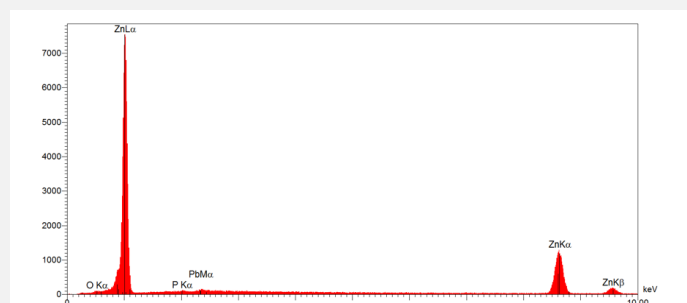
The flashing is composed of Zn with P and Pb (Fig. 6). The latter is probably originating from the solder that was applied to adjoin several metal sheets for the flashings.

Fig. 6: Chemical composition of the metal. Method of analysis: SEM-EDS. Lab. of Electronic Microscopy and Microanalysis, Néode, HEI Arc,

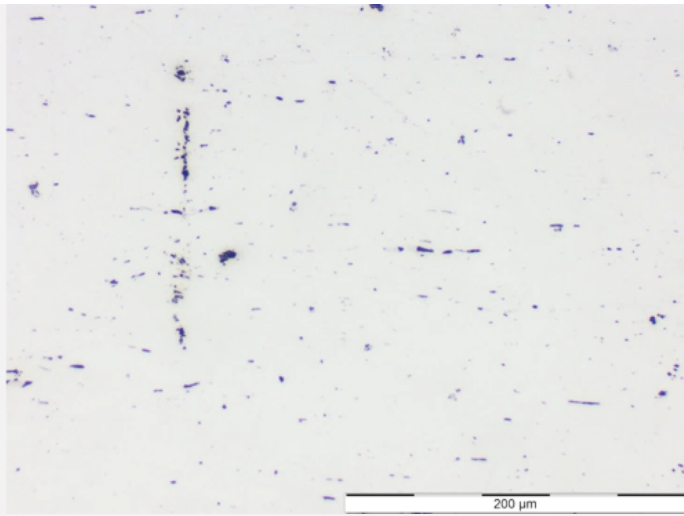
The metal appears white to light grey under bright field (Fig. 7). Under polarized light however (Fig. 8), the microstructure of the metal is visible as small polygonal grains appearing in various shades of brown, a coloured effect due to the anisotropic properties of the metal (Scott 1991: 49). In the SEM-image, white elongated inclusions are visible (Fig. 9) consisting mainly of Zn and Pb with some O (Fig. 10).

Fig. 7: Micrograph of the metal sample from Fig. 4 (detail). Unetched, bright field,

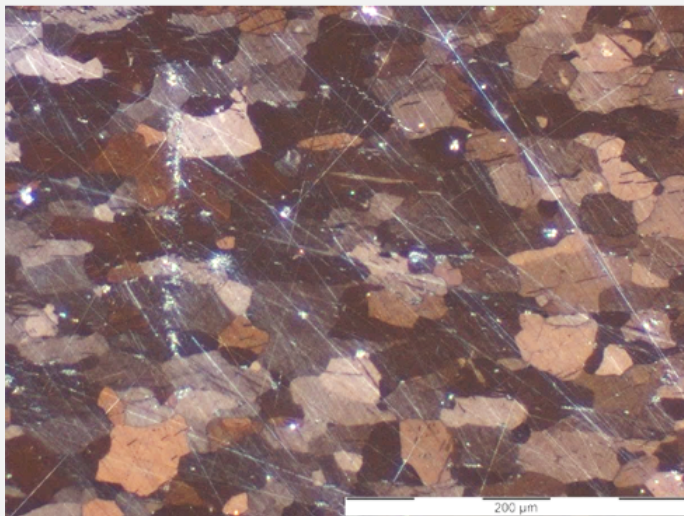
Fig. 8: Micrograph similar to Fig. 7, but under polarized light. The microstructure of the metal shows the presence of small and polygonal grains in shape,

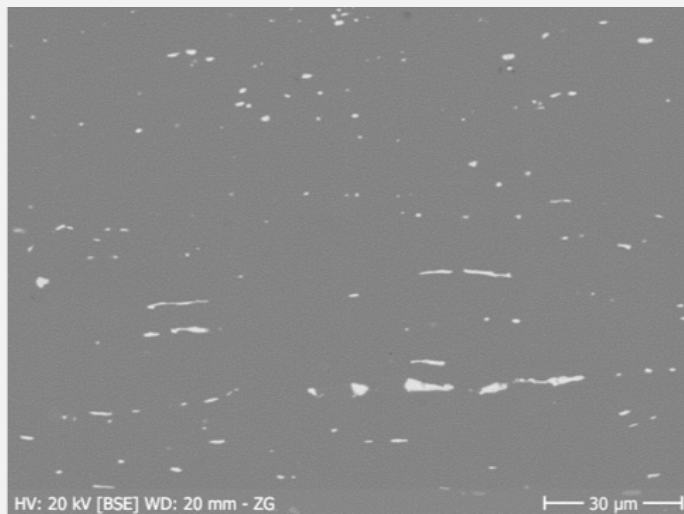
Fig. 9: SEM-image (BSE-mode) of the metal sample from Fig. 4 (detail) showing the white elongated inclusions,

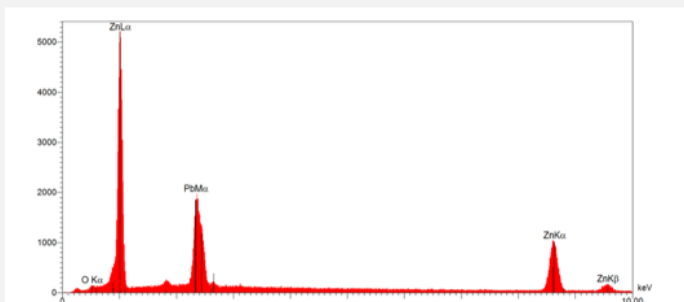
Fig. 10: SEM-EDS spectrum showing the composition of the elongated inclusions from Fig. 9. Method of analysis: SEM-EDS. Lab. of Electronic Microscopy and Microanalysis, Néode, HEI Arc,

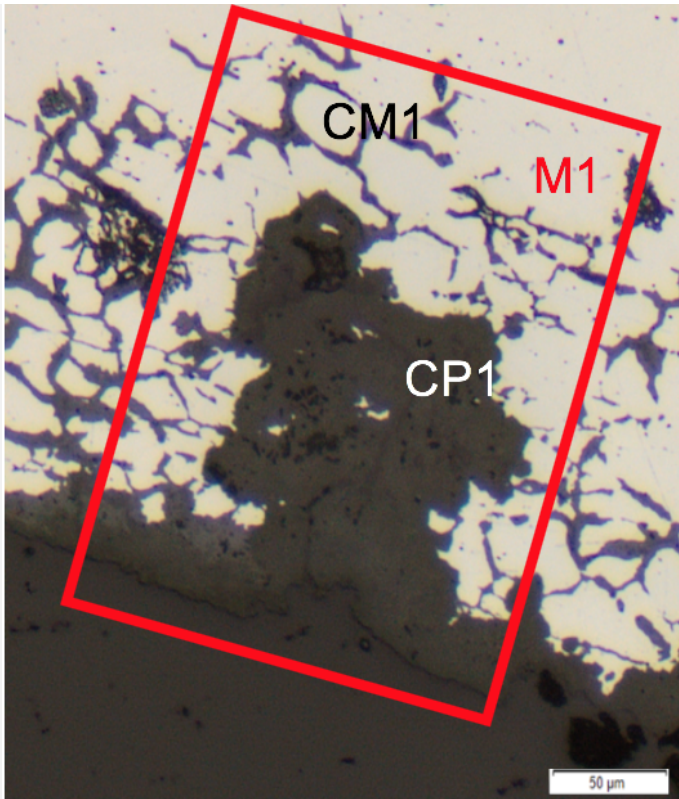
The metal is suffering from intergranular corrosion visible as a white corrosion product (CP1) located within crevices and along the grain boundaries (Figs. 11 and 12). Both the corrosion product (CP1) and the corroded metal (CM1) appear dark grey in bright field (Fig. 11) and white under polarized light (Fig. 12). They both consist of Zn and O (Table 1). The external corrosion product (CP1) contains some S (and not Pb as suggested by Table 1 and Fig. 14) which is probably due to atmospheric pollution. The structural composition of the corrosion product was determined by crystallographic analysis (XRD) to consist of a mixture of zincite (ZnO) and pure zinc (Zn) (Table 2, Fig 13). Mapping of the corroded area by SEM-EDS displays a similar composition but shows additionally the presence of Cl in some of the cracks (Fig. 14).

Table 1: Chemical composition of the corrosion layers from Fig. 11. Method of analysis: SEM-EDS. Lab. of Electronic Microscopy and Microanalysis, Néode, HEI Arc, credit MiCorr_HEI Arc, C.Csefalvay. *The sum is the calculated average of three analyses of the same feature, but in different areas.

Fig. 11: Micrograph of the metal sample from Fig. 4 (detail). Unetched, bright field. The corrosion product (CP1) is located at the surface of the metal and in its crevices. Intergranular corrosion (CM1) is visible as thin grey lines in between the metal grains (M1). The area selected for elementary mapping (Fig. 14) is marked by a red square

The flashing consists of Zn with some Pb from the lead solder. It is covered by a strongly adherent layer of zincite (a zinc oxide), indicative of exposure to an unpolluted environment. Still, the metal exhibits intergranular corrosion, a deterioration phenomenon indicative of aggressive conditions. This can possibly be explained by the different locations of the samples. The cross-section studied is likely to correspond to the surface that was exposed to the atmosphere (surface "b"), while the powder samples were from the rear, unexposed surface (surface "a"). Exposure to moisture and low pH in the form of acidic rain are environmental parameters that would encourage intergranular corrosion. Furthermore, the presence of Cl inside the cracks could be due to pollution and its rather concealed location implies that it would be retained inside the metal and not washed away by rain (Selwyn 2004:153-154).

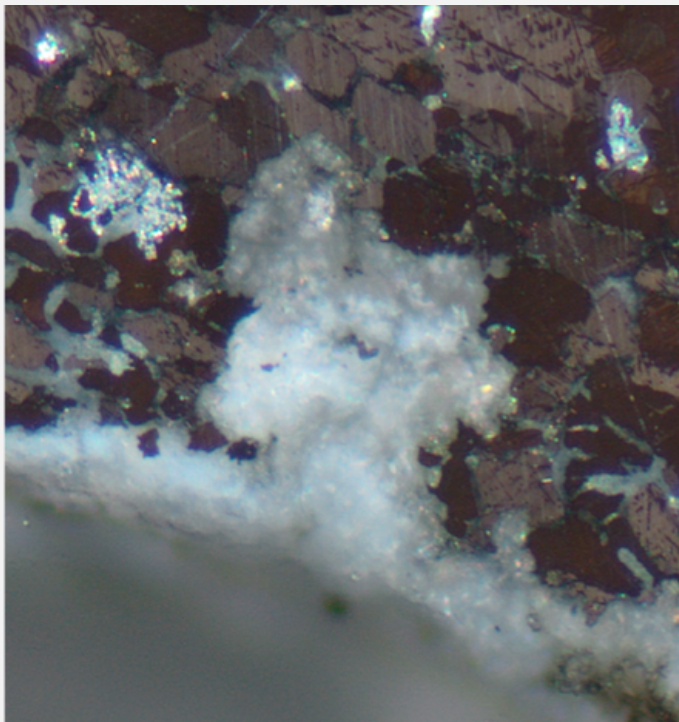
Fig. 12: Micrograph similar to Fig. 11 but under polarized light, the corrosion product (CP1) and the corroded metal (CM1) appear white,

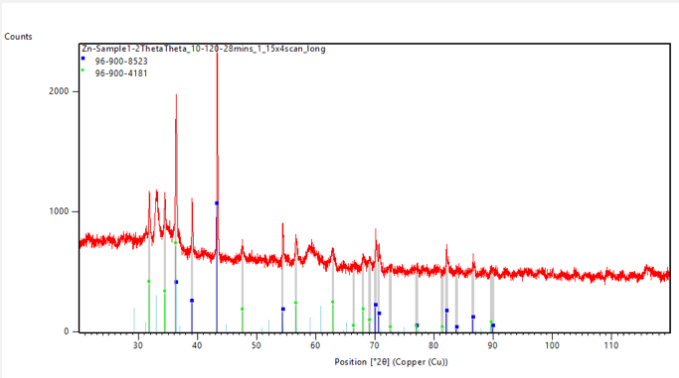
Table 2: Summary of the results from the crystallographic analysis of the white corrosion product (CP1). A representative spectrum is given in Fig. 13. Method of analysis: XRD. Center of X-ray Analytics, Empa-Swiss Federal Laboratories for Materials Science and Technology (Dübendorf), credit MiCorr_Empa, Z.Balogh-Michels. *The results are based on the analysis of two powder samples from different areas (see Fig. 2 for sample locations).

Fig. 13: XRD-spectrum for the analysis of powder sample 1. Ref. 96-900-8523 (in blue) corresponds to pure zinc and 96-900-4181 (in green) to zincite (ZnO),

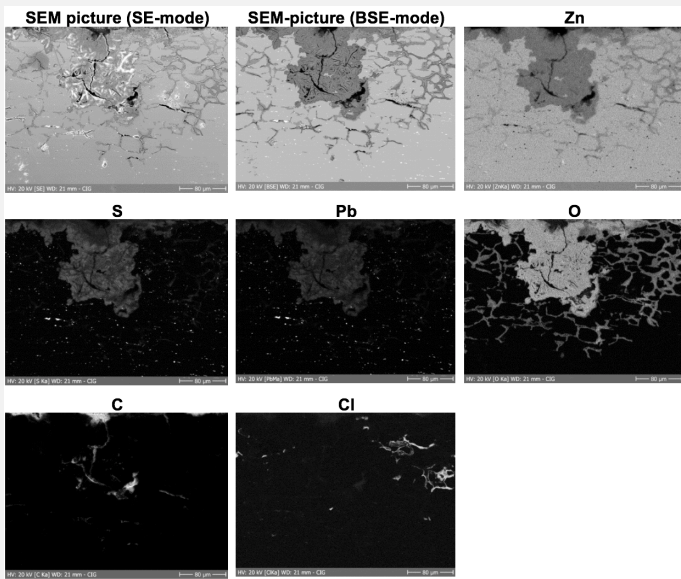
Fig. 14: SEM image and elemental chemical distribution of a selected area of Fig. 11 (rotated almost 180° and reversed). Method of analysis: SEM-EDS. Lab. of Electronic Microscopy and Microanalysis, Néode, HEI Arc,

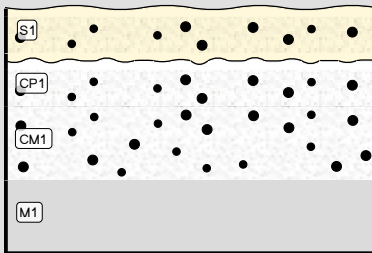
Fig. 5: MiCorr stratigraphy corresponding to the corrosion layers on surface "b" (Figs. 2 and 3). To be compared with Figs. 11 and 12, Credit UiO-IAKH, M.Hovind.
