COATED LAMP POST(?) FRAGMENT – GREY CAST IRON – MODERN TIMES – SWITZERLAND

| Artefact name | Coated lamp post(?) fragment |
| Authors | Christian. Degriigny (HE-Arc CR, Neuchâtel, Neuchâtel, Switzerland) & Mathea. Hovind (University of Oslo, Department of archaeology, conservation and history (IAKH-UiO), Oslo, Oslo, Norway) |

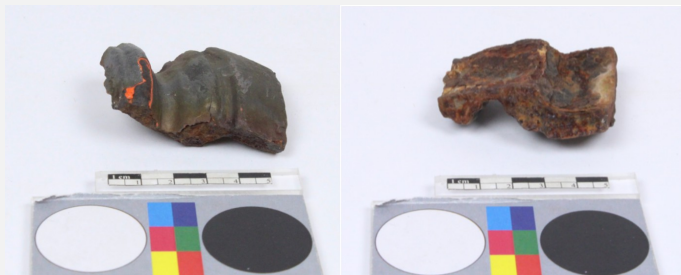
Fig. 1: Cast iron fragment with paint coating; exterior (coated) surface and the rear (non-coated) surface to the left and right, respectively.

| Description of the artefact | Cast iron fragment, externally coated by alternating layers of bright orange and grey paint (Fig. 1). The piece was found on the street in Zurich, Switzerland and is possibly originating from an outdoor construction (e.g. a lamp post). Dimensions: L = 55mm; W = 50mm; T = 7-10mm; WT = 133g. |

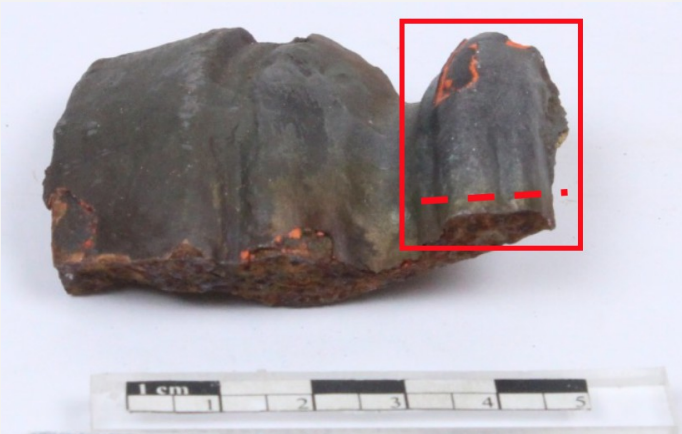
Fig. 2: Zone of the artefact submitted to visual observation (red square) and location of the sampling location (a cross section through metal including a few layers of paint, marked by the stippled line),

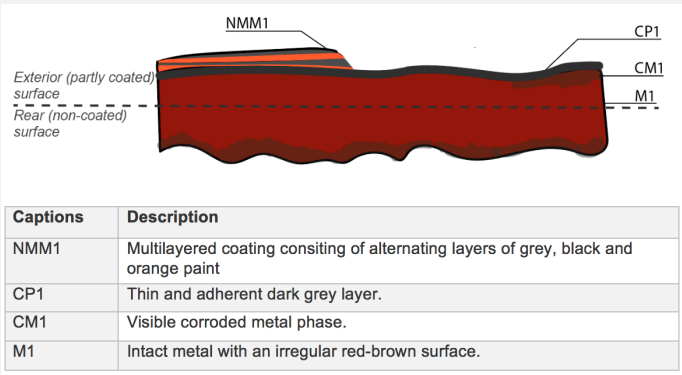
The schematic representation below (Fig. 3) gives an overview of the corrosion layers encountered by visual macroscopic observation.

Fig. 3. Schematic representation of the metal in cross-section. NMM = non-metallic material, CP = corrosion product, CM = corroded metal, M = metal,

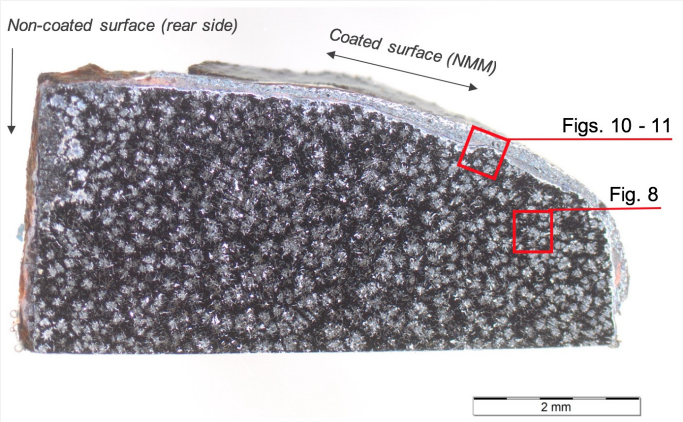
Fig. 4: Micrograph of the sample showing the locations of Figs. 8,10 and 11. The coated surface (NMM) appears light grey,

| Description of sample | The sample (Fig. 4) was cut out from one of the profiles of the coated cast iron fragment (Fig. 2). Its vertical surface corresponds to the rear (non-painted) surface, while the top surface contains three layers of paint. The lower surface is where the sample was cut. The paint flake (Fig. 5) corresponds to the coating that covers the entire fragment. Its location in relation to the remaining artefact is not known, it is however considered to be representative of the overall surface of the object. |

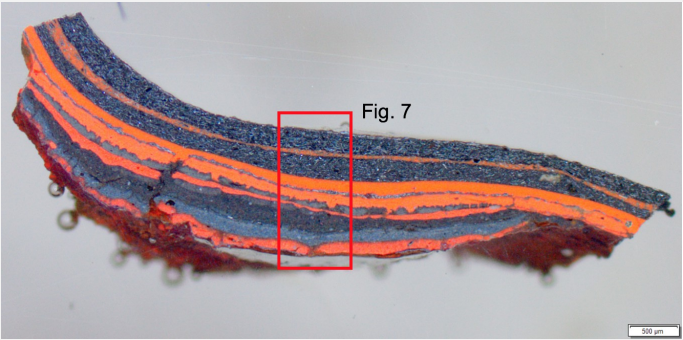
Fig. 5: Micrograph of the paint sample showing the location of Fig. 7 (a MiCorr stratigraphy of the paint layers),

Furthermore, punctual analyses were carried out in order to determine the chemical composition of the paint flake. Three punctual analyses were carried out for each colour (light grey, black and orange in Fig. 5). The colours correspond to the paint layers previously mentioned, but their composition is slightly different (Table 2, Table 3):

- The light grey layer (similar to NMM1) contains Pb, C and O. Its composition is significantly different from NMM1 as it contains neither Ba, S or Al.
- The black layer has a similar composition to NMM2 (C, Fe, O and Al).
- The orange layer is even more rich in lead than NMM3 and contains Ba. This layer is probably a preparatory layer of red lead (Pb3O).

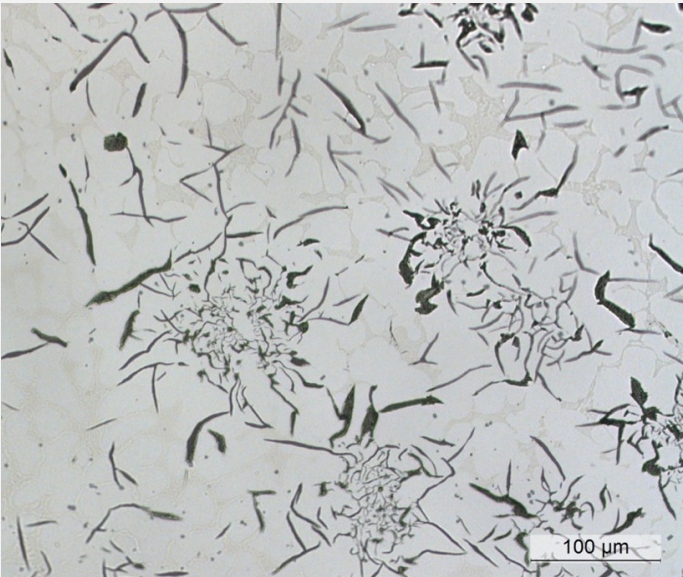
The metal is a grey cast iron with characteristic graphite flakes (Fig. 8). It contains C in addition to P, Mn and some Si (Fig. 9). Its matrix consists of a P-rich eutectoid and a dendritic phase; the latter containing a significant amount of C, but less P than the aforementioned eutectoid (Table 1).

Fig. 8: Micrograph of the metal sample from Fig. 4 (detail), unetched, bright field. The microstructure of the metal consists of graphite flakes in a matrix of dendrites (light grey) and an interdendritic eutectoid phase (light brown). The global analysis of the metal (Fig. 9) was carried out on a surface area of similar size,

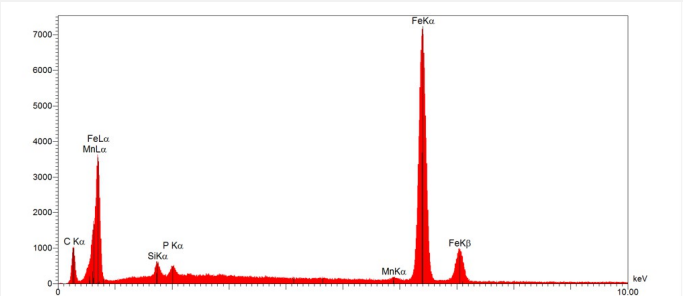
Fig. 9: EDS-spectrum showing the chemical composition of the metal. Method of analysis: SEM-EDS. Lab. of Electronic Microscopy and Microanalysis, Néode, HEI Arc,

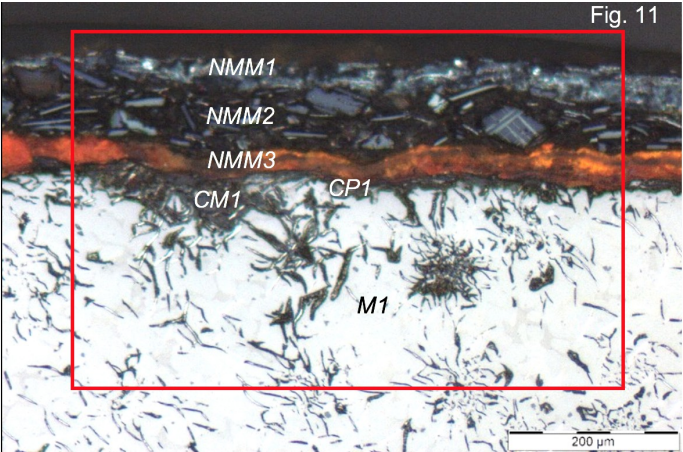
The metal is covered by a coating of alternating layers of paint (appearing light grey, black and bright orange under polarized light, NMM1-NMM3 in Fig. 10). Punctual analyses by SEM-EDS (Table 2) as well as elemental mapping (Fig. 12) reveal that the light grey layer (NMM1) contains a considerable amount of Ba in addition to S, Si and Al. The black layer (NMM2) contains Fe, Si, Mg and Al. The latter is visible as rectangular flakes (see NMM2 in Fig. 11). This layer could consist of Al flakes and FeO in an organic binder (C and O). The underlying, bright orange layer (NMM3) contains Fe and O in addition to a considerable amount of Pb, some Si, Zn and Ca. This layer is probably a preparatory paint consisting of red lead (Pb3O4) and Zn oxide (ZnO). C and O were detected in all layers and are probably components of the binder (Table 2 and Fig. 12).

Fig. 10: Micrograph of the coated surface on the metal sample from Fig. 4 (detail), unetched, polarized light, showing the colours of the paint layers: NMM3 in bright orange, NMM2 in black with Al flakes in light grey. The uppermost layer, NMM1, appears light grey. The red square corresponds to the area chosen for SEM-imaging in BSE-mode (Fig. 11). The metal appears light grey/white due to movement of the polarizer,

The metal is covered by a thin graphitized layer (CP1) as well as a corroded metal phase (CM1). The latter is located just beneath NMM3 and appears dark grey under polarized light (Fig. 10). It consists mainly of Fe and O with Pb and Ca (Table 4, Fig. 12). Pb can probably be explained by the proximity to the Pb-rich paint layer NMM3 (Table 2). The presence of Ca is more interesting however, as it might originate from past exposure to the environment, implying that the paint was not applied immediately after fabrication. The composition of CP1 was not analyzed.

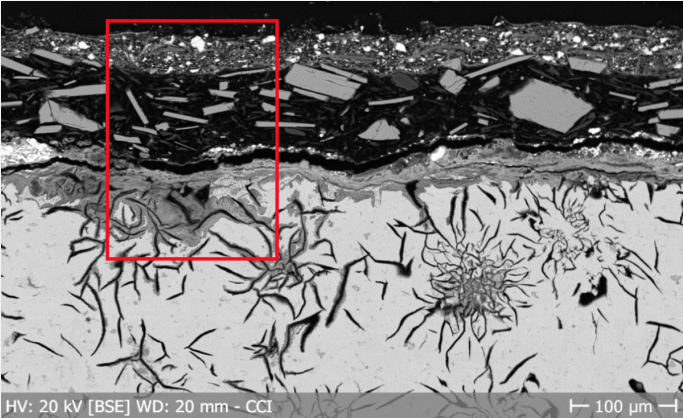
Fig. 11: SEM-image (BSE-mode) of the selected area in Fig. 10 (detail), showing the morphology of the paint layers and the area selected for elemental mapping (Fig. 12),

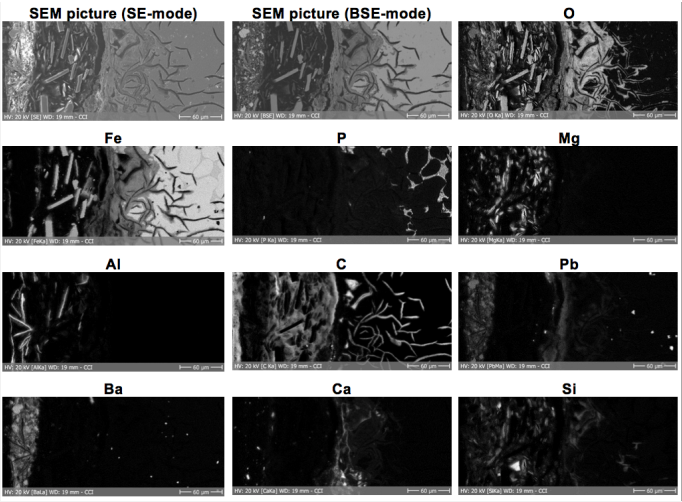
Fig. 12: SEM image and elemental chemical distribution of the selected area from Fig. 11 (rotated 270°). Method of analysis: SEM-EDS. Lab. of Electronic Microscopy and Microanalysis, Néode, HEI Arc,

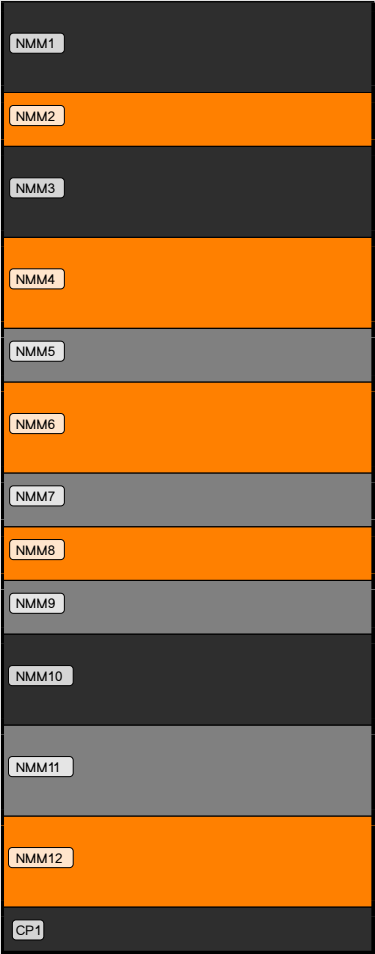
Fig. 6: A MiCorr stratigraphy of the coated metal. To be compared with Fig. 10, Credit UiO-IAKH, M.Hovind.

Fig. 7: A MiCorr stratigraphy of the paint layer from Fig. 5, Credit UiO-IAKH, M.Hovind.

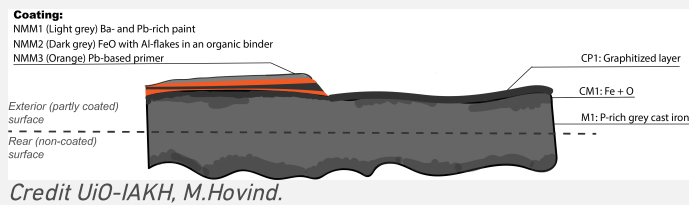
Fig. 13: Corrected stratigraphic representation with results from analyses by SEM-EDS and visual microscopic observation. The colour of the metal was changed to grey as this was the colour of the metal when viewed in cross-section. NMM = non-metallic material, CP = corrosion product, CM = corroded metal, M = metal,

The rain gutter fragment is a grey cast iron with a microstructure consisting of graphite flakes and a P-rich eutectic phase. It is coated by several layers of paint, up to 12 in total. What appears to be a Pb-based primer is located right next to the metal, followed by a black layer consisting of aluminium flakes and iron oxide in an organic binder and superimposed by a light grey, Ba- and Pb-rich paint layer. Inhibitive primers often contain red lead in linseed oil (Hare 2011:979). The uppermost layer is dark in colour and corresponds to the black paint layer previously mentioned.

It seems likely that the rain gutter fragment has been treated with a system of at least three different paints which have all been applied several times, hence the relatively thick coating. The efficiency of the paint system is proven by the fact that internal corrosion is much more prominent in areas that are not protected by paint system. Corrosion control by application of paint films is a well-known treatment of metals (Hare 2011:971, Selwyn 2004:109). The use of an anti-corrosion system consisting of several layers of paint with different colours is known to facilitate monitoring as a break in the coating will be readily visible. Additionally, the presence of more than one paint layer will minimize the risk for a hole in the coating and help avoid localized corrosion (Selwyn 2004:105).
