## TOWEL BAR – AL ALLOY – MODERN TIMES – FRANCE

Artefact name	Towel bar
Authors	Christian. Degriigny (HE-Arc CR, Neuchâtel, Neuchâtel, Switzerland)
Url	/artefacts/410/

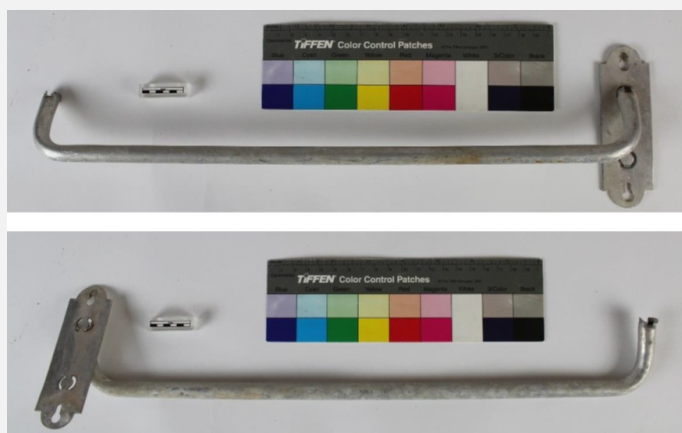
Fig. 1: Front and back sides of a towel bar,

Description of the artefact	Towel bar with traces of use and a broken section (Fig. 1). White deposits have developed on the metal surface. Dimensions: L = 45cm.		
Type of artefact	Household implement		
Origin	Château de Germolles, Mellecey, Bourgogne, France		
Recovering date	Unknown		
Chronology category	Modern Times		
chronology tpq	1801	A.D.	▼
chronology taq	2000	A.D.	▼
Chronology comment	19th - 20th century

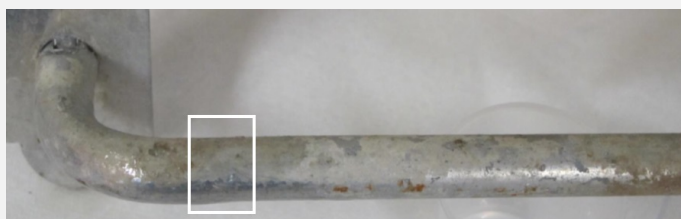
Fig. 2: Detail of the back side of the towel bar showing the location of the sampling area,

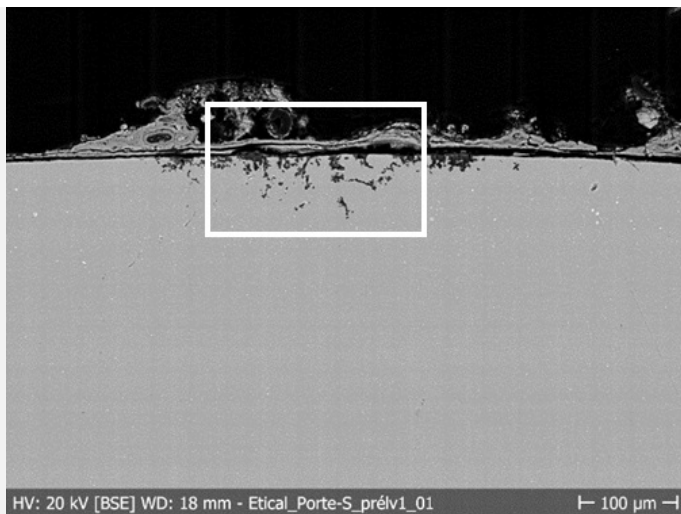
Fig. 3: SEM image of the cross-section showing the location of Fig. 5,

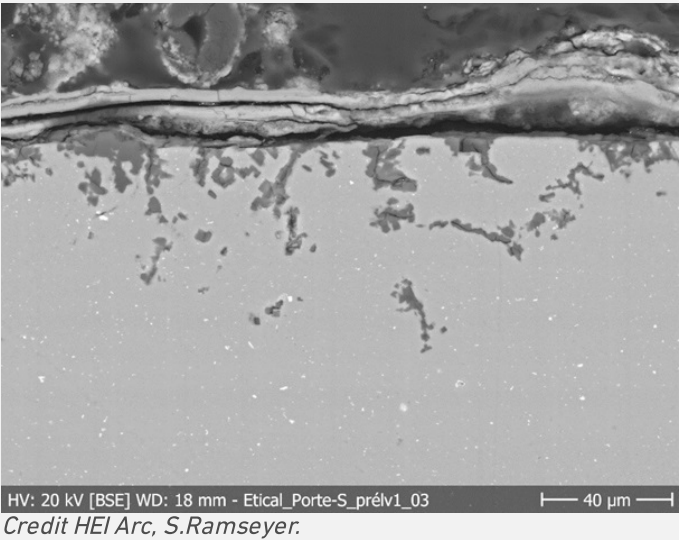
The metal is a relatively pure aluminium alloy with numerous inclusions (Fig. 5). From their chemical composition they can be interpreted as  $\text{Al}_3\text{Fe}$  intermetallic compounds (Fig. 6). Pitting corrosion as well as a start of intergranular

corrosion develops locally under the deposits, outlining some of the grains (Fig. 5).

Fig. 5: SEM image of the metal sample from Fig. 3 (detail), BSE-mode. We observe the presence of numerous inclusions,

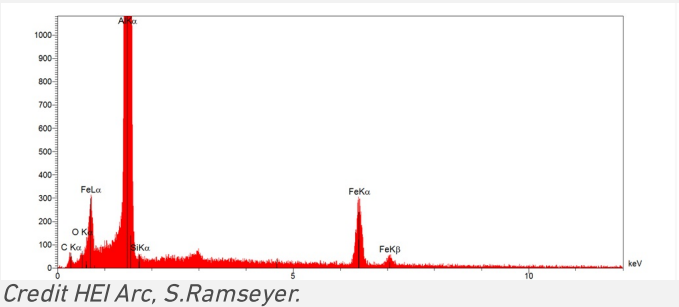
Fig. 6: EDS spectrum of the inclusions of Fig. 5,

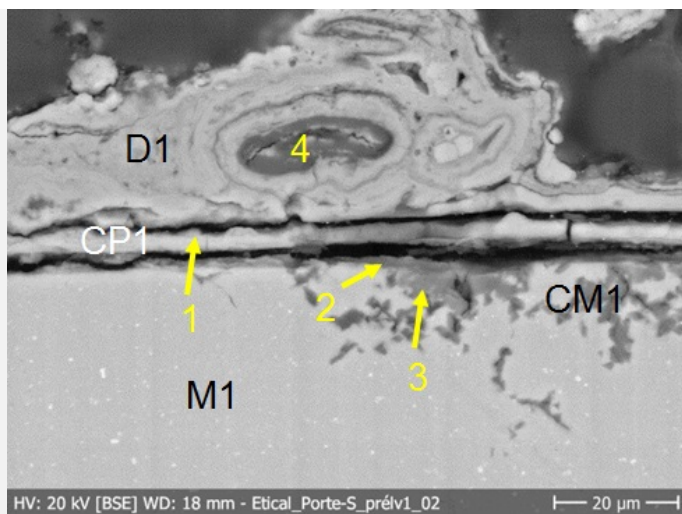
A very thin and loose oxide film has formed on the metal surface (CP1) and is locally covered by white deposits (D1). Intergranular corrosion has developed under the deposits (Fig. 7). Analysis by SEM-EDS indicates that the Al and O-rich oxide layer is contaminated with P and Si (area 1 on Fig. 7 and Fig. 8). These elements are even more present at the interface between CM1 and CP1 with Cl and S (area 2 on Fig. 7 and Fig. 9). The concentration of P and Si decreases in CM1 (area 3 on Fig. 7 and Fig. 10) while the concentration of S and Cl increases (Fig. 11). The deposit is mainly constituted of Ca, O, C and Si (probably CaCO3 and SiO2, area 4 on Fig. 7 and Fig. 12).

Fig. 7: SEM picture with location of EDS analyses of areas 1 to 4), BSE-mode. From bottom to top: the metal (M1) in light grey, the corroded metal (CM1), CP1 and D1,

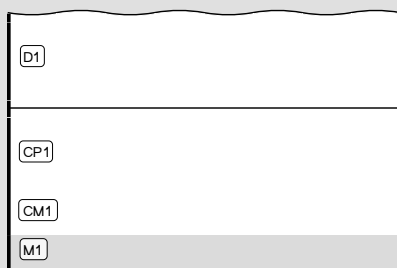
Fig. 4: Stratigraphic representation of the object in cross-section using the MiCorr application. This representation can be compared to Fig. 9, Credit HE-Arc CR, C.Degrigny.
