TOWEL BAR – AL ALLOY – MODERN TIMES – FRANCE

Artefact name Towel bar

Authors Christian. Degriigny (HE-Arc CR, Neuchâtel, Neuchâtel, Switzerland)

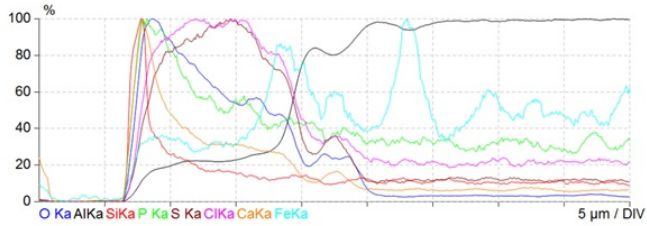
Fig. 11: EDS Linescan from CM1 to M1,
