TOWEL BAR – AL ALLOY – MODERN TIMES – FRANCE

Artefact name	Towel bar
Authors	Christian. Degriigny (HE-Arc CR, Neuchâtel, Neuchâtel, Switzerland)
Url	/artefacts/410/

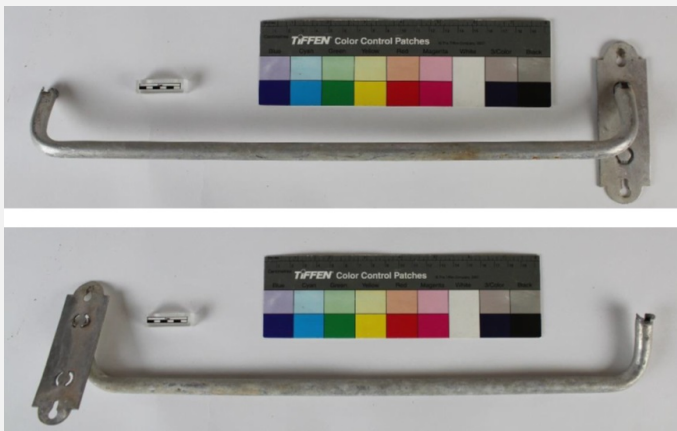
Fig. 1: Front and back sides of a towel bar,

Description of the artefact	Towel bar with traces of use and a broken section (Fig. 1). White deposits have developed on the metal surface. Dimensions: L = 45cm.	
Type of artefact	Household implement	
Origin	Château de Germolles, Mellecey, Bourgogne, France	
Recovering date	Unknown	
Chronology category	Modern Times	
chronology tpq	<input type="text" value="1801"/>	A.D. ▼
chronology taq	<input type="text" value="2000"/>	A.D. ▼
Chronology comment	19th - 20th century

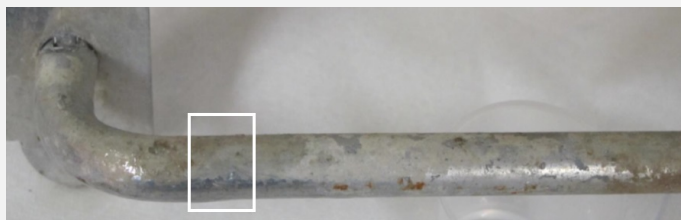
Fig. 2: Detail of the back side of the towel bar showing the location of the sampling area,

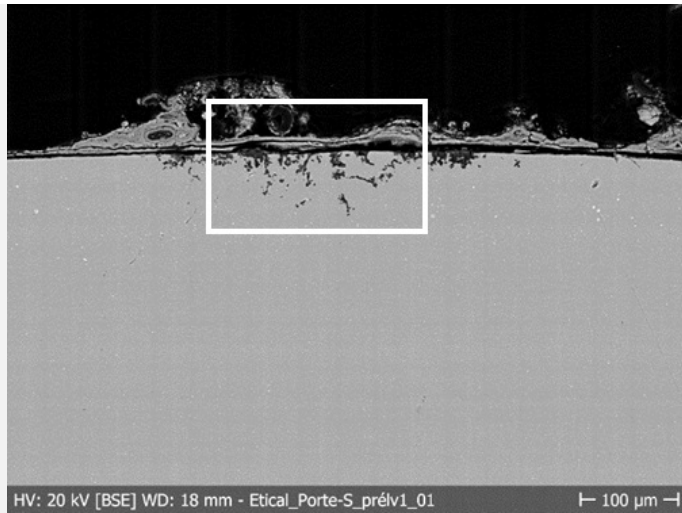
Fig. 3: SEM image of the cross-section showing the location of Fig. 5,

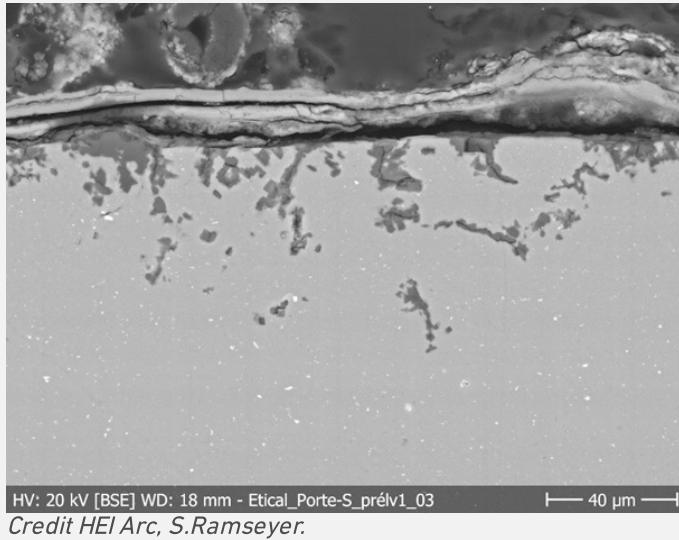
The metal is a relatively pure aluminium alloy with numerous inclusions (Fig. 5). From their chemical composition they can be interpreted as Al₃Fe intermetallic compounds (Fig. 6). Pitting corrosion as well as a start of intergranular

corrosion develops locally under the deposits, outlining some of the grains (Fig. 5).

Fig. 5: SEM image of the metal sample from Fig. 3 (detail), BSE-mode. We observe the presence of numerous inclusions,

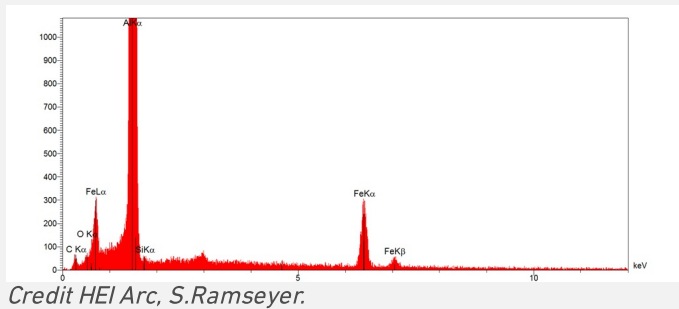
Fig. 6: EDS spectrum of the inclusions of Fig. 5,

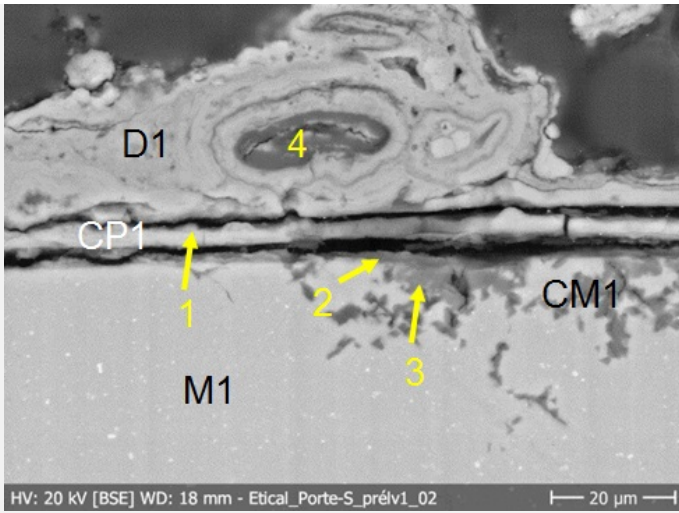
A very thin and loose oxide film has formed on the metal surface (CP1) and is locally covered by white deposits (D1). Intergranular corrosion has developed under the deposits (Fig. 7). Analysis by SEM-EDS indicates that the Al and O-rich oxide layer is contaminated with P and Si (area 1 on Fig. 7 and Fig. 8). These elements are even more present at the interface between CM1 and CP1 with Cl and S (area 2 on Fig. 7 and Fig. 9). The concentration of P and Si decreases in CM1 (area 3 on Fig. 7 and Fig. 10) while the concentration of S and Cl increases (Fig. 11). The deposit is mainly constituted of Ca, O, C and Si (probably CaCO₃ and SiO₂, area 4 on Fig. 7 and Fig. 12).

Fig. 7: SEM picture with location of EDS analyses of areas 1 to 4), BSE-mode. From bottom to top: the metal (M1) in light grey, the corroded metal (CM1), CP1 and D1,

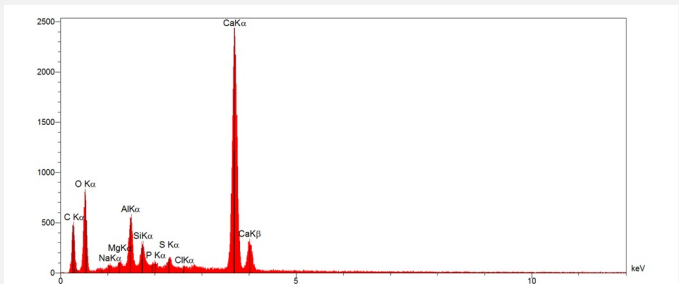
Fig. 8: EDS spectrum of area 1 of Fig. 7,

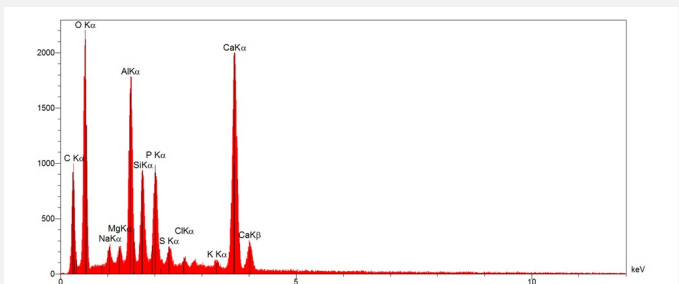
Fig. 9: EDS spectrum of area 2 of Fig. 7,

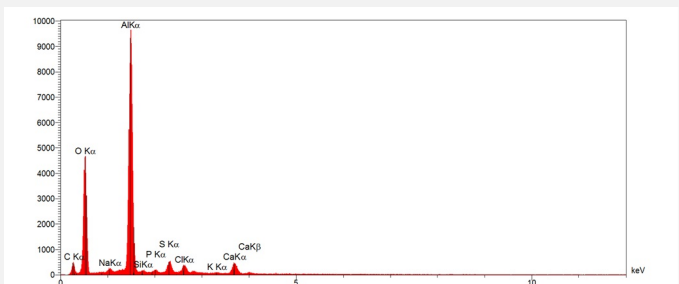
Fig. 10: EDS spectrum of area 3 of Fig. 7,

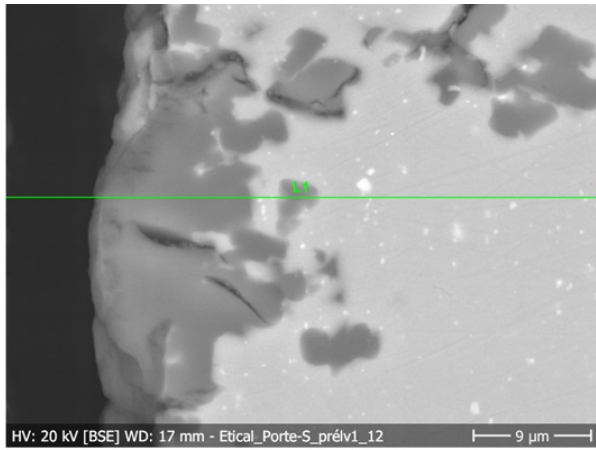
Fig. 11: EDS Linescan from CM1 to M1,
