## TOWEL BAR – AL ALLOY – MODERN TIMES – FRANCE

Artefact name	Towel bar
Authors	Christian. Degriigny (HE-Arc CR, Neuchâtel, Neuchâtel, Switzerland)
Url	/artefacts/410/

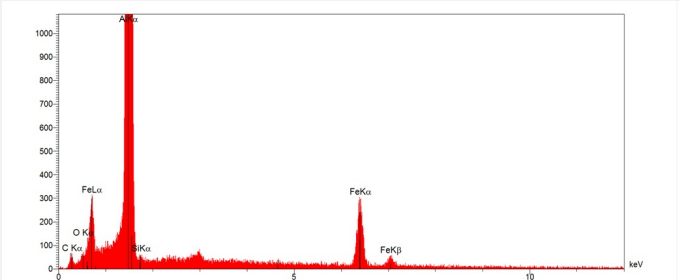
Fig. 6: EDS spectrum of the inclusions of Fig. 5,
