CHISEL POINT DEV 995 1069 PR – EUTECTOID TO HYPEREUTECTOID STEEL – EARLY MEDIEVAL TIMES – SWITZERLAND

Artefact name Chisel point DEV 995 1069 PR

Authors Marianne. Senn (EMPA, Dübendorf, Zurich, Switzerland) & Christian. Degriigny (HE-Arc CR, Neuchâtel, Neuchâtel, Switzerland)

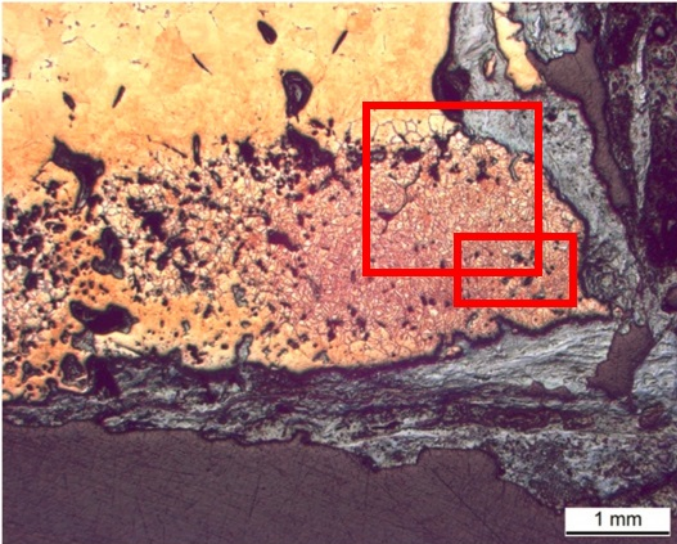
The remaining metal is a eutectoid to hypereutectoid steel (C 0.8-1 mass%) with cracks and porosity (Figs. 5 and 6). Its composition is given in Table 1 (except Fe). Of the trace elements, only Ni reaches a medium concentration (Ni 0.07 mass%). The composition and the high Ni/Co ratio are atypical for iron worked in smithies of the settlement at Develier-Courtételle JU, CH. The few slag inclusions and their chemical composition confirm this (Table 2). The slag is rich in CaO whereas the pisolithic or bean ore worked in the Central Jura smelting district is rich in Al₂O₃. The slag inclusions cannot be smithing slag because the artefact is formed from one piece of metal. The slag probably incorporated while refining the bloom or during the bloom smelting process. The ore from which this metal was smelted cannot yet be identified. Intergranular corrosion has developed, penetrating into the metal structure (Fig. 6). The etched metal shows a dominant martensitic structure, typical of quench hardened steel (Figs. 5, 7, 8 and 9). The characteristic forms of the martensite are non-organised needles (Fig. 8). In restricted areas bainite nodules occur (Figs. 7 and 8). In the centre of the point, hypereutectoid steel is composed of cementite in the grain boundaries and in needle like shapes within the grains (Fig. 10). Hypereutectoid regions also occur in the centre of the shaft and on its left surface (Fig. 5). Here the hypereutectoid steel is composed of martensite and cementite in the grain boundaries and in needle form within the grains (Figs. 6 and 9). Nevertheless, most of the chisel is dominated by eutectoid steel. The average hardness of the quench hardened eutectoid steel is about HV1 690. In the bainite nodules the average hardness drops to about HV1 350, the martensite has an average hardness of HV1 750.

Fig. 5: Micrograph of the metal sample from Fig. 3 (inverted picture, detail), etched, bright field. The metal contains porosity and cracks (in black). The micrographs of Figs. 6 and 9 are marked by the top and bottom rectangles respectively,

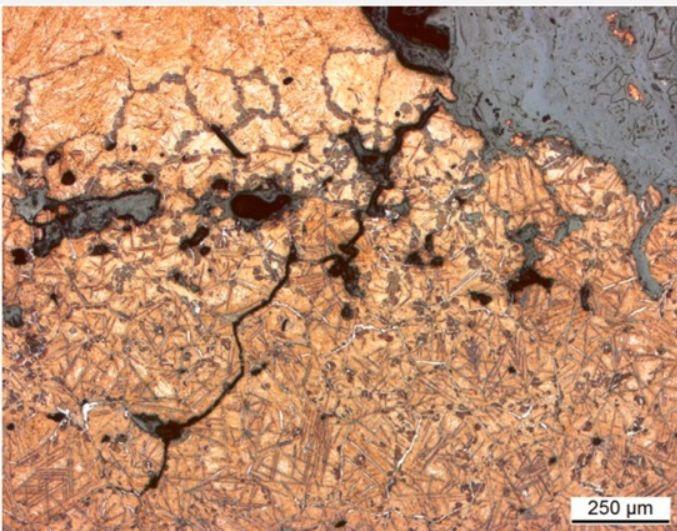
Fig. 6: Micrograph of the metal sample, detail from Fig. 5, etched, bright field. We observe martensite (in orange), cementite (in grey), porosity and intergranular cracks (in black) and corrosion,

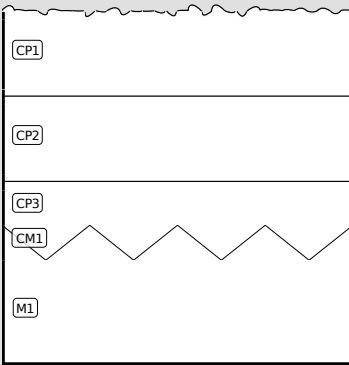
Fig. 4: Stratigraphic representation of the object in cross-section using the MiCorr application. The characteristics of the strata are only accessible by clicking on the drawing that redirects you to the search tool by stratigraphy representation. This representation can be compared to Fig. 11, Credit HE-Arc CR.
