# CHISEL POINT DEV 995 1069 PR – EUTECTOID TO HYPEREUTECTOID STEEL – EARLY MEDIEVAL TIMES – SWITZERLAND

**Artefact name** Chisel point DEV 995 1069 PR

**Authors** Marianne. Senn (EMPA, Dübendorf, Zurich, Switzerland) & Christian. Degriigny (HE-Arc CR, Neuchâtel, Neuchâtel, Switzerland)

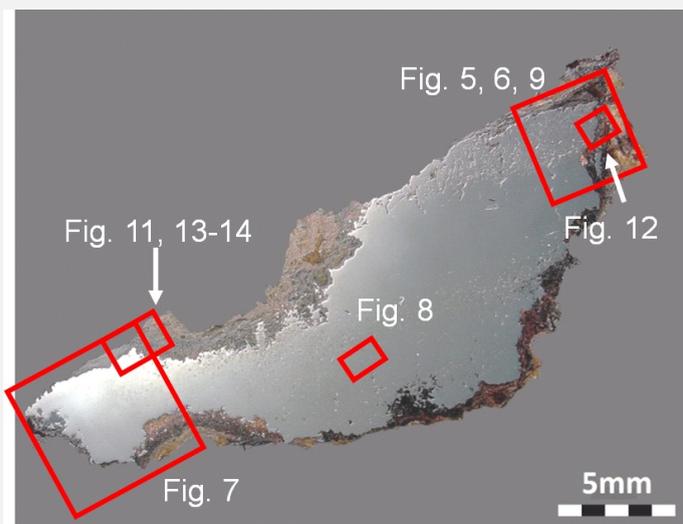
Fig. 3: Micrograph of the cross-section showing the location of Figs. 5 to 9 and 11 to 14,

<b>Description of sample</b>	A longitudinal cut from a chisel point (Figs. 2 and 3) undertaken after restoration. Dimensions: L = 30mm; W = 11mm (approximately).
<b>Alloy</b>	Eutectoid to hypereutectoid steel
<b>Technology</b>	Quench hardened
<b>Lab number of sample</b>	DEV1069
<b>Sample location</b>	Empa (Marianne Senn)
<b>Responsible institution</b>	Office de la Culture, Porrentruy, Jura
<b>Date and aim of sampling</b>	2000, metallography and chemical composition of the metal

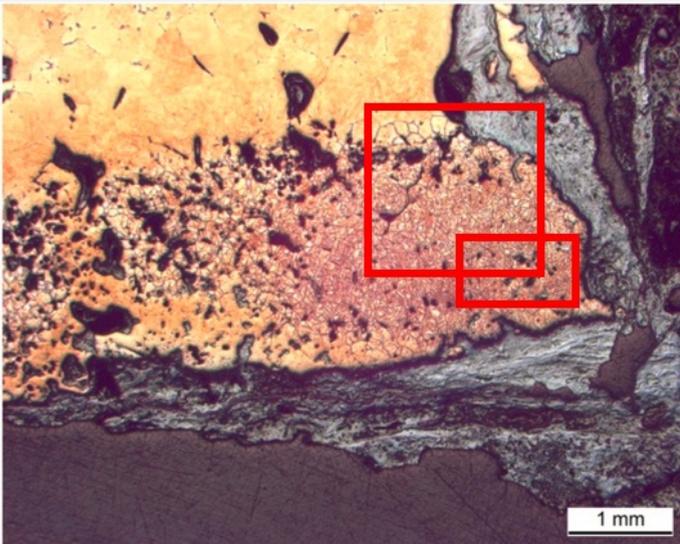
The remaining metal is a eutectoid to hypereutectoid steel (C 0.8-1 mass%) with cracks and porosity (Figs. 5 and 6). Its composition is given in Table 1 (except Fe). Of the trace elements, only Ni reaches a medium concentration (Ni 0.07 mass%). The composition and the high Ni/Co ratio are atypical for iron worked in smithies of the settlement at Develier-Courtételle JU, CH. The few slag inclusions and their chemical composition confirm this (Table 2). The slag is rich in CaO whereas the pisolithic or bean ore worked in the Central Jura smelting district is rich in Al<sub>2</sub>O<sub>3</sub>. The slag inclusions cannot be smithing slag because the artefact is formed from one piece of metal. The slag probably incorporated while refining the bloom or during the bloom smelting process. The ore from which this metal was smelted cannot yet be identified. Intergranular corrosion has developed, penetrating into the metal structure (Fig. 6). The etched metal shows a dominant martensitic structure, typical of quench hardened steel (Figs. 5, 7, 8 and 9). The characteristic forms of the martensite are non-organised needles (Fig. 8). In restricted areas bainite nodules occur (Figs. 7 and 8). In the centre of the point, hypereutectoid steel is composed of cementite in the grain boundaries and in needle like shapes within the grains (Fig. 10). Hypereutectoid regions also occur in the centre of the shaft and on its left surface (Fig. 5). Here the hypereutectoid steel is composed of martensite and cementite in the grain boundaries and in needle form within the grains (Figs. 6 and 9). Nevertheless, most of the chisel is dominated by eutectoid steel. The average hardness of the quench hardened eutectoid steel is about HV1 690. In the bainite nodules the average hardness drops to about HV1 350, the martensite has an average hardness of HV1 750.

Fig. 5: Micrograph of the metal sample from Fig. 3 (inverted picture, detail), etched, bright field. The metal contains porosity and cracks (in black). The micrographs of Figs. 6 and 9 are marked by the top and bottom rectangles respectively,

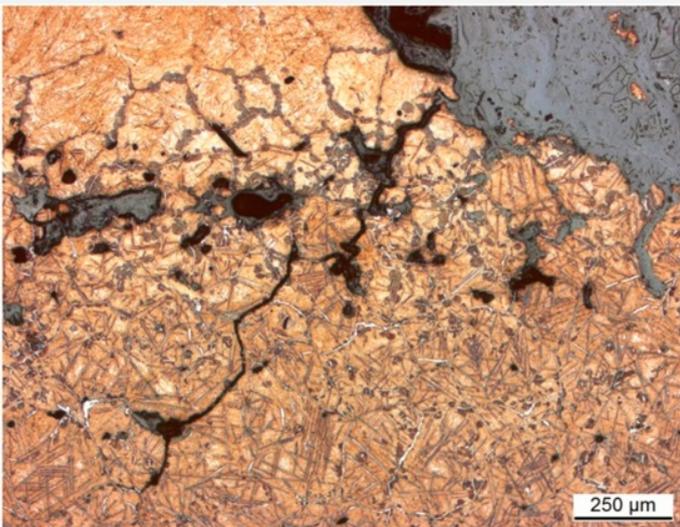
Fig. 6: Micrograph of the metal sample, detail from Fig. 5, etched, bright field. We observe martensite (in orange), cementite (in grey), porosity and intergranular cracks (in black) and corrosion,

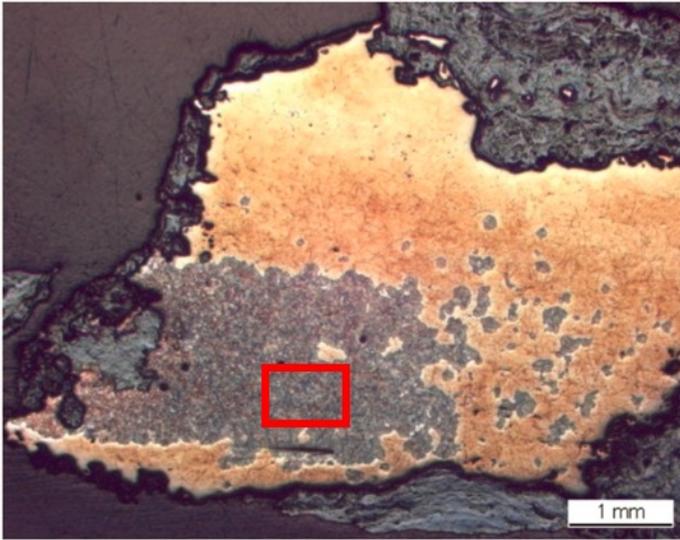
Fig. 7: Micrograph of the metal sample from Fig. 3 (inverted picture, detail), etched, bright field. We observe the metal with martensite (orange) and bainite nodules (blue). The micrograph of Fig. 10 is marked by a rectangle,

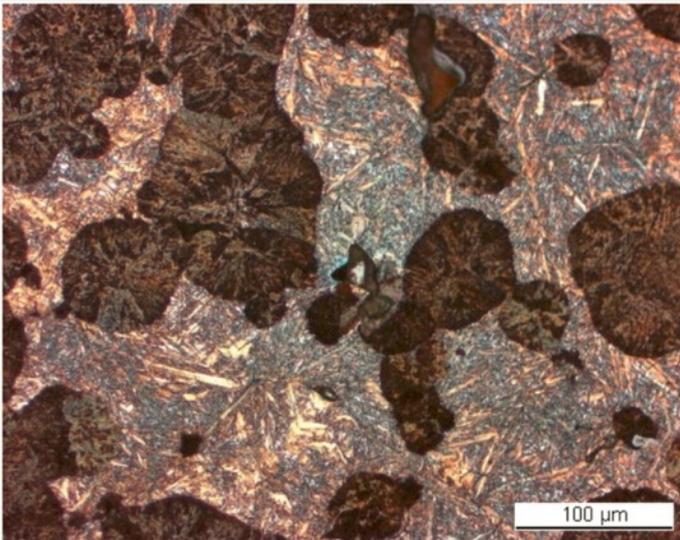
Fig. 8: Micrograph of the metal sample from Fig. 3 (detail), etched, bright field. We observe dark bainite nodules combined with martensite needles,

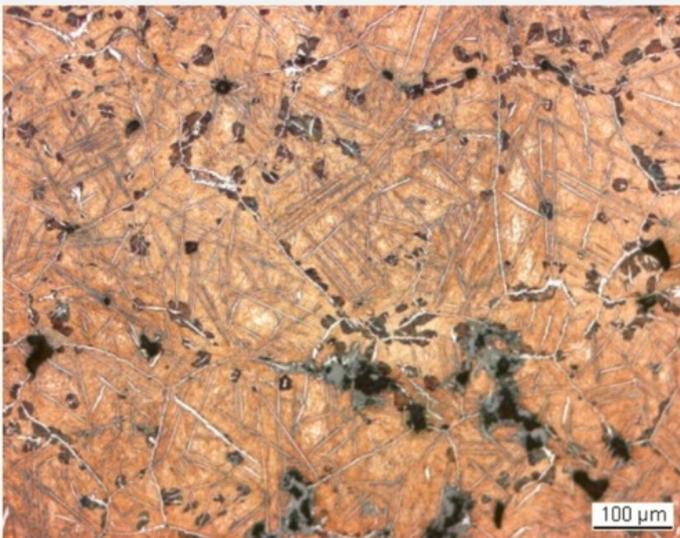
Fig. 9: Micrograph of the metal sample, detail from Fig. 5, etched, bright field. Hypereutectoid steel with a structure of cementite in white in the grain boundaries and in needle form combined with martensite (pink). Some bainite occurs around the grain boundaries,

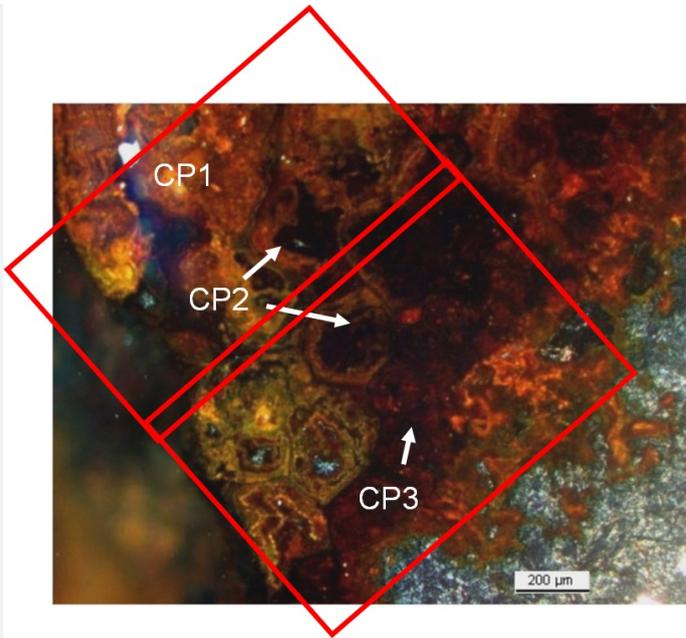
The metal is heavily corroded and the thickness of the corrosion crust is irregular, but averages about 0.5mm. The corrosion products enclose different ghost structures: the corrosion crust has preserved the shape of polygonal grains (Figs. 11 and 13) and cementite needles (Fig. 12). Under polarised light, the corrosion products at the metal - corrosion crust interface are dark-red and form an inner S-rich layer (CP3, Figs. 11 and 13). Cl occurs locally (CP3) and C is present in layers CP2 and CP3 (Fig. 13). The outer layer of the corrosion products (CP1) is orange and contains more O than the inner layer CP3 (Figs. 11 and 14).

Fig. 11: Micrograph showing the metal - corrosion crust interface from Fig. 3 (rotated by 270°, detail) and corresponding to the stratigraphy of Fig. 4, unetched, polarised light. Polygonal grains are visible as ghost structure in the corrosion crust. The mapped areas (Figs. 13 and 14) are marked by two rectangles (bottom: Fig. 13 and top: Fig. 14),

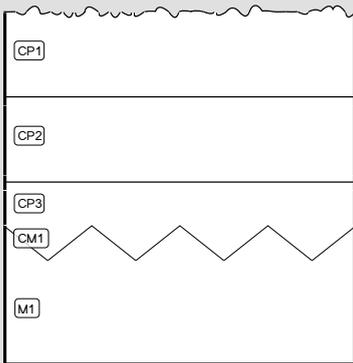
Fig. 4: Stratigraphic representation of the object in cross-section using the MiCorr application. The characteristics of the strata are only accessible by clicking on the drawing that redirects you to the search tool by stratigraphy representation. This representation can be compared to Fig. 11, Credit HE-Arc CR.
