# CHISEL POINT DEV 995 1069 PR – EUTECTOID TO HYPEREUTECTOID STEEL – EARLY MEDIEVAL TIMES – SWITZERLAND

**Artefact name** Chisel point DEV 995 1069 PR

**Authors** Marianne. Senn (EMPA, Dübendorf, Zurich, Switzerland) & Christian. Degryny (HE-Arc CR, Neuchâtel, Neuchâtel, Switzerland)

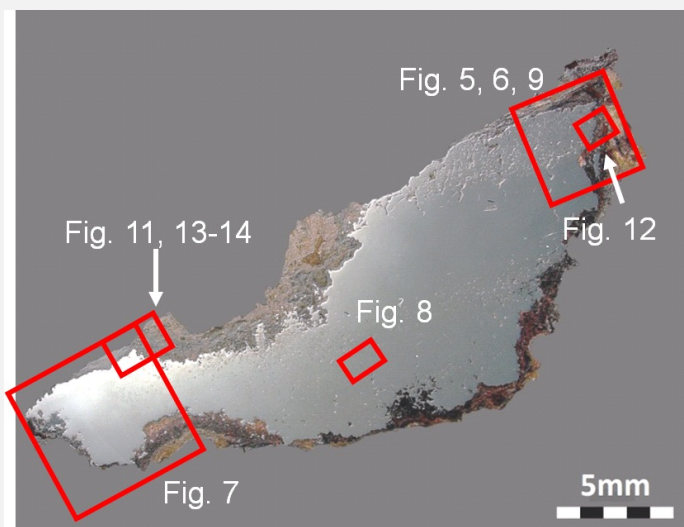
Fig. 3: Micrograph of the cross-section showing the location of Figs. 5 to 9 and 11 to 14,

<b>Description of sample</b>	A longitudinal cut from a chisel point (Figs. 2 and 3) undertaken after restoration. Dimensions: L = 30mm; W = 11mm (approximately).
<b>Alloy</b>	Eutectoid to hypereutectoid steel
<b>Technology</b>	Quench hardened
<b>Lab number of sample</b>	DEV1069
<b>Sample location</b>	Empa (Marianne Senn)
<b>Responsible institution</b>	Office de la Culture, Porrentruy, Jura
<b>Date and aim of sampling</b>	2000, metallography and chemical composition of the metal

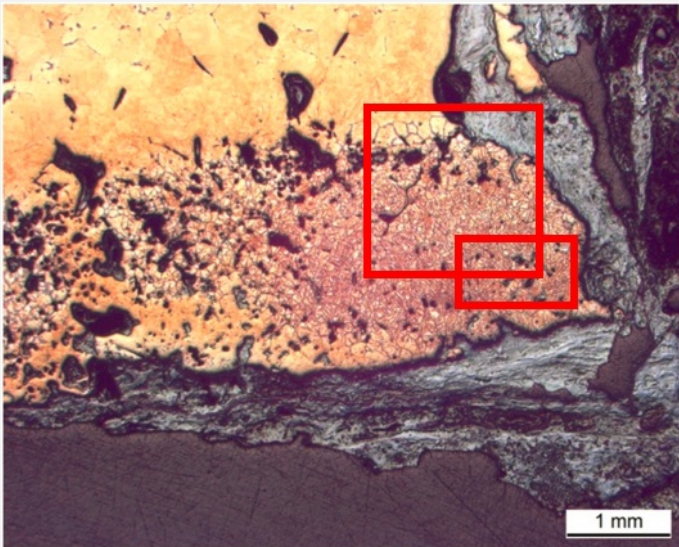
The remaining metal is a eutectoid to hypereutectoid steel (C 0.8-1 mass%) with cracks and porosity (Figs. 5 and 6). Its composition is given in Table 1 (except Fe). Of the trace elements, only Ni reaches a medium concentration (Ni 0.07 mass%). The composition and the high Ni/Co ratio are atypical for iron worked in smithies of the settlement at Develier-Courtételle JU, CH. The few slag inclusions and their chemical composition confirm this (Table 2). The slag is rich in CaO whereas the pisolithic or bean ore worked in the Central Jura smelting district is rich in Al<sub>2</sub>O<sub>3</sub>. The slag inclusions cannot be smithing slag because the artefact is formed from one piece of metal. The slag probably incorporated while refining the bloom or during the bloom smelting process. The ore from which this metal was smelted cannot yet be identified. Intergranular corrosion has developed, penetrating into the metal structure (Fig. 6). The etched metal shows a dominant martensitic structure, typical of quench hardened steel (Figs. 5, 7, 8 and 9). The characteristic forms of the martensite are non-organised needles (Fig. 8). In restricted areas bainite nodules occur (Figs. 7 and 8). In the centre of the point, hypereutectoid steel is composed of cementite in the grain boundaries and in needle like shapes within the grains (Fig. 10). Hypereutectoid regions also occur in the centre of the shaft and on its left surface (Fig. 5). Here the hypereutectoid steel is composed of martensite and cementite in the grain boundaries and in needle form within the grains (Figs. 6 and 9). Nevertheless, most of the chisel is dominated by eutectoid steel. The average hardness of the quench hardened eutectoid steel is about HV1 690. In the bainite nodules the average hardness drops to about HV1 350, the martensite has an average hardness of HV1 750.

Fig. 5: Micrograph of the metal sample from Fig. 3 (inverted picture, detail), etched, bright field. The metal contains porosity and cracks (in black). The micrographs of Figs. 6 and 9 are marked by the top and bottom rectangles respectively,

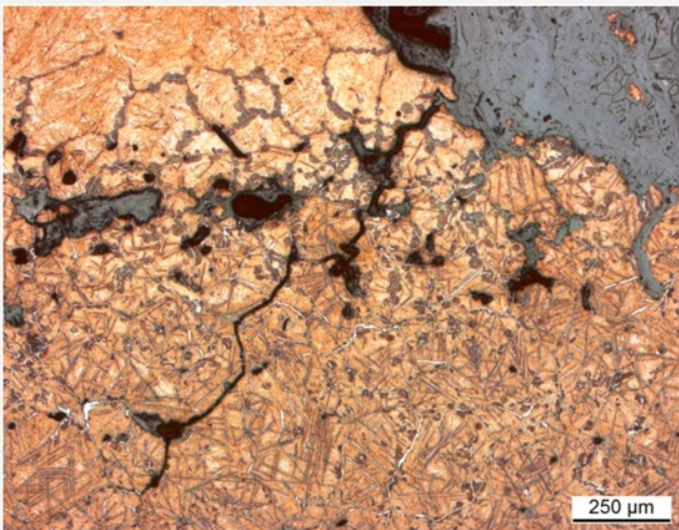
Fig. 6: Micrograph of the metal sample, detail from Fig. 5, etched, bright field. We observe martensite (in orange), cementite (in grey), porosity and intergranular cracks (in black) and corrosion,

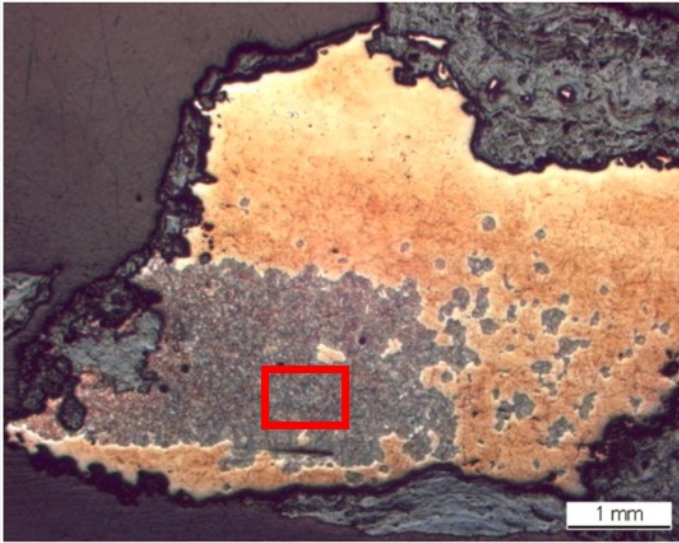
Fig. 7: Micrograph of the metal sample from Fig. 3 (inverted picture, detail), etched, bright field. We observe the metal with martensite (orange) and bainite nodules (blue). The micrograph of Fig. 10 is marked by a rectangle,

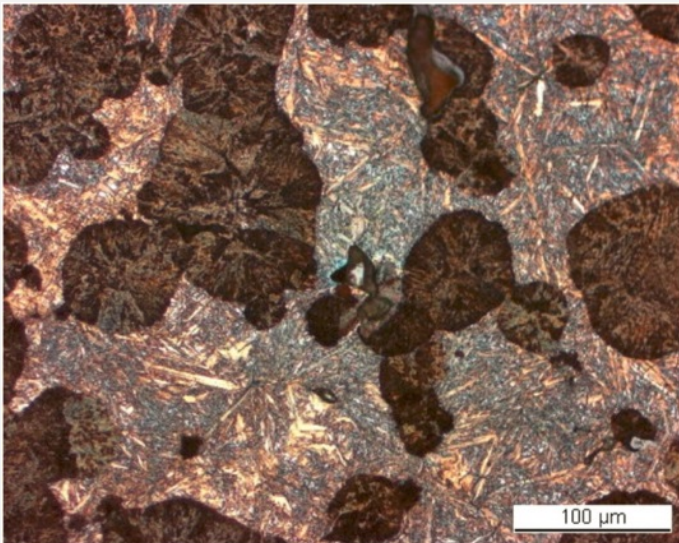
Fig. 8: Micrograph of the metal sample from Fig. 3 (detail), etched, bright field. We observe dark bainite nodules combined with martensite needles,

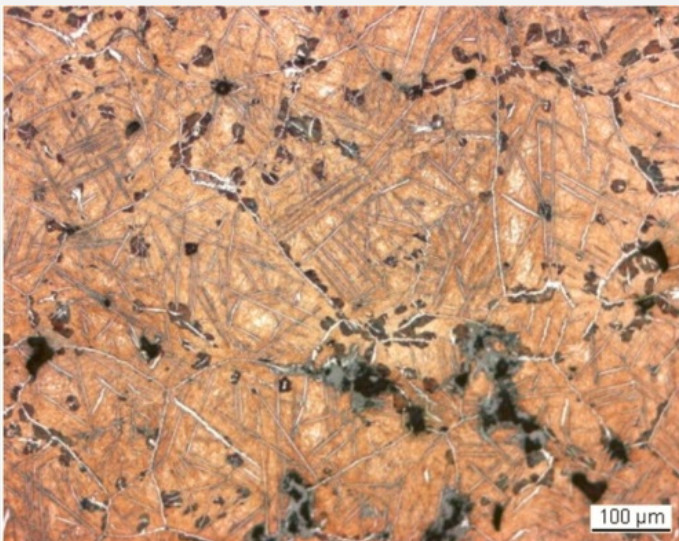
Fig. 9: Micrograph of the metal sample, detail from Fig. 5, etched, bright field. Hypereutectoid steel with a structure of cementite in white in the grain boundaries and in needle form combined with martensite (pink). Some bainite occurs around the grain boundaries,

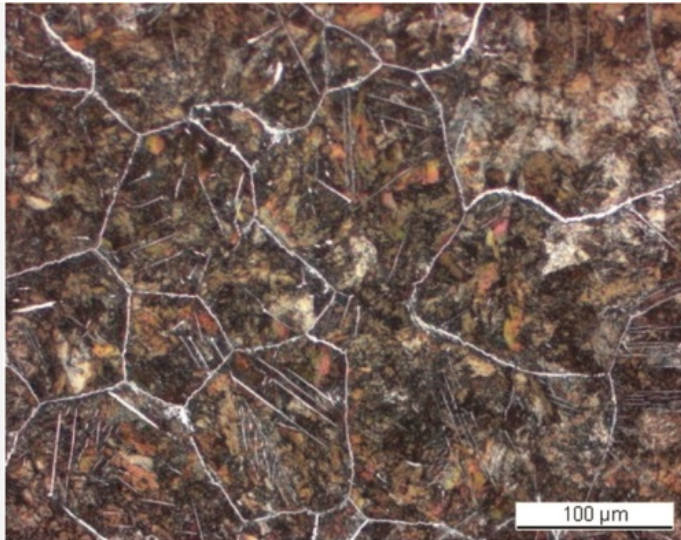
Fig. 10: Micrograph of the metal sample, detail from Fig. 7, etched, bright field. Hypereutectoid steel with a structure of cementite in white in the grain boundaries and in needle form combined with bainite (dark),

The tool is made of hard, eutectoid to hypereutectoid steel and was, as a last manufacturing step, entirely quenched. In this state it is too hard and brittle to be used. It is likely that the quenched hypereutectoid structure provoked the breakage of the tool when it was first used. The absence of a tempering process at the end is unclear. The chemical composition of the metal and the slag inclusions indicate that the artefact was imported to the hamlet of Develier-Courtételle JU. The corrosion has, in areas, replaced the metal structure retaining a ghost structure; the outer layer has been mostly removed during surface cleaning. Extensive pitting corrosion has occurred, typical for steel with an elevated C content. The presence of S in the inner layer can be explained by putrefaction processes in the soil. Chlorides are still present at the metal-corrosion interface as no desalination process was attempted. Iron carbonates are present in the centre of a corrosion pit. The corrosion is of terrestrial type.

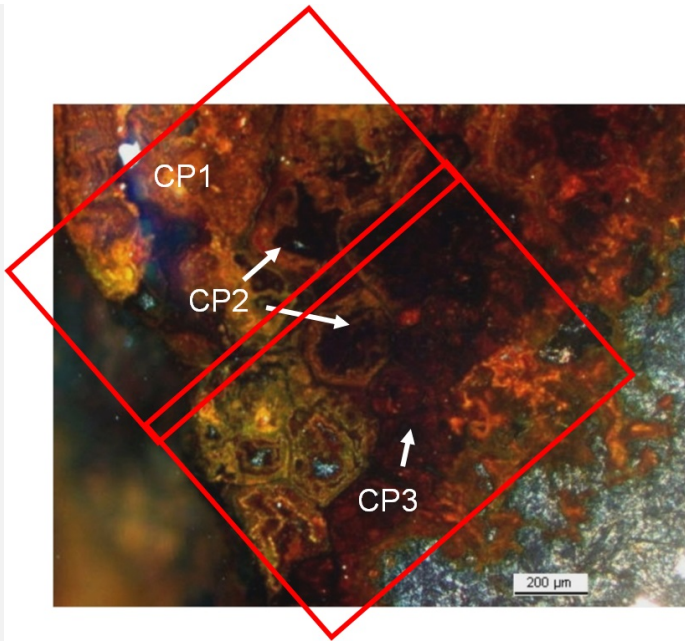
The metal is heavily corroded and the thickness of the corrosion crust is irregular, but averages about 0.5mm. The corrosion products enclose different ghost structures: the corrosion crust has preserved the shape of polygonal grains (Figs. 11 and 13) and cementite needles (Fig. 12). Under polarised light, the corrosion products at the metal - corrosion crust interface are dark-red and form an inner S-rich layer (CP3, Figs. 11 and 13). Cl occurs locally (CP3) and C is present in layers CP2 and CP3 (Fig. 13). The outer layer of the corrosion products (CP1) is orange and contains more O than the inner layer CP3 (Figs. 11 and 14).

Fig. 11: Micrograph showing the metal - corrosion crust interface from Fig. 3 (rotated by 270°, detail) and corresponding to the stratigraphy of Fig. 4, unetched, polarised light. Polygonal grains are visible as ghost structure in the corrosion crust. The mapped areas (Figs. 13 and 14) are marked by two rectangles (bottom: Fig. 13 and top: Fig. 14),

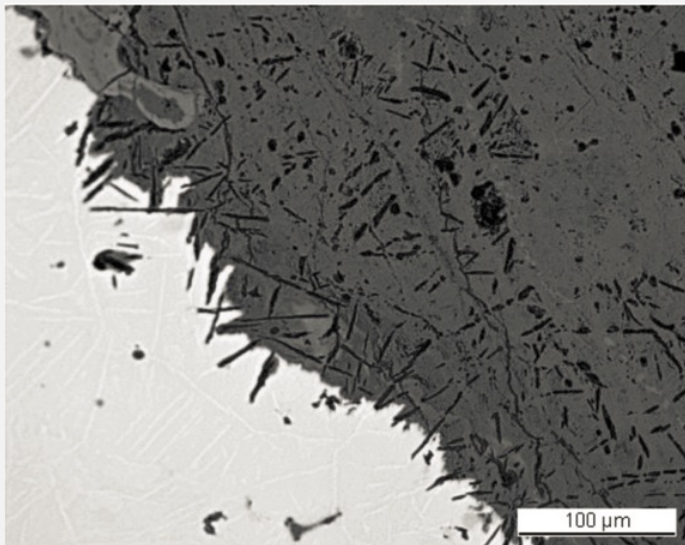
Fig. 12: Micrograph showing the metal - corrosion crust interface from Fig. 3 (detail), unetched, bright field. The cementite is visible as white needles in the metal and its ghost structure as black needles in the corrosion crust,

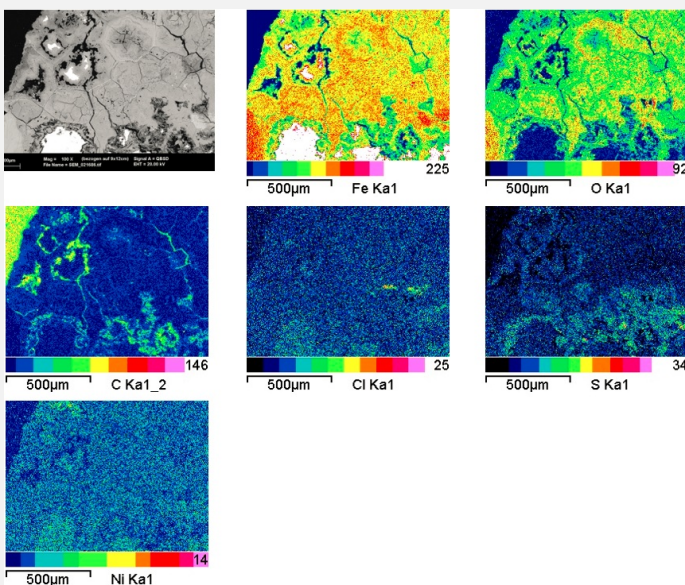
Fig. 13: SEM image, BSE-mode, and elemental chemical distribution of the selected area from Fig. 11 (rotated by 45°). Method of examination: SEM/EDS, Laboratory of Analytical Chemistry, Empa,

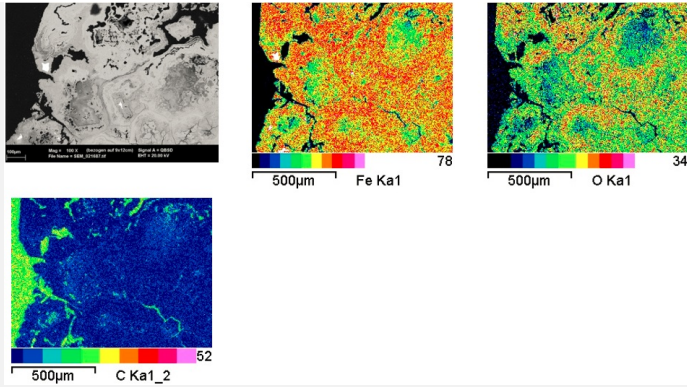
Fig. 14: SEM image, BSE-mode, and elemental chemical distribution of the selected area from Fig. 11 (rotated by 45°). Method of examination: SEM/EDS, Laboratory of Analytical Chemistry, Empa,

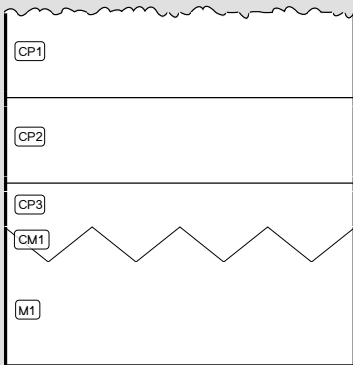
Fig. 4: Stratigraphic representation of the object in cross-section using the MiCorr application. The characteristics of the strata are only accessible by clicking on the drawing that redirects you to the search tool by stratigraphy representation. This representation can be compared to Fig. 11, Credit HE-Arc CR.
