CHISEL POINT DEV 995/1069 PR – EUTECTOID TO HYPEREUTECTOID STEEL – EARLY MEDIEVAL TIMES – SWITZERLAND

Artefact name	Chisel point DEV 995/1069 PR
Authors	Marianne. Senn (EMPA, Dübendorf, Zurich, Switzerland) & Christian. Degrieny (HE-Arc CR, Neuchâtel, Neuchâtel, Switzerland)
Url	/artefacts/434/

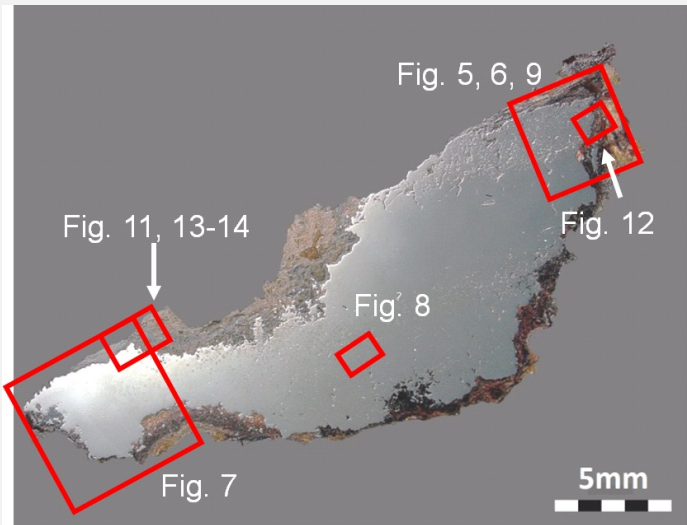
Fig. 3: Micrograph of the cross-section showing the location of Figs. 5 to 9 and 11 to 14,

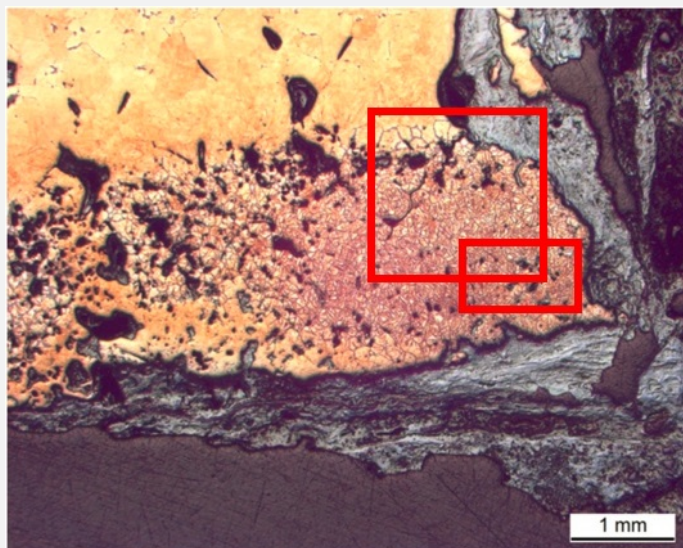
The remaining metal is a eutectoid to hypereutectoid steel (C 0.8-1 mass%) with cracks and porosity (Figs. 5 and 6). Its composition is given in Table 1 (except Fe). Of the trace elements, only Ni reaches a medium concentration (Ni 0.07 mass%). The composition and the high Ni/Co ratio are atypical for iron worked in smithies of the settlement at Develier-Courtételle JU, CH. The few slag inclusions and their chemical composition confirm this (Table 2). The slag is rich in CaO whereas the pisolithic or bean ore worked in the Central Jura smelting district is rich in Al₂O₃. The slag inclusions cannot be smithing slag because the artefact is formed from one piece of metal. The slag probably incorporated while refining the bloom or during the bloom smelting process. The ore from which this metal was smelted cannot yet be identified. Intergranular corrosion has developed, penetrating into the metal structure (Fig. 6). The etched metal shows a dominant martensitic structure, typical of quench hardened steel (Figs. 5, 7, 8 and 9). The characteristic forms of the martensite are non-organised needles (Fig. 8). In restricted areas bainite nodules occur (Figs. 7 and 8). In the centre of the point, hypereutectoid steel is composed of cementite in the grain boundaries and in needle like shapes within the grains (Fig. 10). Hypereutectoid regions also occur in the centre of the shaft and on its left surface (Fig. 5). Here the hypereutectoid steel is composed of martensite and cementite in the grain boundaries and in needle form within the grains (Figs. 6 and 9). Nevertheless, most of the chisel is dominated by eutectoid steel. The average hardness of the quench hardened eutectoid steel is about HV1 690. In the bainite nodules the average hardness drops to about HV1 350, the martensite has an average hardness of HV1 750.

Fig. 5: Micrograph of the metal sample from Fig. 3 (inverted picture, detail), etched, bright field. The metal contains porosity and cracks (in black). The micrographs of Figs. 6 and 9 are marked by the top and bottom rectangles respectively,

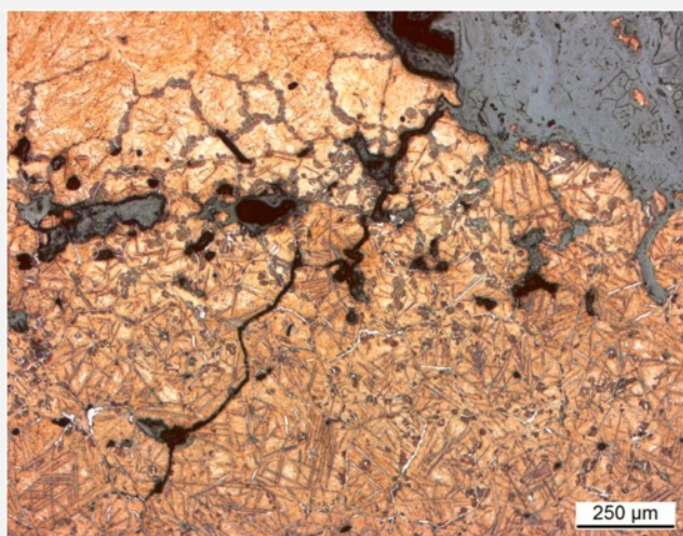
Fig. 6: Micrograph of the metal sample, detail from Fig. 5, etched, bright field. We observe martensite (in orange), cementite (in grey), porosity and intergranular cracks (in black) and corrosion,

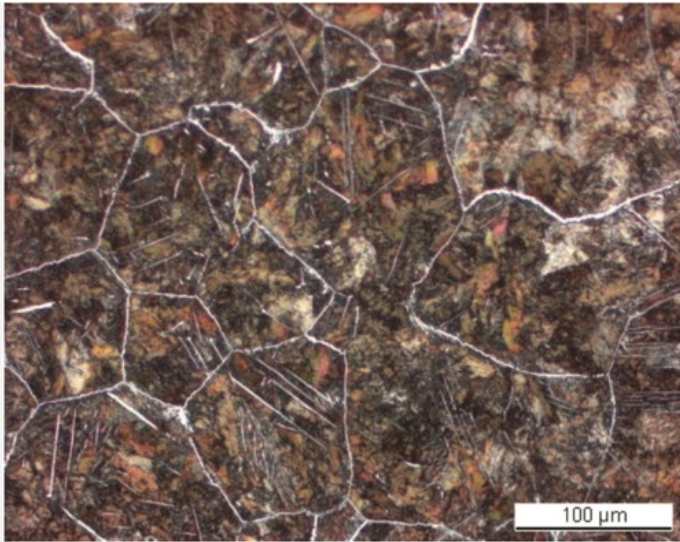
Fig. 10: Micrograph of the metal sample, detail from Fig. 7, etched, bright field. Hypereutectoid steel with a structure of cementite in white in the grain boundaries and in needle form combined with bainite (dark),

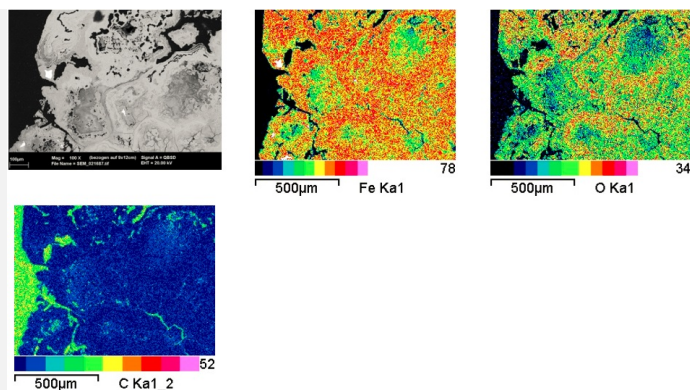
Fig. 14: SEM image, BSE-mode, and elemental chemical distribution of the selected area from Fig. 11 (rotated by 45°). Method of examination: SEM/EDS, Laboratory of Analytical Chemistry, Empa,

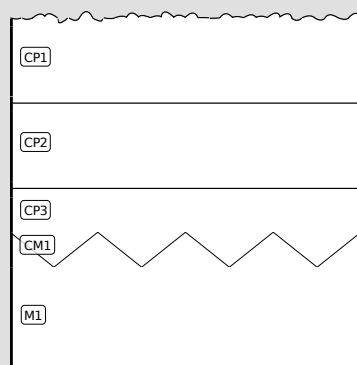
Fig. 4: Stratigraphic representation of the object in cross-section using the MiCorr application. The characteristics of the strata are only accessible by clicking on the drawing that redirects you to the search tool by stratigraphy representation. This representation can be compared to Fig. 11, Credit HE-Arc CR.
