CHISEL POINT DEV 995 1069 PR – EUTECTOID TO HYPEREUTECTOID STEEL – EARLY MEDIEVAL TIMES – SWITZERLAND

Artefact name Chisel point DEV 995 1069 PR

Authors Marianne. Senn (EMPA, Dübendorf, Zurich, Switzerland) & Christian. Degriigny (HE-Arc CR, Neuchâtel, Neuchâtel, Switzerland)

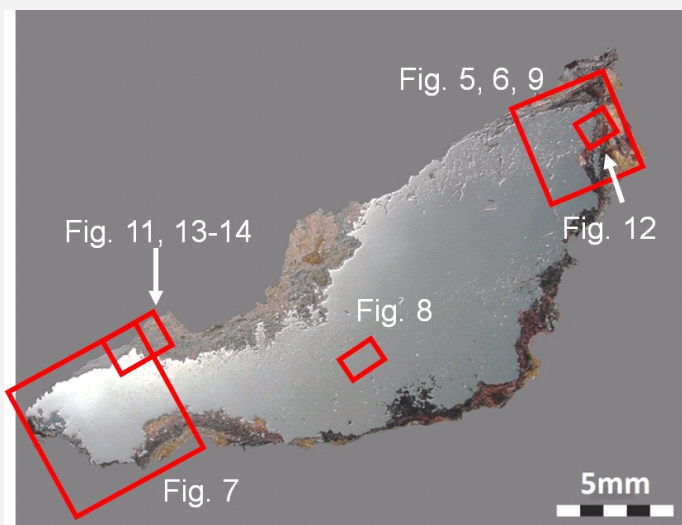
Fig. 3: Micrograph of the cross-section showing the location of Figs. 5 to 9 and 11 to 14,

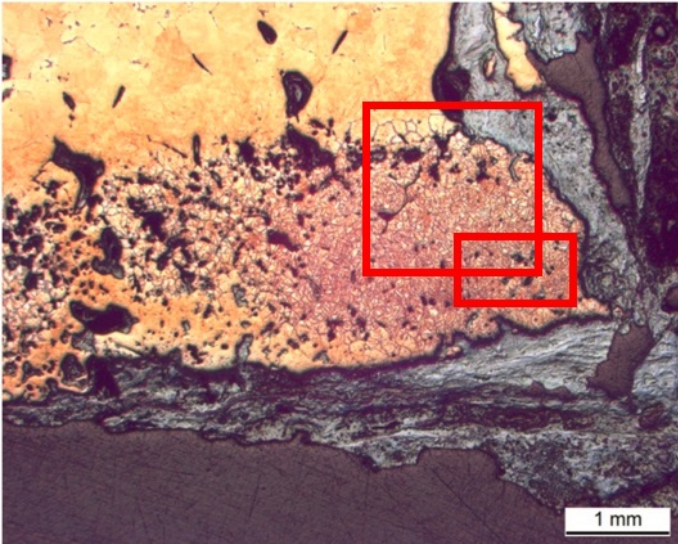
The remaining metal is a eutectoid to hypereutectoid steel (C 0.8-1 mass%) with cracks and porosity (Figs. 5 and 6). Its composition is given in Table 1 (except Fe). Of the trace elements, only Ni reaches a medium concentration (Ni 0.07 mass%). The composition and the high Ni/Co ratio are atypical for iron worked in smithies of the settlement at Develier-Courtételle JU, CH. The few slag inclusions and their chemical composition confirm this (Table 2). The slag is rich in CaO whereas the pisolithic or bean ore worked in the Central Jura smelting district is rich in Al₂O₃. The slag inclusions cannot be smithing slag because the artefact is formed from one piece of metal. The slag probably incorporated while refining the bloom or during the bloom smelting process. The ore from which this metal was smelted cannot yet be identified. Intergranular corrosion has developed, penetrating into the metal structure (Fig. 6). The etched metal shows a dominant martensitic structure, typical of quench hardened steel (Figs. 5, 7, 8 and 9). The characteristic forms of the martensite are non-organised needles (Fig. 8). In restricted areas bainite nodules occur (Figs. 7 and 8). In the centre of the point, hypereutectoid steel is composed of cementite in the grain boundaries and in needle like shapes within the grains (Fig. 10). Hypereutectoid regions also occur in the centre of the shaft and on its left surface (Fig. 5). Here the hypereutectoid steel is composed of martensite and cementite in the grain boundaries and in needle form within the grains (Figs. 6 and 9). Nevertheless, most of the chisel is dominated by eutectoid steel. The average hardness of the quench hardened eutectoid steel is about HV1 690. In the bainite nodules the average hardness drops to about HV1 350, the martensite has an average hardness of HV1 750.

Fig. 5: Micrograph of the metal sample from Fig. 3 (inverted picture, detail), etched, bright field. The metal contains porosity and cracks (in black). The micrographs of Figs. 6 and 9 are marked by the top and bottom rectangles respectively,

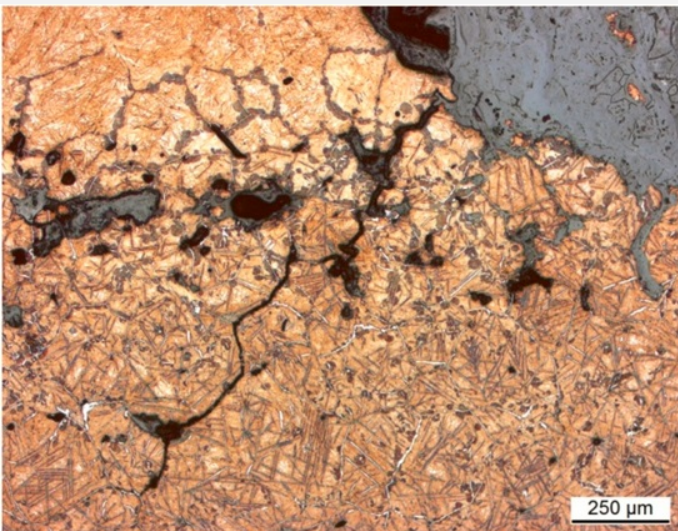
Fig. 6: Micrograph of the metal sample, detail from Fig. 5, etched, bright field. We observe martensite (in orange), cementite (in grey), porosity and intergranular cracks (in black) and corrosion,

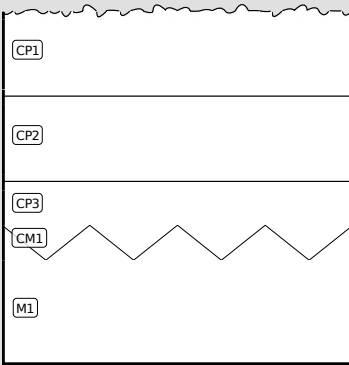
Fig. 4: Stratigraphic representation of the object in cross-section using the MiCorr application. The characteristics of the strata are only accessible by clicking on the drawing that redirects you to the search tool by stratigraphy representation. This representation can be compared to Fig. 11, Credit HE-Arc CR.
