# CHISEL POINT DEV 995 1069 PR – EUTECTOID TO HYPEREUTECTOID STEEL – EARLY MEDIEVAL TIMES – SWITZERLAND

**Artefact name** Chisel point DEV 995 1069 PR

**Authors** Marianne. Senn (EMPA, Dübendorf, Zurich, Switzerland) & Christian. Degriigny (HE-Arc CR, Neuchâtel, Neuchâtel, Switzerland)

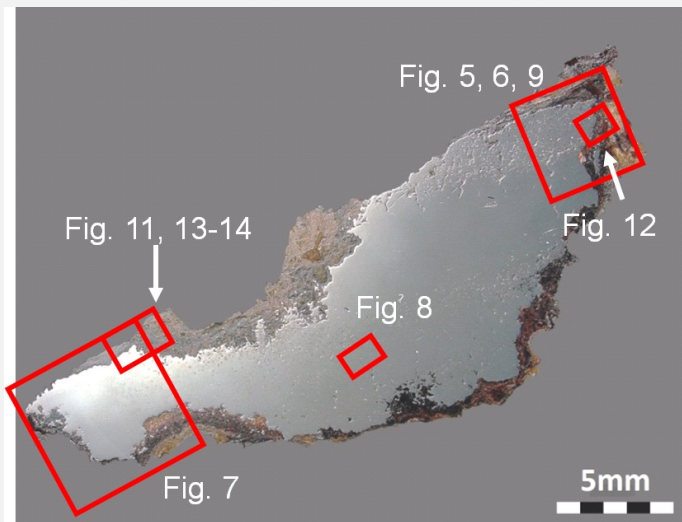
Fig. 3: Micrograph of the cross-section showing the location of Figs. 5 to 9 and 11 to 14,

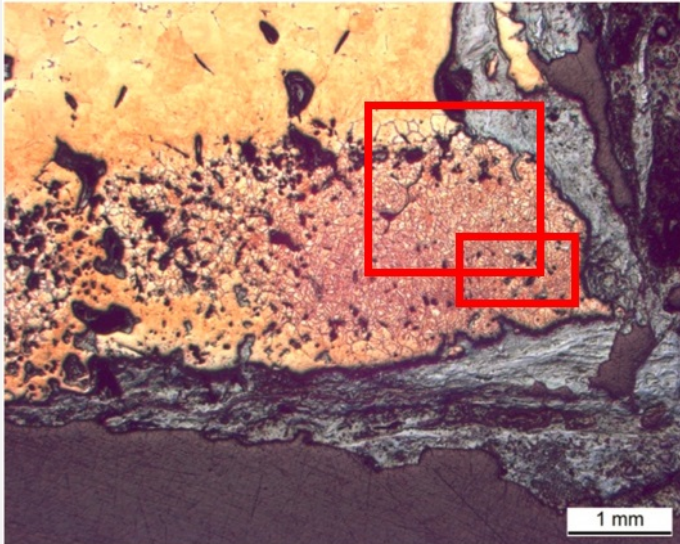
The remaining metal is a eutectoid to hypereutectoid steel (C 0.8-1 mass%) with cracks and porosity (Figs. 5 and 6). Its composition is given in Table 1 (except Fe). Of the trace elements, only Ni reaches a medium concentration (Ni 0.07 mass%). The composition and the high Ni/Co ratio are atypical for iron worked in smithies of the settlement at Develier-Courtételle JU, CH. The few slag inclusions and their chemical composition confirm this (Table 2). The slag is rich in CaO whereas the pisolithic or bean ore worked in the Central Jura smelting district is rich in Al<sub>2</sub>O<sub>3</sub>. The slag inclusions cannot be smithing slag because the artefact is formed from one piece of metal. The slag probably incorporated while refining the bloom or during the bloom smelting process. The ore from which this metal was smelted cannot yet be identified. Intergranular corrosion has developed, penetrating into the metal structure (Fig. 6). The etched metal shows a dominant martensitic structure, typical of quench hardened steel (Figs. 5, 7, 8 and 9). The characteristic forms of the martensite are non-organised needles (Fig. 8). In restricted areas bainite nodules occur (Figs. 7 and 8). In the centre of the point, hypereutectoid steel is composed of cementite in the grain boundaries and in needle like shapes within the grains (Fig. 10). Hypereutectoid regions also occur in the centre of the shaft and on its left surface (Fig. 5). Here the hypereutectoid steel is composed of martensite and cementite in the grain boundaries and in needle form within the grains (Figs. 6 and 9). Nevertheless, most of the chisel is dominated by eutectoid steel. The average hardness of the quench hardened eutectoid steel is about HV1 690. In the bainite nodules the average hardness drops to about HV1 350, the martensite has an average hardness of HV1 750.

Fig. 5: Micrograph of the metal sample from Fig. 3 (inverted picture, detail), etched, bright field. The metal contains porosity and cracks (in black). The micrographs of Figs. 6 and 9 are marked by the top and bottom rectangles respectively,

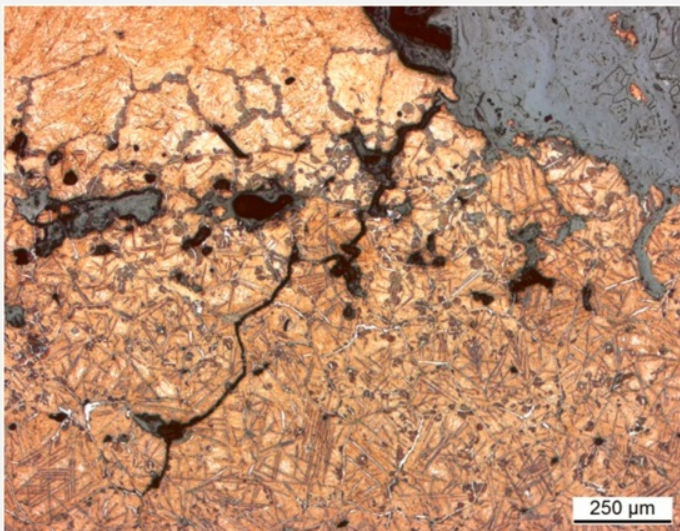
Fig. 6: Micrograph of the metal sample, detail from Fig. 5, etched, bright field. We observe martensite (in orange), cementite (in grey), porosity and intergranular cracks (in black) and corrosion,

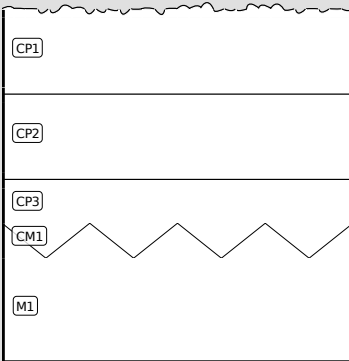
Fig. 4: Stratigraphic representation of the object in cross-section using the MiCorr application. The characteristics of the strata are only accessible by clicking on the drawing that redirects you to the search tool by stratigraphy representation. This representation can be compared to Fig. 11, Credit HE-Arc CR.
