# HEADREST OR HORSE BIT VFIG 2003.7 - LEADED BRONZE - MODERN TIMES

**Artefact name** Headrest or horse bit VFig 2003.7

**Authors** Christian. Degrigny (HE-Arc CR, Neuchâtel, Neuchâtel, Switzerland) & Valentin. Boissonnas (HE-Arc CR, Neuchâtel, Neuchâtel, Switzerland)

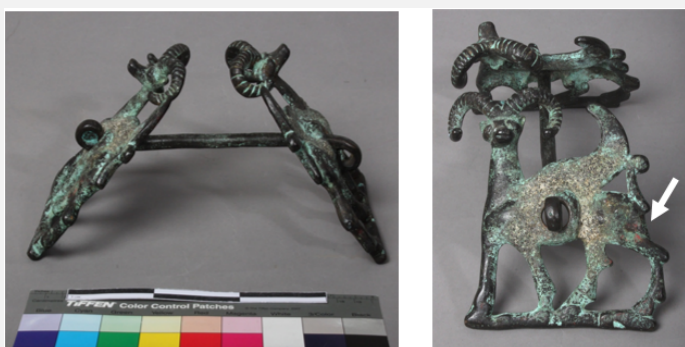
Fig. 1: Headrest or horse bit, side and front view,

<b>Description of the artefact</b>	Artefact made of two figurative (winged wild sheep) plates attached by a central bar (Fig. 1). One of the volutes of the bar is filled with metal suggesting it was cast with its end rolled up already. The surfaces of the plates (both sides) and the central bar are covered with a black adherent layer. A heterogeneous green layer is visible over this black layer. Well adhering hard brown-grey sediment-like deposits are present mostly in the middle of the plates on both sides. Red and orange spots are unevenly distributed on the surface (white arrow). Dimensions: W plates = 13mm; H plates = 105mm, L bar = 185mm, WT = 925g.
<b>Type of artefact</b>	Headrest or horse bit
<b>Origin</b>	Luristan (?)
<b>Recovering date</b>	Date unknown
<b>Chronology category</b>	Modern Times
<b>chronology tpq</b>	<input type="text"/> ---- ▾
<b>chronology taq</b>	<input type="text"/> ---- ▾

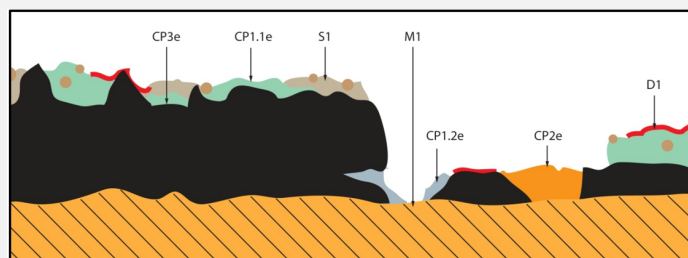
- S1:** soil (sand and limestone)
- D1:** red deposit
- CP1.1e:** outer light green-blue corrosion layer
- CP1.2e:** outer white-blue-grey corrosion layer
- CP2e:** outer orange corrosion layer
- CP3e/i:** outer/inner black brown corrosion layer
- M1:** metal

Fig. 3: Stratigraphic representation of the artefact in cross-section by macroscopic observation,

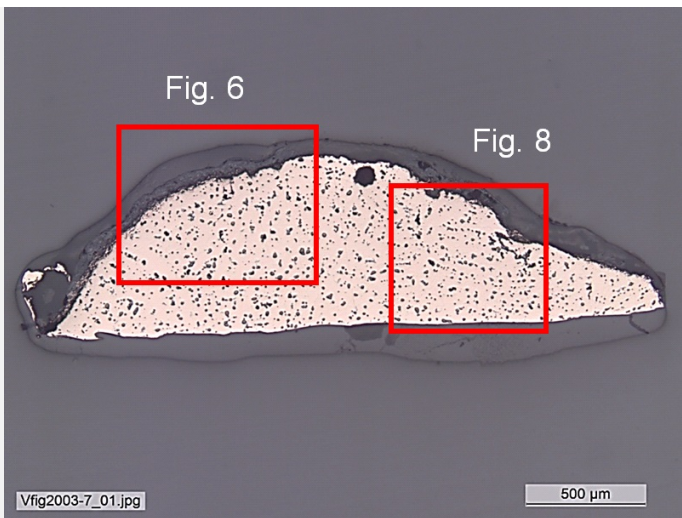
Fig. 4: Micrograph of the cross-section of sample from Fig. 2 showing the location of Figs. 6 and 8,

<b>Description of sample</b>	The sample was cut on the bottom of one of the plates (Fig. 2). On Fig. 4, the top and round shape of the sample is the outer part of the metal. It is covered with corrosion layers. The lower part of the sample corresponds to the cut metal with no corrosion products.
<b>Alloy</b>	Leaded Bronze
<b>Technology</b>	Cast and cold worked (with final annealing?)
<b>Lab number of sample</b>	None
<b>Sample location</b>	HE-Arc CR, Neuchâtel, Neuchâtel
<b>Responsible institution</b>	Bible & Orient Museum, Fribourg, Fribourg
<b>Date and aim of sampling</b>	2014, metallography and chemical analyses

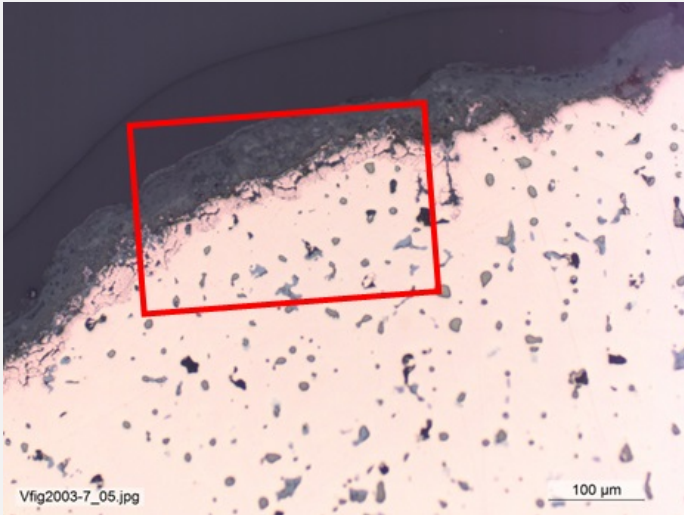
The remaining metal is a leaded bronze (Table 1) containing numerous copper sulphide and lead (Pb) inclusions (Figs. 6 and 7). The porosity is difficult to distinguish since the pores seem to have similar dimensions as the inclusions that could have been removed during the polishing of the sample (Fig. 6). After etching, the structure of the metal appears to be made up mostly of dendrites, but a grain structure seems to have developed on the right side of the sample, with occasional twin lines (Figs. 8 and 9). The twinned grain structure could be the result of cold work and annealing after casting, possibly through the application of an artificial patina under heat.

Fig. 6: Micrograph of the cross-section of Fig. 4 (detail), unetched, bright field. Light grey copper sulphide and tiny round Pb inclusions as well as "porosities" can be observed. Area of Fig. 10 is marked by a rectangle,

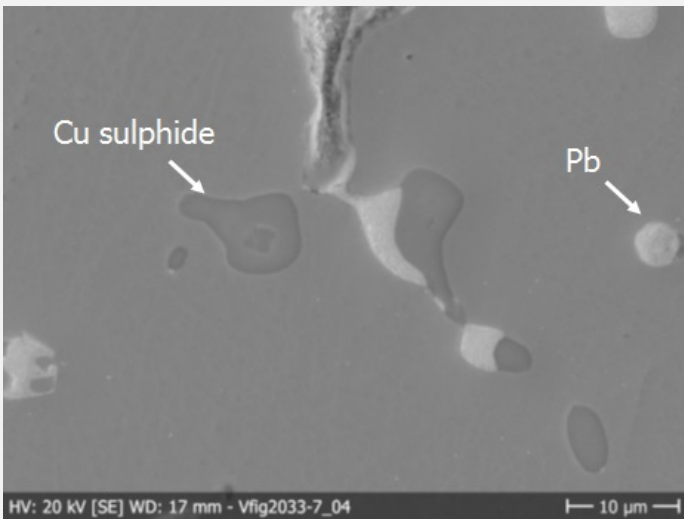
Fig. 7: SEM image, SE-mode, showing copper sulphide and lead inclusions,

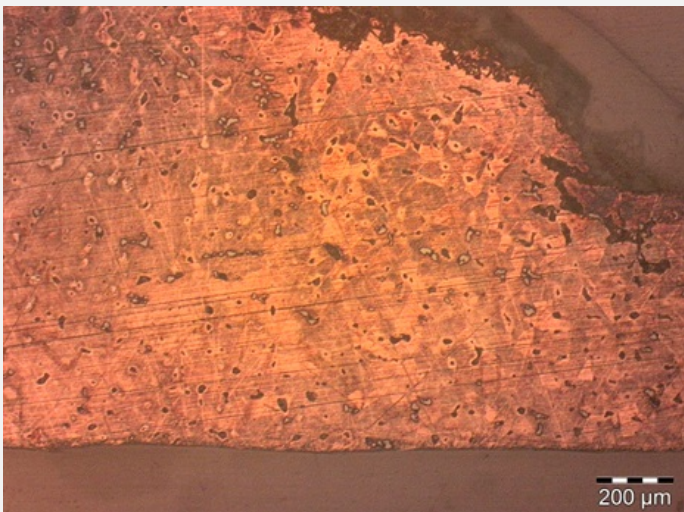
Fig. 8: Micrograph of the metal sample from Fig. 4 showing a dendritic structure and grains,

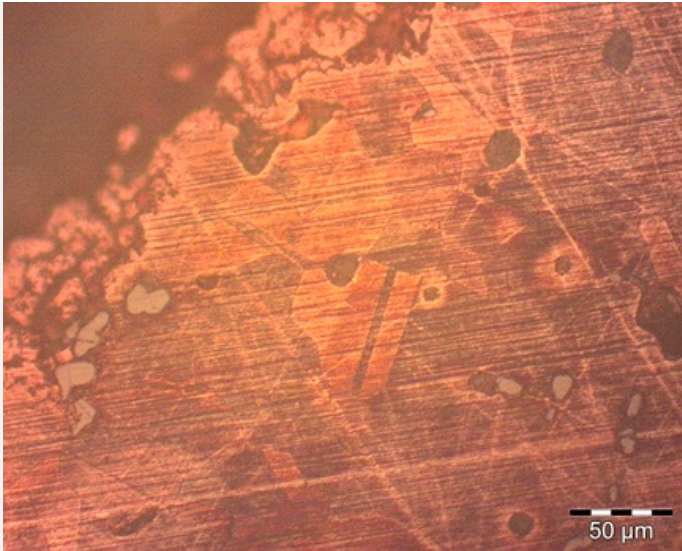
Fig. 9: Micrograph of a selected area showing grains and twin lines,

<b>Microstructure</b>	Dendritic structure & limited grain structure (with twin lines)
<b>First metal element</b>	Cu
<b>Other metal elements</b>	Sn, Pb

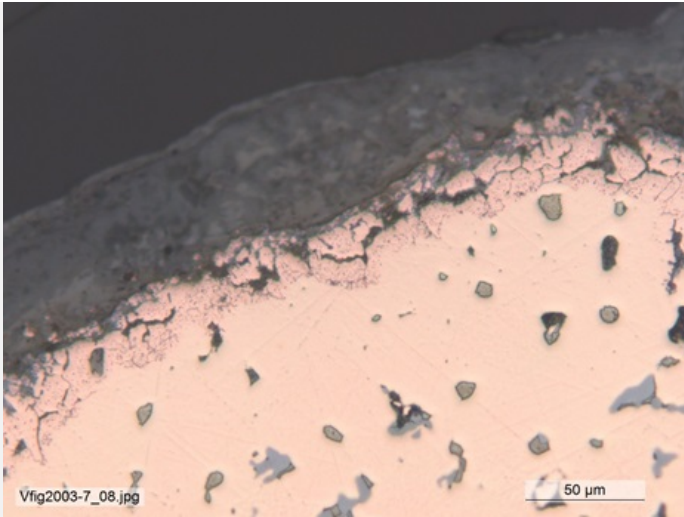
The remaining metal seems to have developed intergranular corrosion at the interface metal / corrosion layer (Fig. 10) slightly enriched in Sn (Fig. 12). The outer green corrosion product (CP2) is matte, powdery and mixed with sediments. It looks regular on Figs. 10 and 11 (around 50μm). This corrosion layer is mainly composed of lead (and/or sulphur), oxygen, silicon, chlorine and is depleted in Cu (Fig. 12 and table 2) except in its top part (CP1) where it is Cl, Cu and O-rich (Fig. 12 and table 2). FTIR seems to indicate that it is constituted of atacamite ( $\text{Cu}_2\text{Cl}(\text{OH})_3$ , Fig. 13). This is confirmed on the EDS spectra of figure 14 where Pb is clearly detected. The inner black corrosion product (CP3) is a dark brown, matte layer (Figs. 2 and 11). It covers all the surface of the object, and forms a very thin layer. It is sulphur and oxygen-rich (Fig. 15). FTIR analysis could not reveal the presence of a specific corrosion product.

Fig. 10: Micrograph of the metal sample from Fig. 6, unetched, bright field,

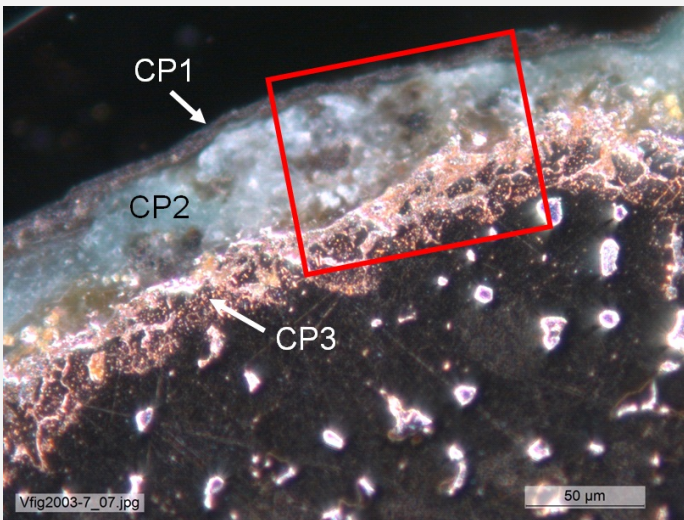
Fig. 11: Micrograph similar to Fig. 10 and corresponding to the stratigraphy of Fig. 5, polarised light. The mapped area (Fig. 12, SEM) is marked by a rectangle,

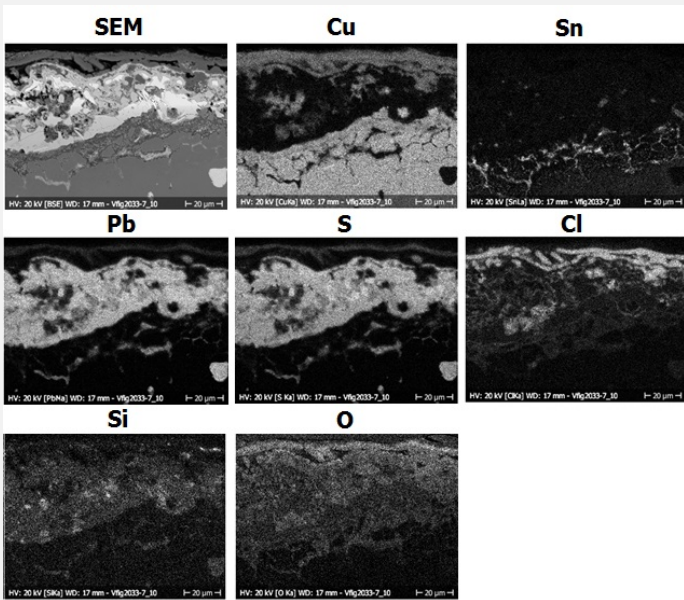
Fig. 12: SEM image, SE-mode, and elemental chemical distribution of the selected area of Fig. 11. Method of examination: SEM-EDS, Lab of Electronic Microscopy and Microanalysis, IMA (Néode), HEI Arc,

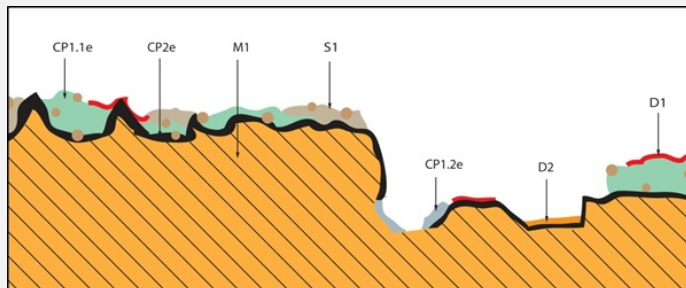
Based on the analyses carried out, the schematic representation of the stratigraphy of corrosion layers has been corrected: a thin, black sulphur-rich layer covers the metal surface. A thick green layer has developed on top and seems to be constituted mainly of atacamite enriched in lead with sediments on top.

Fig. 16: Improved stratigraphic representation of the artefact from visual observations and analyses (additional mention e or i within the coding correspond to strata in contact with the environment (e) and internal strata (i)),
