# HEADREST OR HORSE BIT VFIG 2003.7 - LEADED BRONZE - MODERN TIMES

**Artefact name** Headrest or horse bit VFig 2003.7

**Authors** Christian. Degrigny (HE-Arc CR, Neuchâtel, Neuchâtel, Switzerland) & Valentin. Boissonnas (HE-Arc CR, Neuchâtel, Neuchâtel, Switzerland)

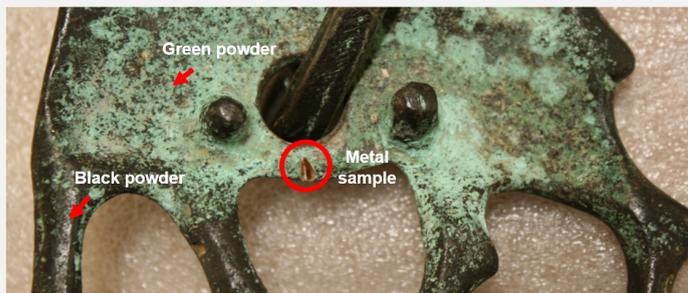
Fig. 2: Location of sampling areas,

<b>Description of sample</b>	The sample was cut on the bottom of one of the plates (Fig. 2). On Fig. 4, the top and round shape of the sample is the outer part of the metal. It is covered with corrosion layers. The lower part of the sample corresponds to the cut metal with no corrosion products.
<b>Alloy</b>	Leaded Bronze
<b>Technology</b>	Cast and cold worked (with final annealing?)
<b>Lab number of sample</b>	None
<b>Sample location</b>	HE-Arc CR, Neuchâtel, Neuchâtel
<b>Responsible institution</b>	Bible & Orient Museum, Fribourg, Fribourg
<b>Date and aim of sampling</b>	2014, metallography and chemical analyses

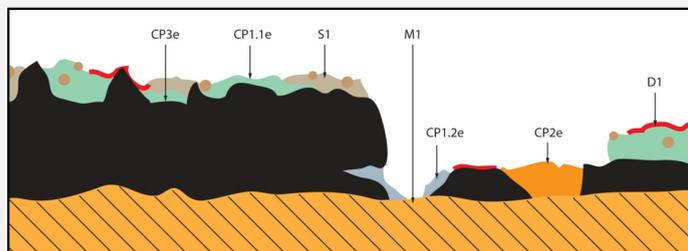
**S1:** soil (sand and limestone)  
**D1:** red deposit  
**CP1.1e:** outer light green-blue corrosion layer  
**CP1.2e:** outer white-blue-grey corrosion layer  
**CP2e:** outer orange corrosion layer  
**CP3e/i:** outer/inner black brown corrosion layer  
**M1:** metal

Fig. 3: Stratigraphic representation of the artefact in cross-section by macroscopic observation,

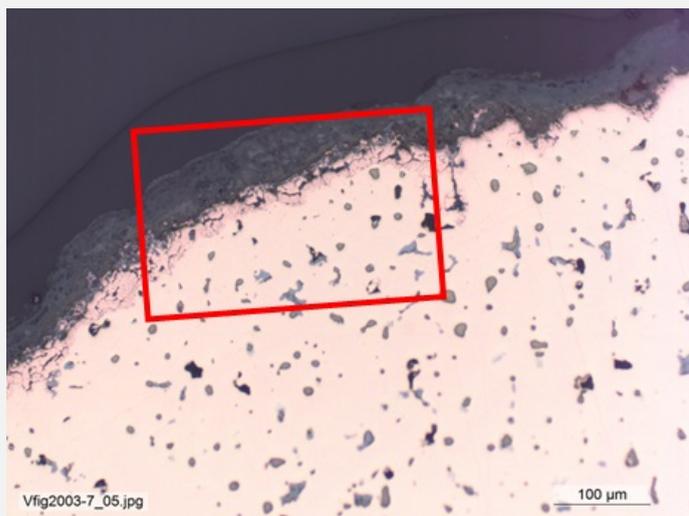
The remaining metal is a leaded bronze (Table 1) containing numerous copper sulphide and lead (Pb) inclusions (Figs. 6 and 7). The porosity is difficult to distinguish since the pores seem to have similar dimensions as the inclusions that could have been removed during the polishing of the sample (Fig. 6). After etching, the structure of the metal appears to be made up mostly of dendrites, but a grain structure seems to have developed on the right side of the sample, with occasional twin lines (Figs. 8 and 9). The twinned grain

Fig. 6: Micrograph of the cross-section of Fig. 4 (detail), unetched, bright field. Light grey copper sulphide and tiny round Pb inclusions as well as "porosities" can be observed. Area of Fig. 10 is marked by a rectangle,

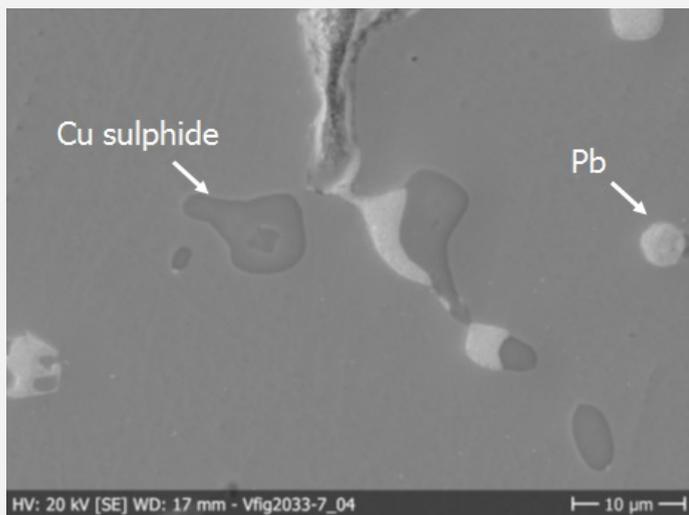
Fig. 7: SEM image, SE-mode, showing copper sulphide and lead inclusions,

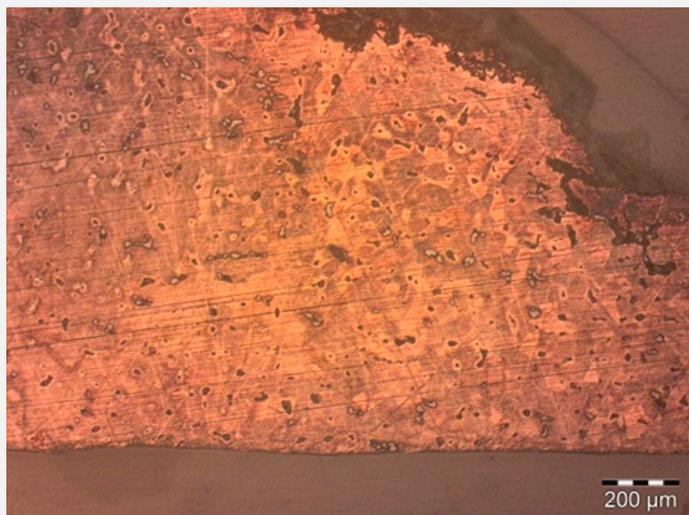
Fig. 8: Micrograph of the metal sample from Fig. 4 showing a dendritic structure and grains,

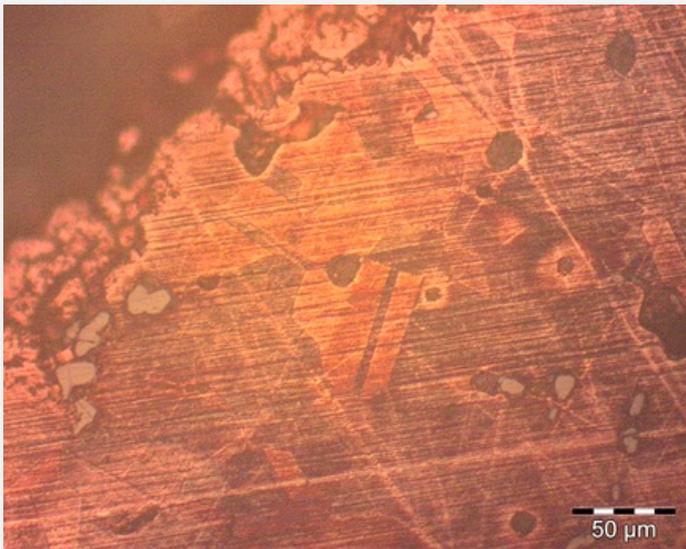
structure could be the result of cold work and annealing after casting, possibly through the application of an artificial patina under heat.

Fig. 9: Micrograph of a selected area showing grains and twin lines,

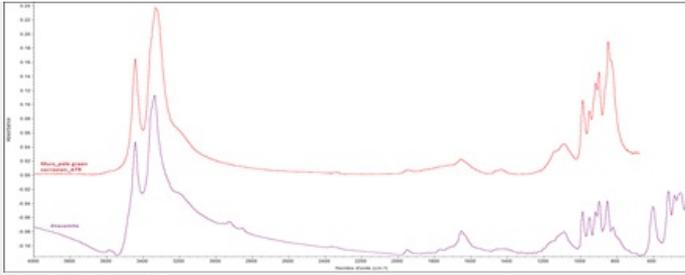
Fig. 13: FTIR spectrum (ATR mode) of the green corrosion powder and comparison to atacamite (purple) spectrum. Method of analysis: FTIR spectroscopy, HE- Arc CR,

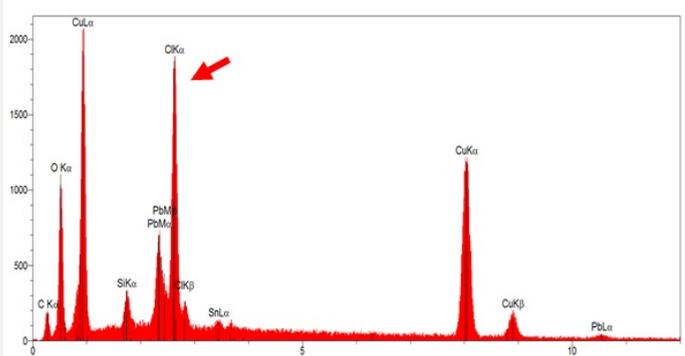
Fig. 14: EDS analysis of the green corrosion powder (Fig. 2). Method of analysis: SEM-EDS, Lab of Electronic Microscopy and Microanalysis, IMA (Néode), HEI Arc,

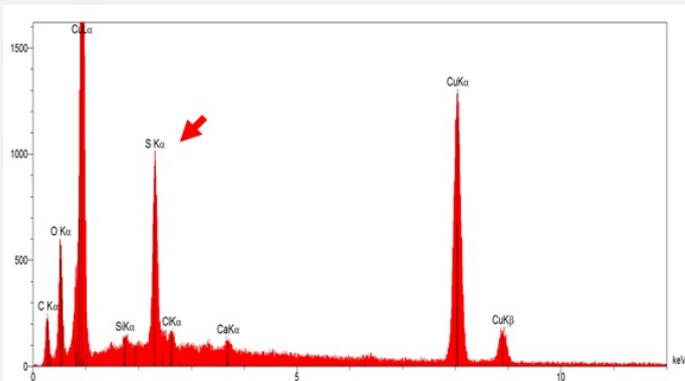
Fig. 15: EDS analysis of the black corrosion powder (Fig. 2). Method of analysis: SEM-EDS, Lab of Electronic Microscopy and Microanalysis, IMA (Néode), HEI Arc,

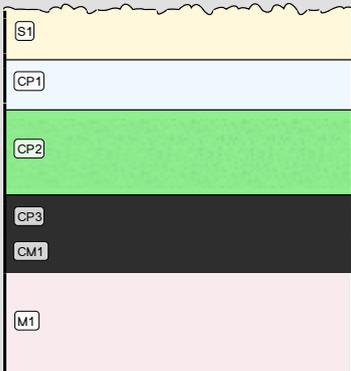
Fig. 5: Stratigraphic representation of the object in cross-section using the MiCorr application. The characteristics of the strata are only accessible by clicking on the drawing that redirects you to the search tool by stratigraphy representation. This representation can be compared to Fig 11, Credit HE-Arc CR.

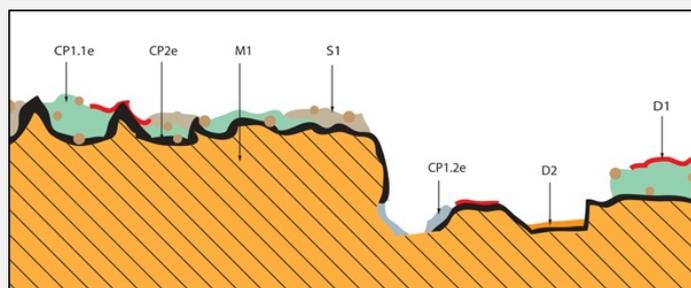
Based on the analyses carried out, the schematic representation of the stratigraphy of corrosion layers has been corrected: a thin, black sulphur-rich layer covers the metal surface. A thick green layer has developed on top and seems to be constituted mainly of atacamite enriched in lead with sediments on top.

Fig. 16: Improved stratigraphic representation of the artefact from visual observations and analyses (additional mention e or i within the coding correspond to strata in contact with the environment (e) and internal strata (i),
