# HEADREST OR HORSE BIT VFIG 2003.7 - LEADED BRONZE - MODERN TIMES

**Artefact name** Headrest or horse bit VFig 2003.7

**Authors** Christian. Degrigny (HE-Arc CR, Neuchâtel, Neuchâtel, Switzerland) & Valentin. Boissonnas (HE-Arc CR, Neuchâtel, Neuchâtel, Switzerland)

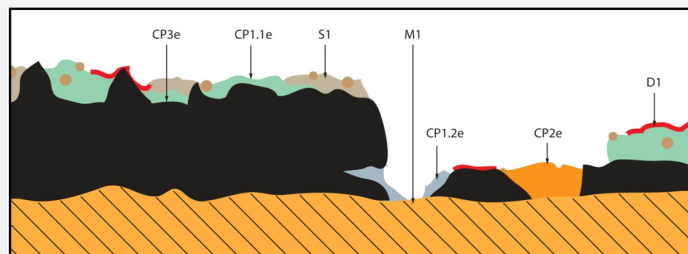
Fig. 3: Stratigraphic representation of the artefact in cross-section by macroscopic observation,

- S1**: soil (sand and limestone)
- D1**: red deposit
- CP1.1e**: outer light green-blue corrosion layer
- CP1.2e**: outer white-blue-grey corrosion layer
- CP2e**: outer orange corrosion layer
- CP3e/i**: outer/inner black brown corrosion layer
- M1**: metal

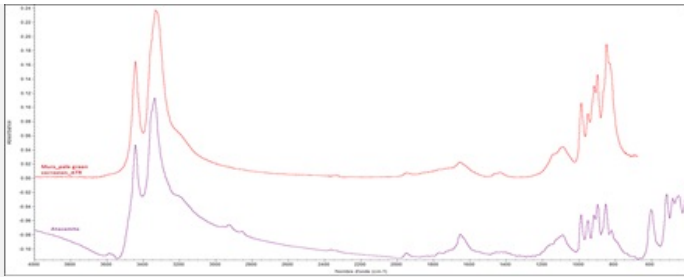
Fig. 13: FTIR spectrum (ATR mode) of the green corrosion powder and comparison to atacamite (purple) spectrum. Method of analysis: FTIR spectroscopy, HE- Arc CR,

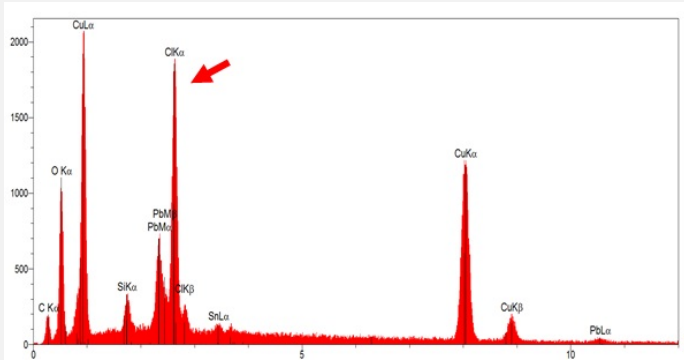
Fig. 14: EDS analysis of the green corrosion powder (Fig. 2). Method of analysis: SEM-EDS, Lab of Electronic Microscopy and Microanalysis, IMA (Néode), HEI Arc,
