CIRCULAR DOOR KNOCKER STRIKING PLATE – CU ALLOY – MODERN TIMES – SWITZERLAND

Artefact name	Circular door knocker striking plate
Authors	Marianne. Senn (EMPA, Dübendorf, Zurich, Switzerland) & Christian. Degryny (HE-Arc CR, Neuchâtel, Neuchâtel, Switzerland)
Url	/artefacts/437/

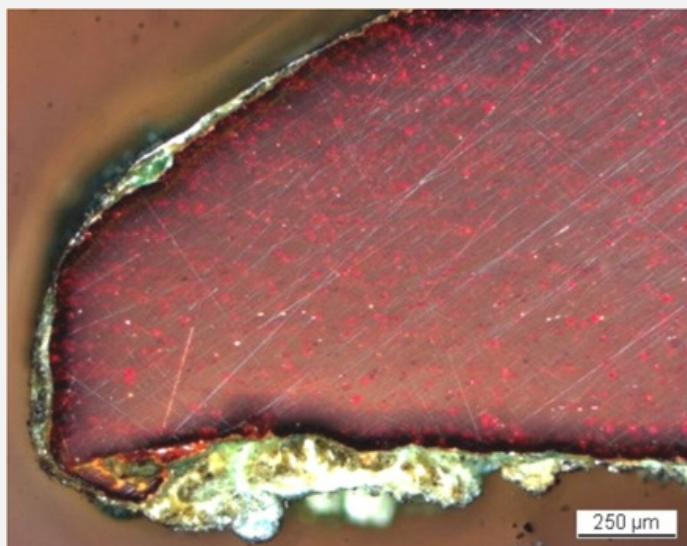
mode, Fig. 9). Due to the rolling process the copper oxide inclusions are parallel to the longitudinal orientation of the sample (Figs. 5 and 6). They were identified as cuprite by Raman spectroscopy (Fig. 7). The etched alloy shows a structure of polygonal grains with annealing twins (Fig. 6). The grain size is variable. The average hardness of the alloy is HV1 80, which is quite high compared to the average hardness of a pure annealed copper of around HV1 40-50 (Schumann 1991, 627).

Fig. 5: Micrograph of the metal sample from Fig. 3 (reversed picture), unetched, polarised light. The red copper oxide inclusions form rows in the copper alloy matrix.,

The average thickness of the corrosion crust is about 90µm, but may be thinner or thicker depending on the area of origin (Fig. 5). Under polarized light, we observe a multilayer system with a dense and thin inner red corrosion layer (CP2, probably cuprite/Cu₂O) on the metal (Fig. 8) containing chlorides (Fig. 9 and Table 3). This is followed by bands of heterogeneous green corrosion products (CP1, possibly copper chloride / sulphate / carbonate). This outer corrosion layer is contaminated with atmospheric components (Si, Al, Cl, C and O and perhaps gypsum particles (CaSO₄)) (Fig. 9).

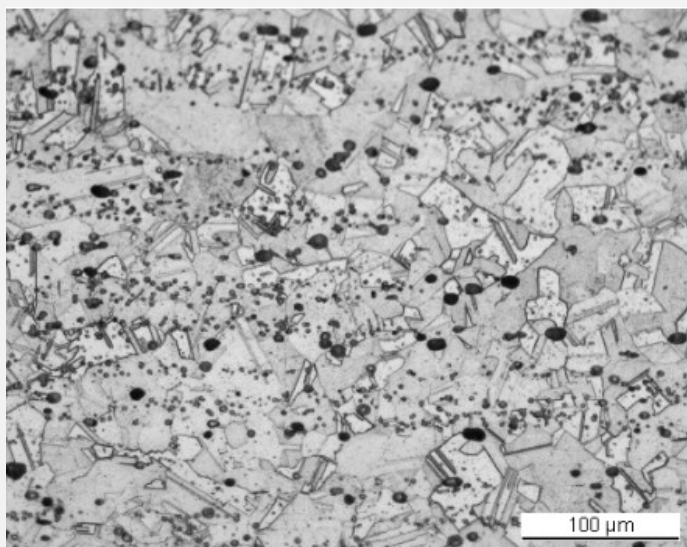
Fig. 6: Micrograph of the metal sample from Fig. 3 (detail), etched, bright field. The metal shows a structure of polygonal and twinned grains. Copper oxide inclusions are visible as dark spots,

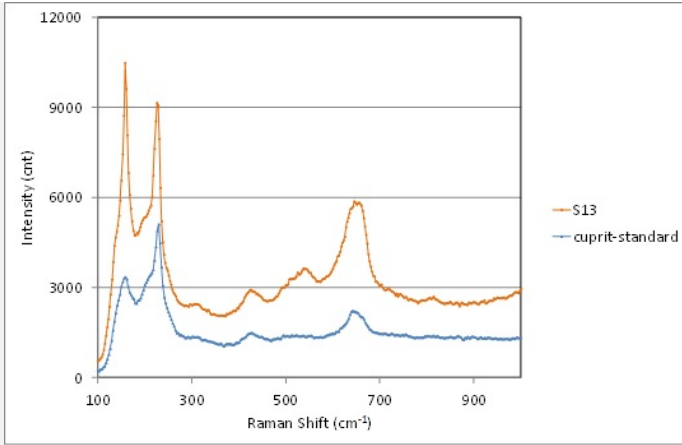
Fig. 7: Raman spectrum of a red inclusion (S13) of Fig. 5 compared to a cuprite standard spectrum. Settings: laser wavelength 532nm,

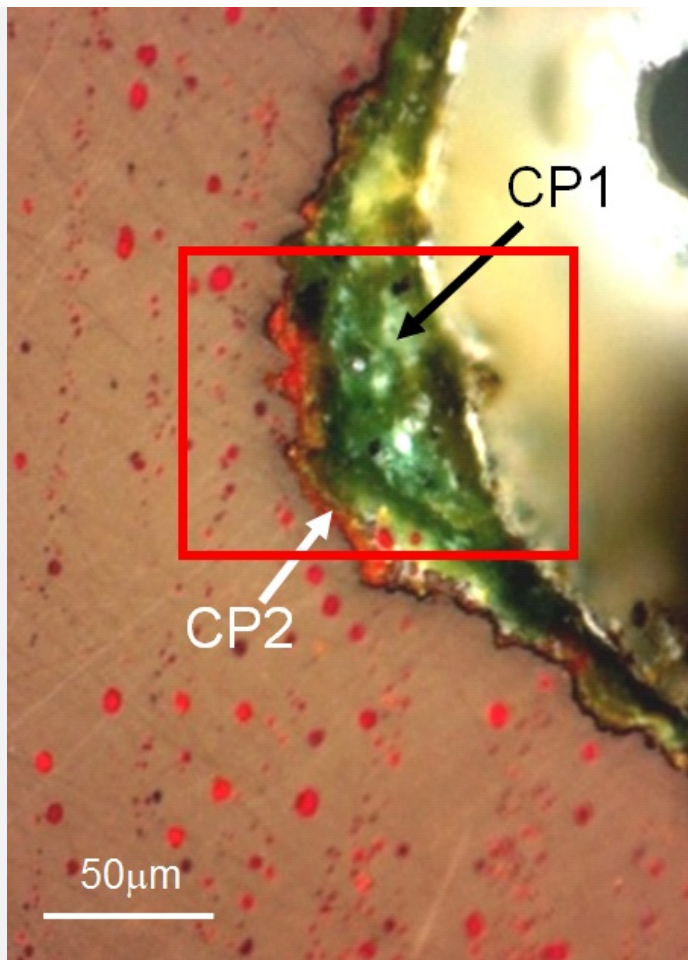
Fig. 8: Micrograph of the metal sample from Fig. 3 (rotated by 90°) and corresponding to the stratigraphy of Fig. 4, polarised light. Metal with red copper oxide inclusions. The black particles in the green corrosion layer are quartz inclusions. The mapped area of Fig. 9 is marked by a rectangle,

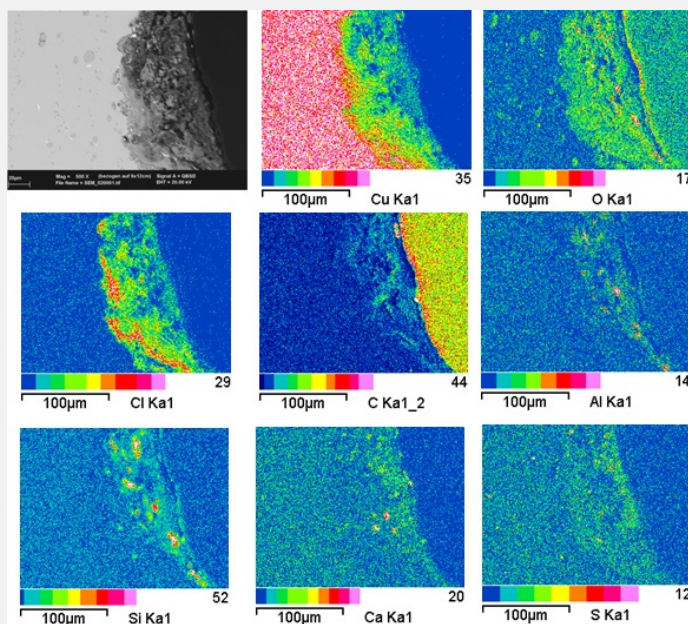
Table 2: Chemical composition (mass %) of the inclusions (light-grey and white in Fig. 9) in the metal. Method of analysis: SEM/EDS, Laboratory of Analytical Chemistry, Empa.

Fig. 9: SEM image, BSE-mode, and elemental chemical distribution of the selected area of Fig. 8. Method of examination: SEM/EDS, Laboratory of Analytical Chemistry, Empa,

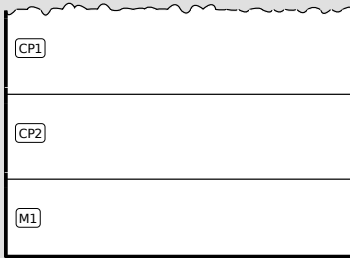
Fig. 4: Stratigraphic representation of the object in cross-section using the MiCorr application. The characteristics of the strata are only accessible by clicking on the drawing that redirects you to the search tool by stratigraphy representation. This representation can be compared to Fig. 8, Credit HE-Arc CR.
