CIRCULAR DOOR KNOCKER STRIKING PLATE - CU ALLOY - MODERN TIMES - SWITZERLAND

Artefact name	Circular door knocker striking plate
Authors	Marianne. Senn (EMPA, Dübendorf, Zurich, Switzerland) & Christian. Degrigny (HE-Arc CR, Neuchâtel, Neuchâtel, Switzerland)
Url	/artefacts/437/

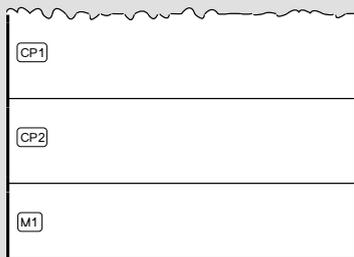
Fig. 4: Stratigraphic representation of the object in cross-section using the MiCorr application. The characteristics of the strata are only accessible by clicking on the drawing that redirects you to the search tool by stratigraphy representation. This representation can be compared to Fig. 8, Credit HE-Arc CR.
