# CIRCULAR DOOR KNOCKER STRIKING PLATE - CU ALLOY - MODERN TIMES - SWITZERLAND

<b>Artefact name</b>	Circular door knocker striking plate
<b>Authors</b>	Marianne. Senn (EMPA, Dübendorf, Zurich, Switzerland) & Christian. Degriigny (HE-Arc CR, Neuchâtel, Neuchâtel, Switzerland)
<b>Url</b>	/artefacts/437/

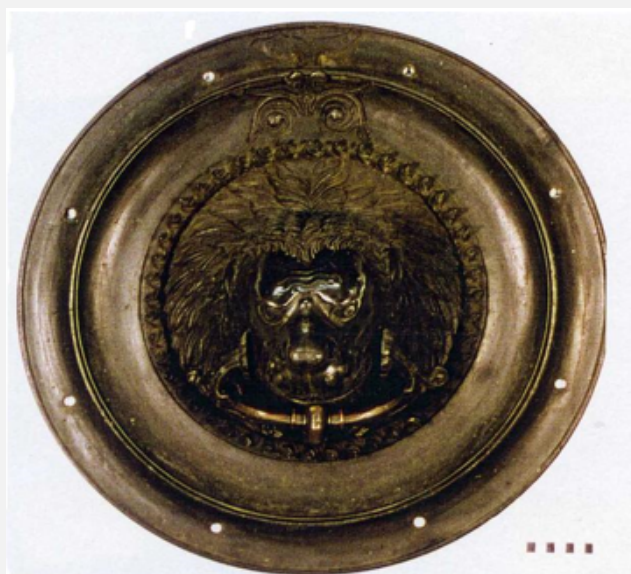
Fig. 1: Copper alloy circular base from a door knocker (after Benoît, 1994),

<b>Description of the artefact</b>	Circular base no 2 (from a set of two) of a door knocker with a protruding lion head holding a hinge in his fangs, Ø.ext = 64cm. The circular base is covered by a gilded (?) decorative relief (Fig. 1, Benoit, 1994, 6).
<b>Type of artefact</b>	Architectural element
<b>Origin</b>	Door knocker of Lausanne cathedral, Lausanne, Vaud, Switzerland
<b>Recovering date</b>	None
<b>Chronology category</b>	Modern Times
<b>chronology tpq</b>	<input type="text" value="1601"/> A.D. ▾
<b>chronology taq</b>	<input type="text" value="1700"/> A.D. ▾
<b>Chronology comment</b>	17th Century AD

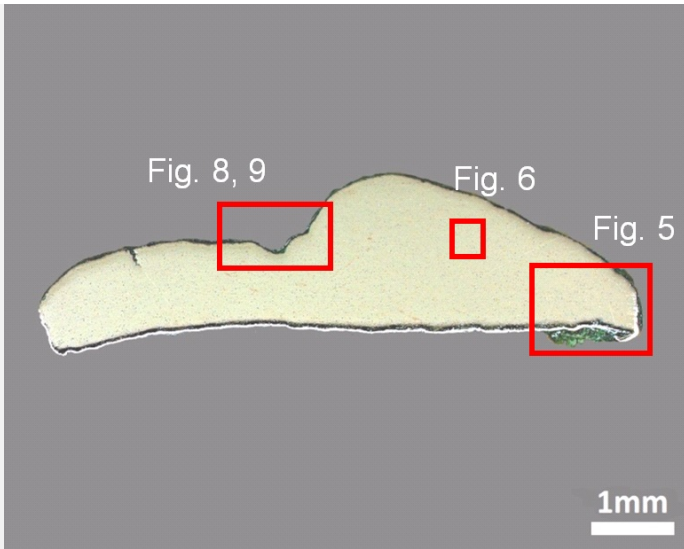
Fig. 3: Micrograph of the cross-section showing the location of Figs. 5 to 6 and 8 to 9,

<b>Description of sample</b>	No information is given on where the sample has been taken. A supposed location is however illustrated in Fig. 2. The polished sample shows a well preserved metal surface with some cracks covered by a thin corrosion crust (Fig. 3).
<b>Alloy</b>	Cu Alloy
<b>Technology</b>	Rolled, annealed after cold working
<b>Lab number of sample</b>	MAH 94-156-001
<b>Sample location</b>	Musées d'art et d'histoire, Genève, Geneva
<b>Responsible institution</b>	Musées d'art et d'histoire, Genève, Geneva
<b>Date and aim of sampling</b>	1994, metallography and presence or not of a gilding treatment

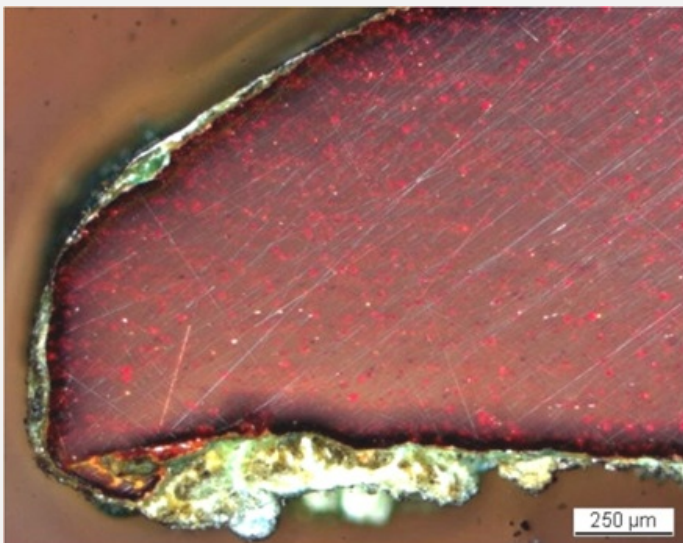
red (Figs. 5 and 8) while with SEM in BSE-mode they look light-grey (Fig. 9). Heavy metals inclusions appear white with SEM (BSE-mode, Fig. 9). Due to the rolling process the copper oxide inclusions are parallel to the longitudinal orientation of the sample (Figs. 5 and 6). They were identified as cuprite by Raman spectroscopy (Fig. 7). The etched alloy shows a structure of polygonal grains with annealing twins (Fig. 6). The grain size is variable. The average hardness of the alloy is HV1 80, which is quite high compared to the average hardness of a pure annealed copper of around HV1 40-50 (Schumann 1991, 627).

Fig. 5: Micrograph of the metal sample from Fig. 3 (reversed picture), unetched, polarised light. The red copper oxide inclusions form rows in the copper alloy matrix.,

The average thickness of the corrosion crust is about 90µm, but may be thinner or thicker depending on the area of origin (Fig. 5). Under polarized light, we observe a multilayer system with a dense and thin inner red corrosion layer (CP2, probably cuprite/Cu<sub>2</sub>O) on the metal (Fig. 8) containing chlorides (Fig. 9 and Table 3). This is followed by bands of heterogeneous green corrosion products (CP1, possibly copper chloride / sulphate / carbonate). This outer corrosion layer is contaminated with atmospheric components (Si, Al, Cl, C and O and perhaps gypsum particles (CaSO<sub>4</sub>)) (Fig. 9).

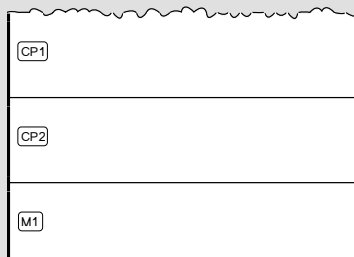
Fig. 4: Stratigraphic representation of the object in cross-section using the MiCorr application. The characteristics of the strata are only accessible by clicking on the drawing that redirects you to the search tool by stratigraphy representation. This representation can be compared to Fig. 8, Credit HE-Arc CR.
