# CIRCULAR DOOR KNOCKER STRIKING PLATE - CU ALLOY - MODERN TIMES - SWITZERLAND

<b>Artefact name</b>	Circular door knocker striking plate
<b>Authors</b>	Marianne. Senn (EMPA, Dübendorf, Zurich, Switzerland) & Christian. Degrigny (HE-Arc CR, Neuchâtel, Neuchâtel, Switzerland)
<b>Url</b>	/artefacts/437/

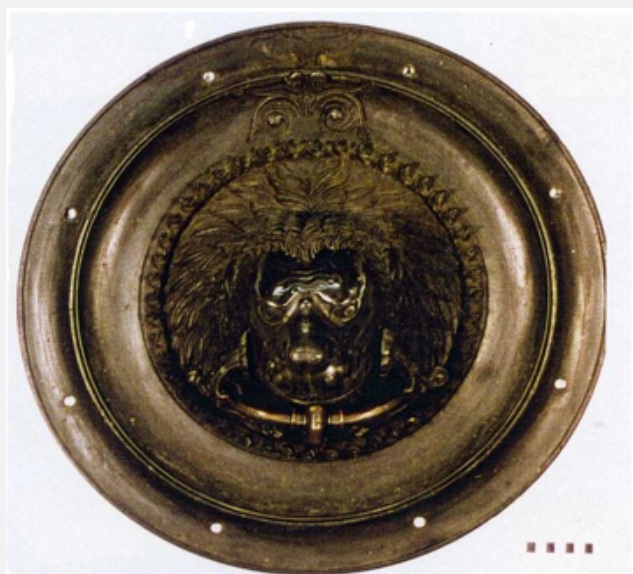
Fig. 1: Copper alloy circular base from a door knocker (after Benoît, 1994),

<b>Description of the artefact</b>	Circular base no 2 (from a set of two) of a door knocker with a protruding lion head holding a hinge in his fangs, Ø.ext = 64cm. The circular base is covered by a gilded (?) decorative relief (Fig. 1, Benoit, 1994, 6).
<b>Type of artefact</b>	Architectural element
<b>Origin</b>	Door knocker of Lausanne cathedral, Lausanne, Vaud, Switzerland
<b>Recovering date</b>	None
<b>Chronology category</b>	Modern Times
<b>chronology tpq</b>	<input type="text" value="1601"/> A.D. ▾
<b>chronology taq</b>	<input type="text" value="1700"/> A.D. ▾
<b>Chronology comment</b>	17th Century AD

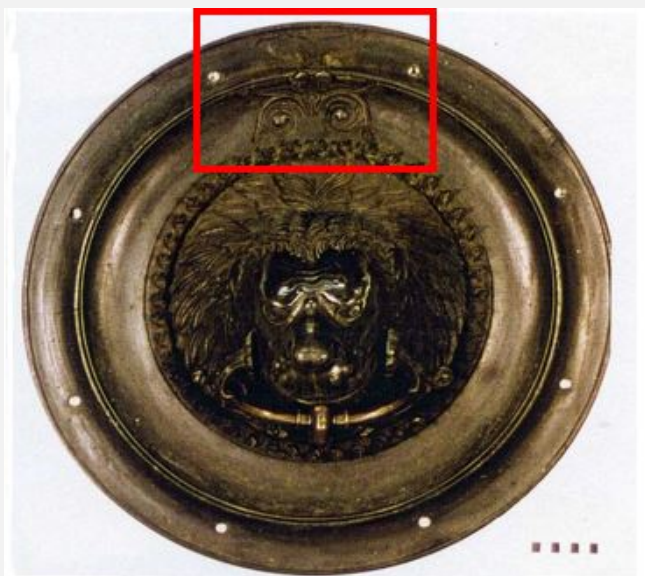
Fig. 2: Possible location of sampling area,

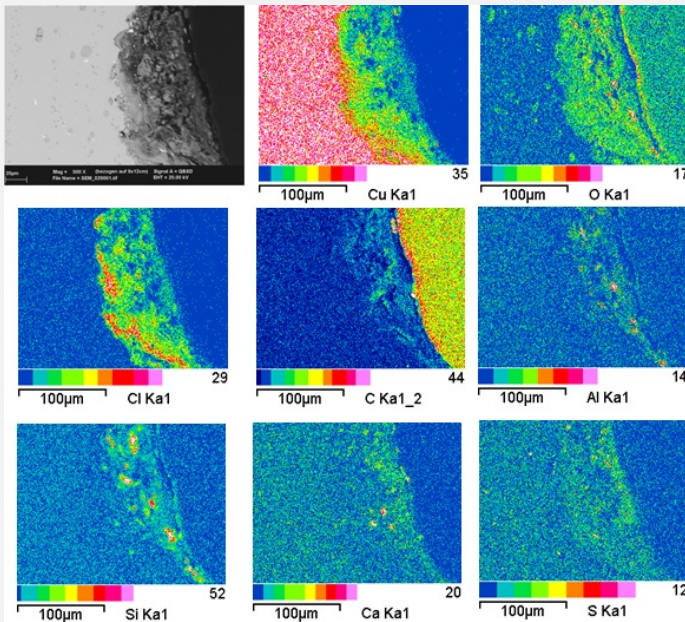
Table 2: Chemical composition (mass %) of the inclusions (light-grey and white in Fig. 9) in the metal. Method of analysis: SEM/EDS, Laboratory of Analytical Chemistry, Empa.

Fig. 9: SEM image, BSE-mode, and elemental chemical distribution of the selected area of Fig. 8. Method of examination: SEM/EDS, Laboratory of Analytical Chemistry, Empa,

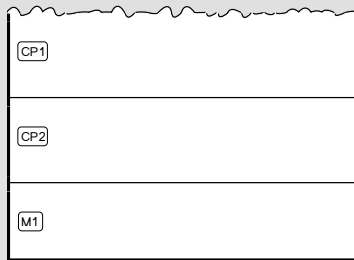
Fig. 4: Stratigraphic representation of the object in cross-section using the MiCorr application. The characteristics of the strata are only accessible by clicking on the drawing that redirects you to the search tool by stratigraphy representation. This representation can be compared to Fig. 8, Credit HE-Arc CR.
