CIRCULAR DOOR KNOCKER STRIKING PLATE – CU ALLOY – MODERN TIMES – SWITZERLAND

Artefact name	Circular door knocker striking plate
Authors	Marianne. Senn (EMPA, Dübendorf, Zurich, Switzerland) & Christian. Degrigny (HE-Arc CR, Neuchâtel, Neuchâtel, Switzerland)
Url	/artefacts/437/

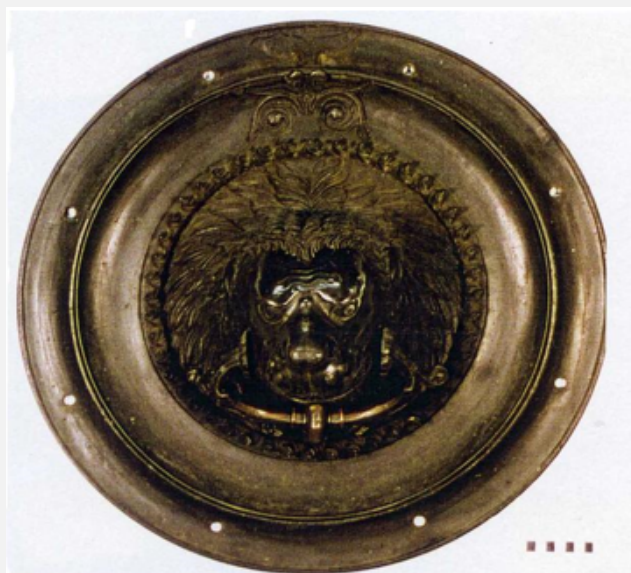
Fig. 1: Copper alloy circular base from a door knocker (after Benoît, 1994),

Description of the artefact	Circular base no 2 (from a set of two) of a door knocker with a protruding lion head holding a hinge in his fangs, Ø.ext = 64cm. The circular base is covered by a gilded (?) decorative relief (Fig. 1, Benoit, 1994, 6).
Type of artefact	Architectural element
Origin	Door knocker of Lausanne cathedral, Lausanne, Vaud, Switzerland
Recovering date	None
Chronology category	Modern Times
chronology tpg	1601 A.D. ▼
chronology taq	1700 A.D. ▼
Chronology comment	17th Century AD
Burial conditions / environment	Outdoor atmosphere

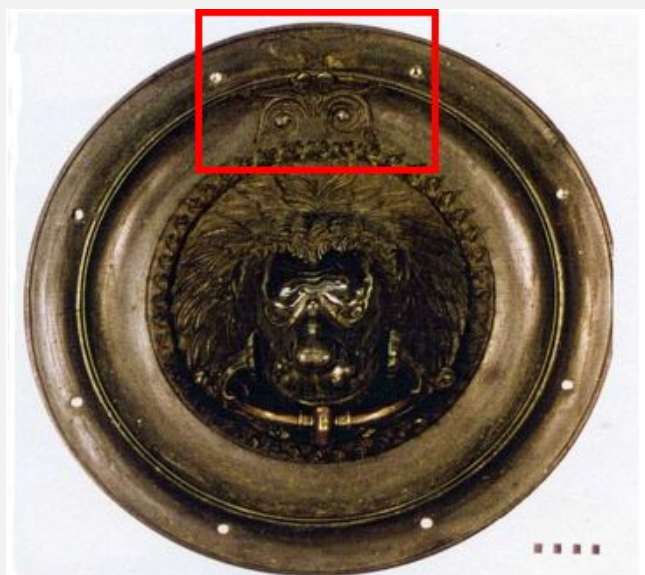
Fig. 2: Possible location of sampling area,

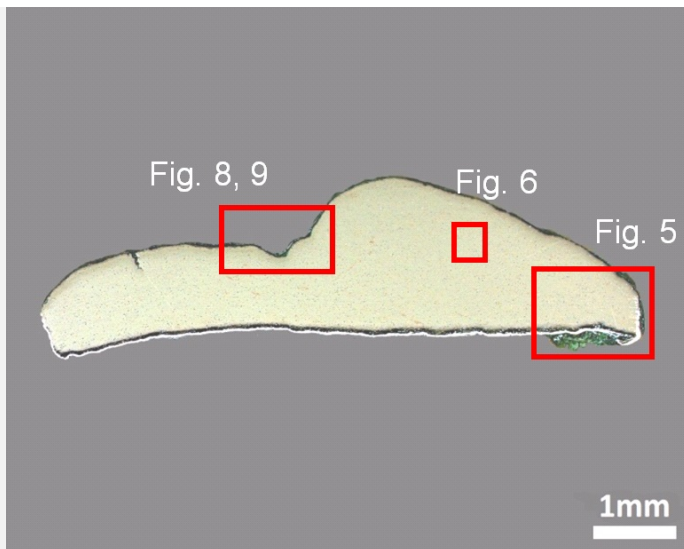
Fig. 3: Micrograph of the cross-section showing the location of Figs. 5 to 6 and 8 to 9,

Description of sample	No information is given on where the sample has been taken. A supposed location is however illustrated in Fig. 2. The polished sample shows a well preserved metal surface with some cracks covered by a thin corrosion crust (Fig. 3).
Alloy	Cu Alloy
Technology	Rolled, annealed after cold working
Lab number of sample	MAH 94-156-001
Sample location	Musées d'art et d'histoire, Genève, Geneva
Responsible institution	Musées d'art et d'histoire, Genève, Geneva
Date and aim of sampling	1994, metallography and presence or not of a gilding treatment

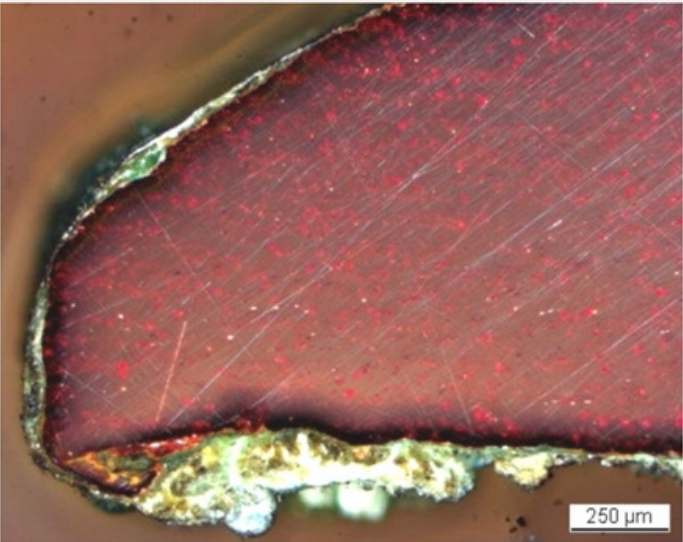
mode, Fig. 9). Due to the rolling process the copper oxide inclusions are parallel to the longitudinal orientation of the sample (Figs. 5 and 6). They were identified as cuprite by Raman spectroscopy (Fig. 7). The etched alloy shows a structure of polygonal grains with annealing twins (Fig. 6). The grain size is variable. The average hardness of the alloy is HV1 80, which is quite high compared to the average hardness of a pure annealed copper of around HV1 40-50 (Schumann 1991, 627).

Fig. 5: Micrograph of the metal sample from Fig. 3 (reversed picture), unetched, polarised light. The red copper oxide inclusions form rows in the copper alloy matrix.,

The average thickness of the corrosion crust is about 90µm, but may be thinner or thicker depending on the area of origin (Fig. 5). Under polarized light, we observe a multilayer system with a dense and thin inner red corrosion layer (CP2, probably cuprite/Cu₂O) on the metal (Fig. 8) containing chlorides (Fig. 9 and Table 3). This is followed by bands of heterogeneous green corrosion products (CP1, possibly copper chloride / sulphate / carbonate). This outer corrosion layer is contaminated with atmospheric components (Si, Al, Cl, C and O and perhaps gypsum particles (CaSO₄)) (Fig. 9).

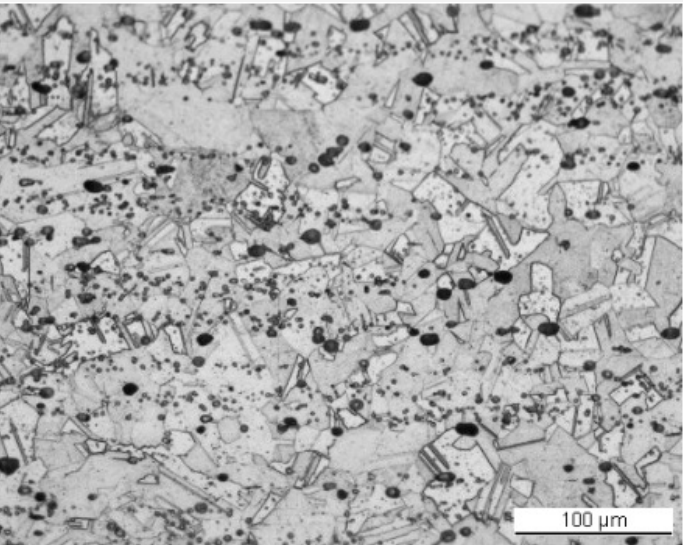
Fig. 6: Micrograph of the metal sample from Fig. 3 (detail), etched, bright field. The metal shows a structure of polygonal and twinned grains. Copper oxide inclusions are visible as dark spots,

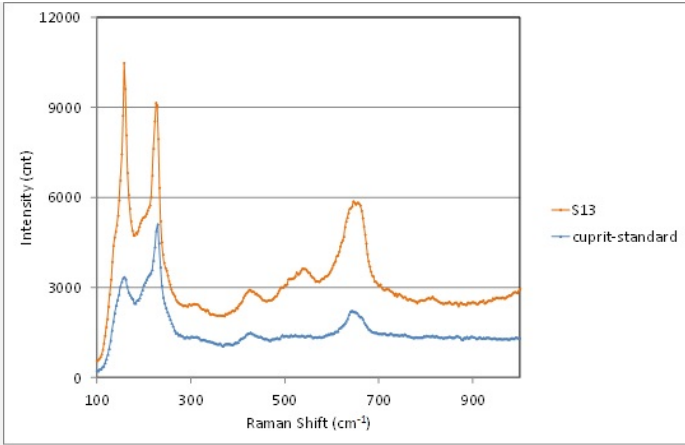
Fig. 7: Raman spectrum of a red inclusion (S13) of Fig. 5 compared to a cuprite standard spectrum. Settings: laser wavelength 532nm,

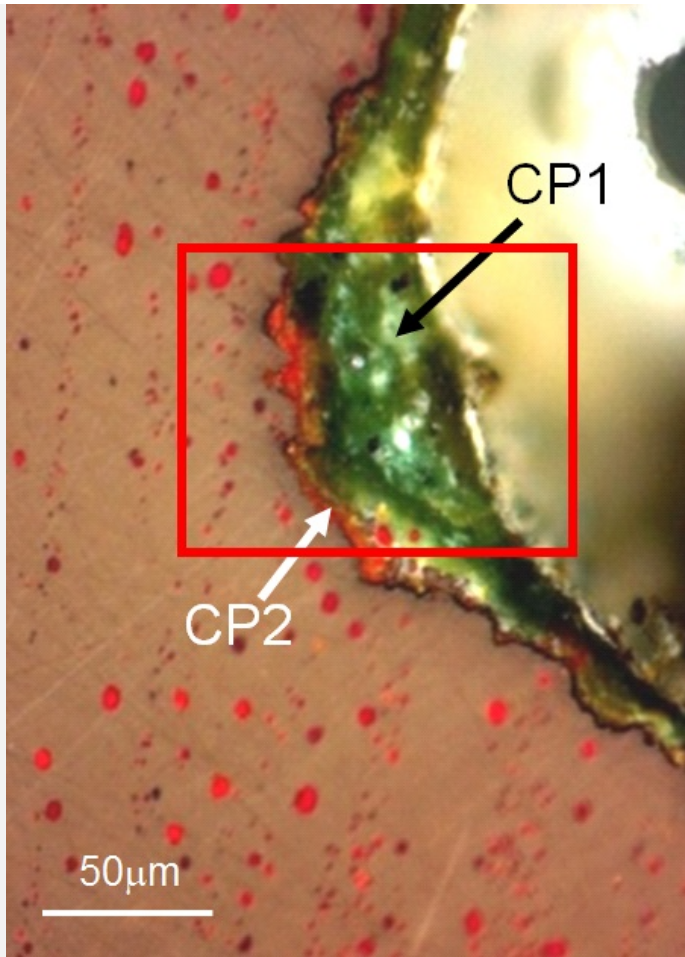
Fig. 8: Micrograph of the metal sample from Fig. 3 (rotated by 90°) and corresponding to the stratigraphy of Fig. 4, polarised light. Metal with red copper oxide inclusions. The black particles in the green corrosion layer are quartz inclusions. The mapped area of Fig. 9 is marked by a rectangle,

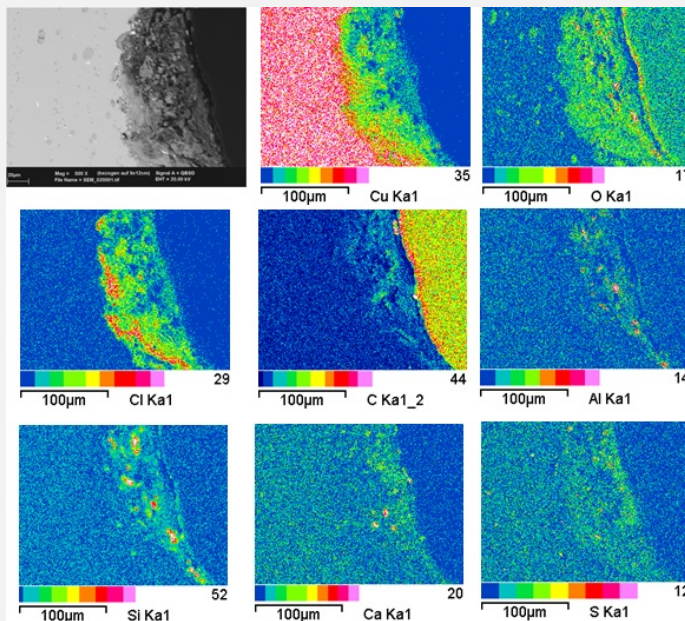
Elements	O	Si	Cl	Cu	Total
CP2, inner red layer	11	<	23	60	94

Fig. 9: SEM image, BSE-mode, and elemental chemical distribution of the selected area of Fig. 8. Method of examination: SEM/EDS, Laboratory of Analytical Chemistry, Empa,

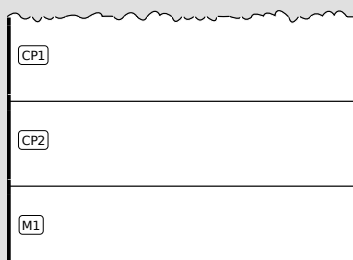
Fig. 4: Stratigraphic representation of the object in cross-section using the MiCorr application. The characteristics of the strata are only accessible by clicking on the drawing that redirects you to the search tool by stratigraphy representation. This representation can be compared to Fig. 8, Credit HE-Arc CR.
