CIRCULAR DOOR KNOCKER STRIKING PLATE - CU ALLOY - MODERN TIMES - SWITZERLAND

Artefact name	Circular door knocker striking plate
Authors	Marianne. Senn (EMPA, Dübendorf, Zurich, Switzerland) & Christian. Degrigny (HE-Arc CR, Neuchâtel, Neuchâtel, Switzerland)
Url	/artefacts/437/

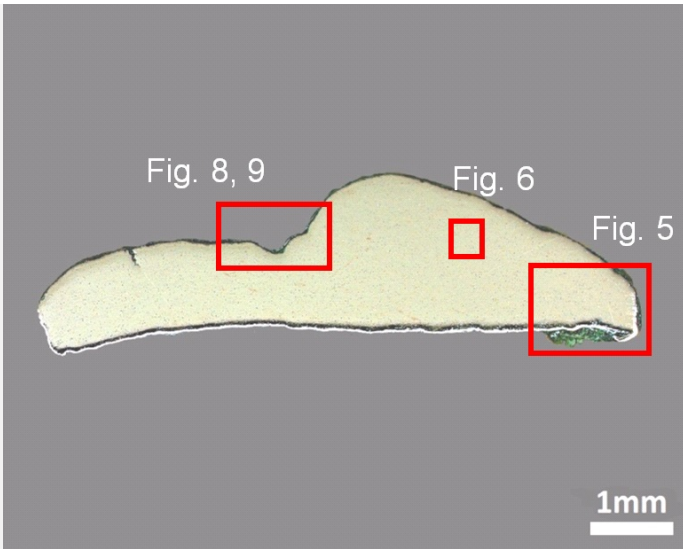
Fig. 3: Micrograph of the cross-section showing the location of Figs. 5 to 6 and 8 to 9,

Description of sample	No information is given on where the sample has been taken. A supposed location is however illustrated in Fig. 2. The polished sample shows a well preserved metal surface with some cracks covered by a thin corrosion crust (Fig. 3).
Alloy	Cu Alloy
Technology	Rolled, annealed after cold working
Lab number of sample	MAH 94-156-001
Sample location	Musées d'art et d'histoire, Genève, Geneva
Responsible institution	Musées d'art et d'histoire, Genève, Geneva
Date and aim of sampling	1994, metallography and presence or not of a gilding treatment

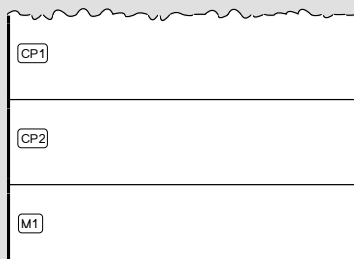
Fig. 4: Stratigraphic representation of the object in cross-section using the MiCorr application. The characteristics of the strata are only accessible by clicking on the drawing that redirects you to the search tool by stratigraphy representation. This representation can be compared to Fig. 8, Credit HE-Arc CR.
