# CIRCULAR DOOR KNOCKER STRIKING PLATE - CU ALLOY - MODERN TIMES - SWITZERLAND

<b>Artefact name</b>	Circular door knocker striking plate
<b>Authors</b>	Marianne. Senn (EMPA, Dübendorf, Zurich, Switzerland) & Christian. Degrigny (HE-Arc CR, Neuchâtel, Neuchâtel, Switzerland)
<b>Url</b>	/artefacts/437/

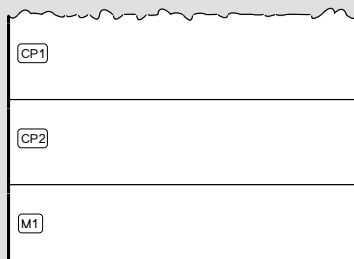
Fig. 4: Stratigraphic representation of the object in cross-section using the MiCorr application. The characteristics of the strata are only accessible by clicking on the drawing that redirects you to the search tool by stratigraphy representation. This representation can be compared to Fig. 8, Credit HE-Arc CR.
