CIRCULAR DOOR KNOCKER STRIKING PLATE - CU ALLOY - MODERN TIMES - SWITZERLAND

Artefact name	Circular door knocker striking plate
Authors	Marianne. Senn (EMPA, Dübendorf, Zurich, Switzerland) & Christian. Degriigny (HE-Arc CR, Neuchâtel, Neuchâtel, Switzerland)
Url	/artefacts/437/

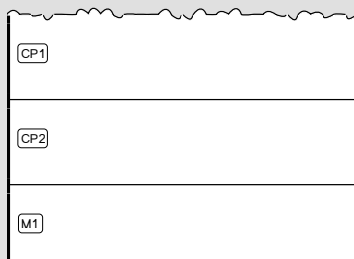
Fig. 4: Stratigraphic representation of the object in cross-section using the MiCorr application. The characteristics of the strata are only accessible by clicking on the drawing that redirects you to the search tool by stratigraphy representation. This representation can be compared to Fig. 8, Credit HE-Arc CR.
