TANG FRAGMENT OF A KNIFE HR-6246 - TIN BRONZE - LATE BRONZE AGE - SWITZERLAND

Artefact name	Tang fragment of a knife HR-6246
Authors	Marianne. Senn (EMPA, Dübendorf, Zurich, Switzerland) & Christian. Degryny (HE-Arc CR, Neuchâtel, Neuchâtel, Switzerland)
Url	/artefacts/439/

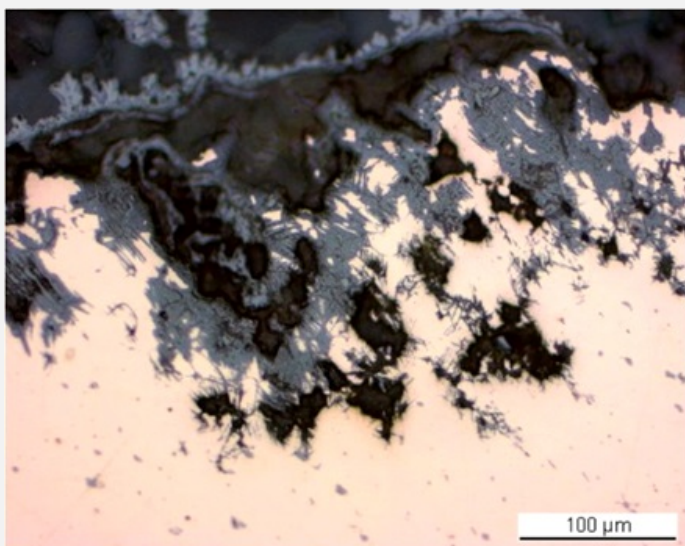
Fig. 5: Micrograph of the metal sample from Fig. 3 (inverted and reversed picture, detail), unetched, bright field. Corrosion products are in dark-grey whereas the metal is in pink. Slip lines are outlined by the development of intergranular corrosion,

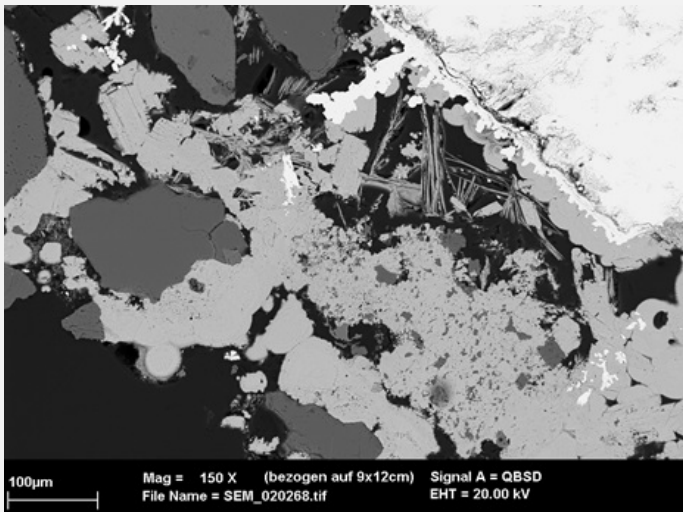
Fig. 10: SEM image, similar to Fig. 9, BSE-mode,

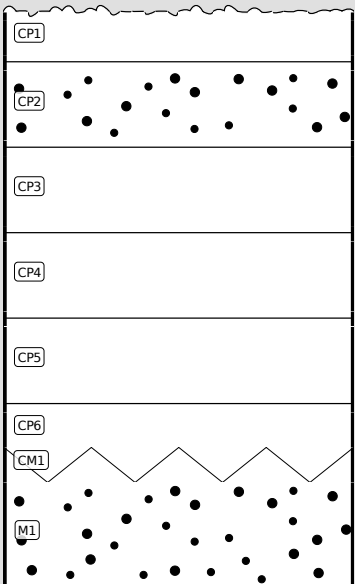
Fig. 4: Stratigraphic representation of the object in cross-section using the MiCorr application. The characteristics of the strata are only accessible by clicking on the drawing that redirects you to the search tool by stratigraphy representation. This representation can be compared to Fig. 8, Credit HE-Arc CR.
