# TANG FRAGMENT OF A KNIFE HR-6246 - TIN BRONZE - LATE BRONZE AGE - SWITZERLAND

Artefact name Tang fragment of a knife HR-6246

Authors Marianne. Senn (EMPA, Dübendorf, Zurich, Switzerland) & Christian. Degrigny (HE-Arc CR, Neuchâtel, Neuchâtel,

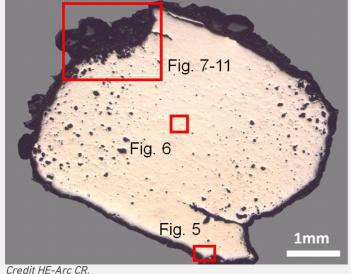
Fig. 3: Micrograph of the cross-section showing the location of Figs. 5

Description of sample The cross-section corresponds to a lateral cut (Fig. 2). The surface is covered with a thick corrosion crust

The remaining metal is a tin bronze (Table 1) with high porosity and large cracks both on the left and right edges of the sample (Fig. 3). The metal contains small, elongated copper sulphide (Table 2) and Pb inclusions that are oriented parallel to the cracks. Near the metal surface, slip lines are outlined by the development of intergranular corrosion (Fig. 5). The etched metal shows small, elongated grains with slip lines (Fig. 6). Annealing is visible in areas near the surface. The average hardness of the metal is HV1 145, but significant variations are observed, depending on where the measurements are taken.

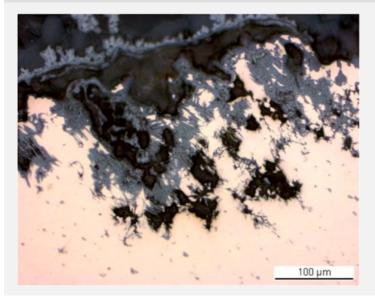
Fig. 5: Micrograph of the metal sample from Fig. 3 (inverted and reversed picture, detail), unetched, bright field. Corrosion products are in dark-grey whereas the metal is in pink. Slip lines are outlined by the development of intergranular corrosion,

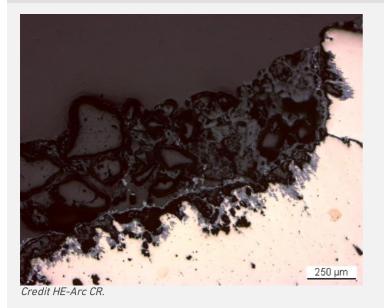
The corrosion crust has a thickness between 0.1mm and 0.7mm (Fig. 3). In bright field (Fig. 7), one can observe that the metal has been replaced by light-grey corrosion products. Adjacent to the metal is a thick, heterogeneous, dark-grey layer with a band of light-grey corrosion products. In polarised light (Fig. 8), all corrosion products which were previously light-grey appear brown-orange, the dark-grey layer turquoise. The elemental chemical distribution of the SEM images (Figs. 9 and 10) reveals that the inner corrosion products are Sn-rich whereas the adjacent band is Cu and S-rich (Fig. 11). The outer layer contains large inclusions (quartz and others, Si, Al and Na, see Figs. 10-11) and is most probably composed of malachite/Cu2(CO3)(OH)2 (only Cu and O are detected – Fig. 11). S is distributed throughout this layer. XRD analyses indicated the presence of posnjakite/Cu4SO4(OH)6H2O, chalcocite/CuS and djurleïte/Cu1.93S (Schweizer 1994).

Fig. 7: Micrograph of the metal sample from Fig. 3 (detail), unetched, bright field. The inner light-grey corrosion products extend into the metal surface (in pink) and appear as a line within the dark-grey corrosion layer,

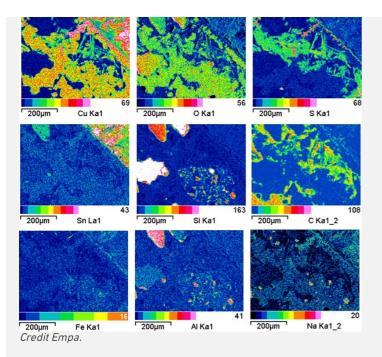
Fig. 11: EDS elemental chemical distribution of the SEM image of Fig. 9. Method of examination: SEM/EDS, Laboratory of Analytical Chemistry, Empa,
