TANG FRAGMENT OF A KNIFE HR-6246 - TIN BRONZE - LATE BRONZE AGE - SWITZERLAND

Artefact name	Tang fragment of a knife HR-6246
Authors	Marianne. Senn (EMPA, Dübendorf, Zurich, Switzerland) & Christian. Degrigny (HE-Arc CR, Neuchâtel, Neuchâtel, Switzerland)
Url	/artefacts/439/

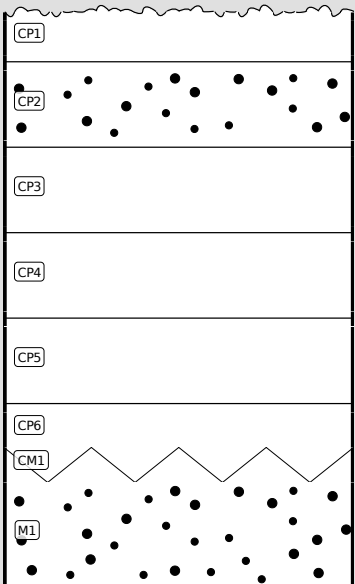
Fig. 4: Stratigraphic representation of the object in cross-section using the MiCorr application. The characteristics of the strata are only accessible by clicking on the drawing that redirects you to the search tool by stratigraphy representation. This representation can be compared to Fig. 8, Credit HE-Arc CR.
