SACRIFICIAL ANODE VHS-8339 - ZN ALLOY - MODERN TIMES

Artefact name	Sacrificial anode VHS-8339
Authors	Marianne. Senn (EMPA, Dübendorf, Zurich, Switzerland) & Christian. Degriigny (HE-Arc CR, Neuchâtel, Neuchâtel, Switzerland)
Url	/artefacts/443/

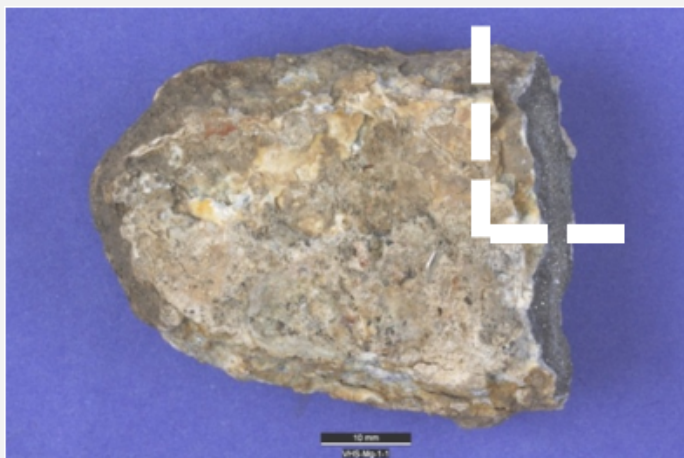
Fig. 2: Location of sampling area,

The sample (Fig. 3) shows a cross-section from the sacrificial anode (Fig. 2). The thickness of the corrosion crust is variable. Dimensions: L = 17mm; W = 14mm.

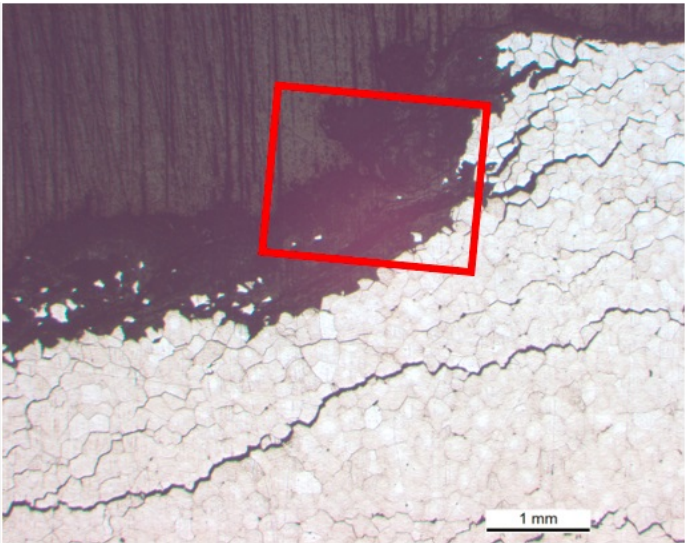
The remaining metal is an almost pure zinc alloy (Table 1). The oxygen content is not from the original alloy, but is due to secondary corrosion. The metal grains are visible without etching and present a polygonal structure (Figs. 5 and 6). The structure is recrystallised after annealing. The recrystallization of zinc alloys begins at room temperature.

Fig. 5: Micrograph of the metal sample from Fig. 3 (reversed picture, detail), unetched, bright field. Extensive intergranular corrosion is visible. The rectangle marks Fig. 7,

Extended intergranular corrosion has developed in the metal structure (Figs. 5, 6). The metal is covered by a corrosion crust that is hardly visible in bright field and which contains remnant metal (Fig. 5). On most of the sample the corrosion crust is uniform. In areas we see cracks (Fig. 7) appearing as brown lines separating the corrosion crust (Fig. 8). In bright field the corrosion crust appears grey containing dark-grey zones (Fig. 7). Under polarized light, the corrosion crust appears white with darker parts including remnant metal (Fig. 8). It contains Zn and O as well as S along some cracks (Table 2 and Fig. 9).

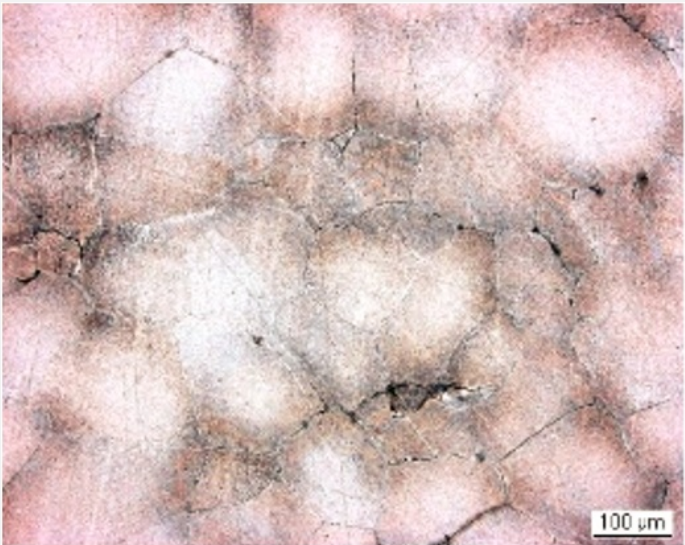
Fig. 6: Micrograph of the metal sample from Fig. 3 (detail), etched,

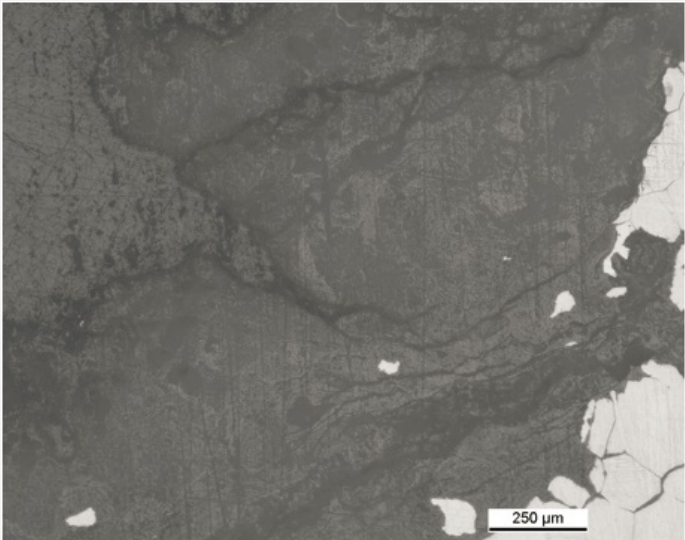
Table 2. Chemical composition (mass %) of the corrosion layer from Figs. 7 and 9. Method of analysis: SEM/EDS, Laboratory of Analytical Chemistry, Empa.

Fig. 7: Micrograph showing the metal - corrosion products interface from Fig. 5 (detail), unetched, bright field,

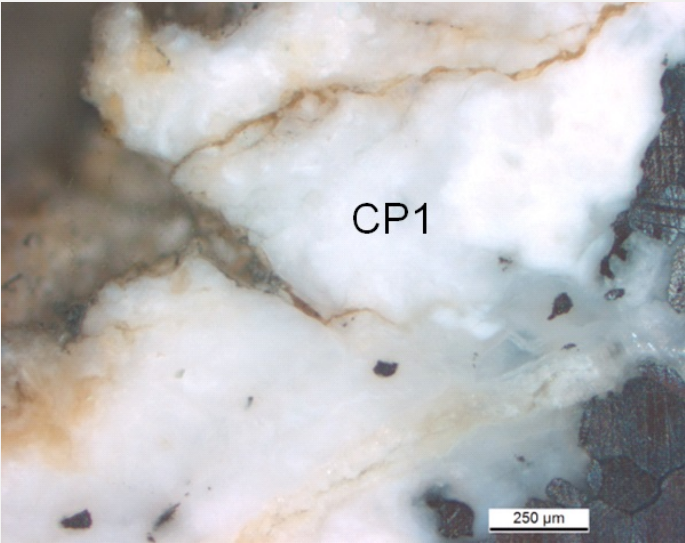
Fig. 8: Micrograph (same as Fig. 7) corresponding to the stratigraphy of Fig. 4, unetched, polarised light. We observe in dark-grey the metal, in white the corrosion crust separated by brown cracks including remnant metal,

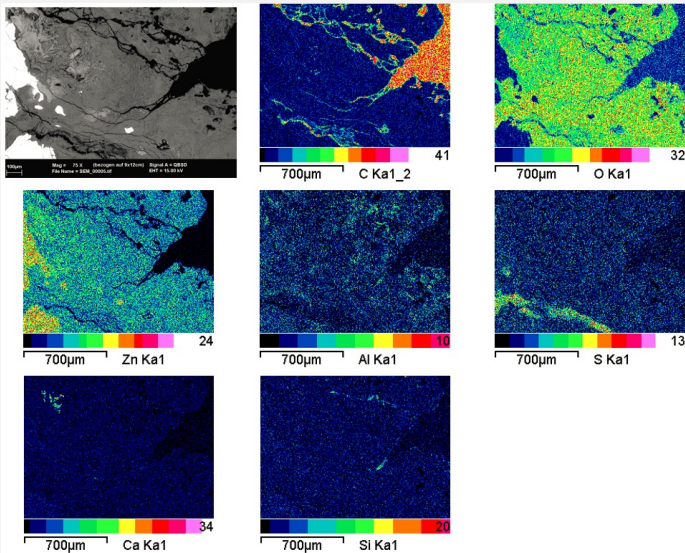
Fig. 9: SEM image, BSE-mode, and elemental chemical distribution of most of the area of Fig. 7 (reversed picture). Method of examination: SEM/EDS, Laboratory of Analytical Chemistry, Empa,
