# SACRIFICIAL ANODE VHS-8339 - ZN ALLOY - MODERN TIMES

Artefact name Sacrificial anode VHS-8339

Authors Marianne. Senn (EMPA, Dübendorf, Zurich, Switzerland) & Christian. Degrigny (HE-Arc CR, Neuchâtel, Neuchâtel,

Origin Submarine "Mesoscaph" from Auguste Piccard

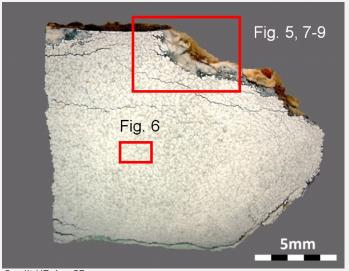
Fig. 3: Micrograph of the cross-section showing the location of Figs. 5 to 9,

The sample (Fig. 3) shows a cross-section from the sacrificial anode (Fig. 2). The thickness of the corrosion crust is variable. Dimensions: L = 17mm; W = 14mm.

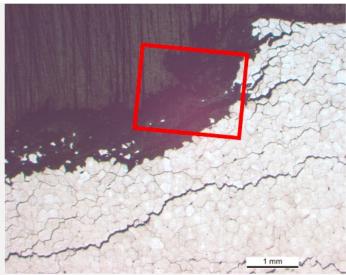
The remaining metal is an almost pure zinc alloy (Table 1). The oxygen content is not from the original alloy, but is due to secondary corrosion. The metal grains are visible without etching and present a polygonal structure (Figs. 5 and 6). The structure is recrystallised after annealing. The recrystallization of zinc alloys begins at room temperature.

Fig. 5: Micrograph of the metal sample from Fig. 3 (reversed picture, detail), unetched, bright field. Extensive intergranular corrosion is visible. The rectangle marks Fig. 7,

Extended intergranular corrosion has developed in the metal structure (Figs. 5, 6). The metal is covered by a corrosion crust that is hardly visible in bright field and which contains remnant metal (Fig. 5). On most of the sample the corrosion crust is uniform. In areas we see cracks (Fig. 7) appearing as brown lines separating the corrosion crust (Fig. 8). In bright field the corrosion crust appears grey containing dark-grey zones (Fig. 7). Under polarized light, the corrosion crust appears white with darker parts including remnant metal (Fig. 8). It contains Zn and O as well as S along some cracks (Table 2 and Fig. 9).

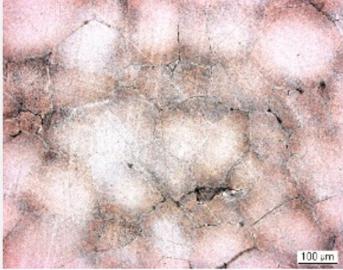
Fig. 6: Micrograph of the metal sample from Fig. 3 (detail), etched,

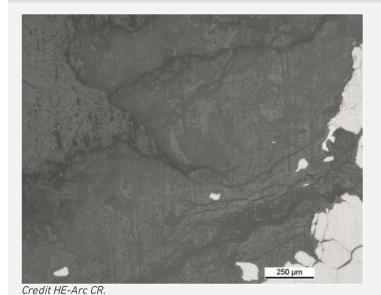
Fig. 7: Micrograph showing the metal - corrosion products interface from Fig. 5 (detail), unetched, bright field,

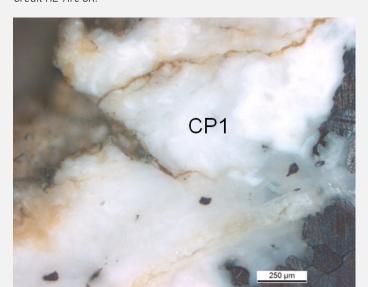
Fig. 8: Micrograph (same as Fig. 7) corresponding to the stratigraphy of Fig. 4, unetched, polarised light. We observe in dark-grey the metal, in white the corrosion crust separated by brown cracks including remnant metal,
