# SACRIFICIAL ANODE VHS-8339 - ZN ALLOY - MODERN TIMES

**Artefact name** Sacrificial anode VHS-8339

**Authors** Marianne. Senn (EMPA, Dübendorf, Zurich, Switzerland) & Christian. Degriigny (HE-Arc CR, Neuchâtel, Neuchâtel, Switzerland)

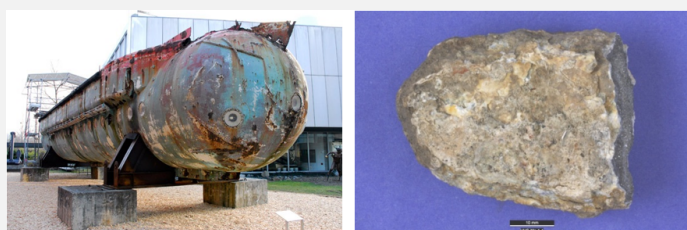
Fig. 1: The submarine and the anode (www.verkehrshaus.ch),

<b>Description of the artefact</b>	The artefact could be a weight or sacrificial anode of a submarine (Fig. 1). It is surrounded by a whitish brown-grey corrosion crust. The broken metal has a greyish shiny colour, whereas the metal part that is cut has a silvery appearance. Dimensions: L = 4.9cm ; WT = 95g.
<b>Type of artefact</b>	Submarine part
<b>Origin</b>	Submarine "Mesoscaph" from Auguste Piccard
<b>Recovering date</b>	The sacrificial anodes (?) might have been added when the submarine was used in the sea.
<b>Chronology category</b>	Modern Times
<b>chronology tpq</b>	<input type="text" value="1970"/> A.D. ▾
<b>chronology taq</b>	<input type="text" value="1974"/> A.D. ▾
<b>Chronology comment</b>	
<b>Burial conditions / environment</b>	Outdoor atmosphere
<b>Artefact location</b>	Swiss Museum of Transport, Luzern, Lucerne
<b>Owner</b>	Swiss Museum of Transport, Luzern, Lucerne
<b>Inv. number</b>	VHS-8339

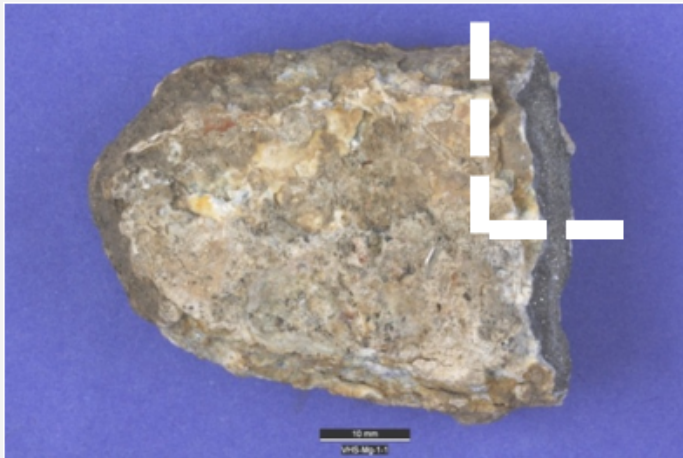
Fig. 2: Location of sampling area,

The sample (Fig. 3) shows a cross-section from the sacrificial anode (Fig. 2). The thickness of the corrosion crust is variable. Dimensions: L = 17mm; W = 14mm.

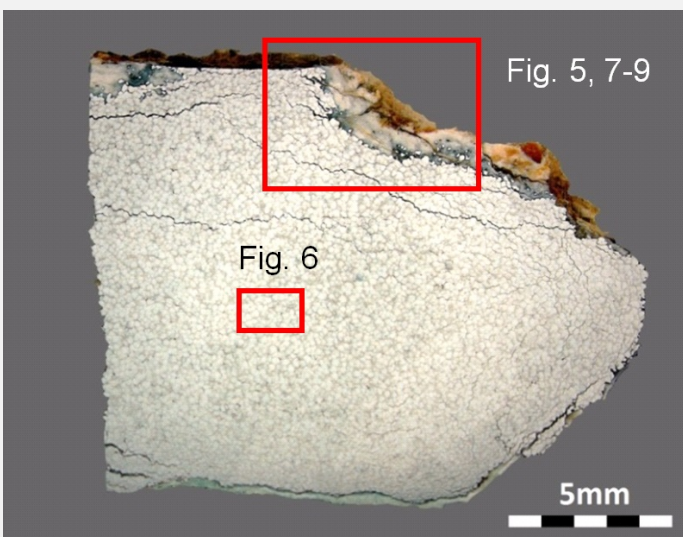
Fig. 3: Micrograph of the cross-section showing the location of Figs. 5 to 9,

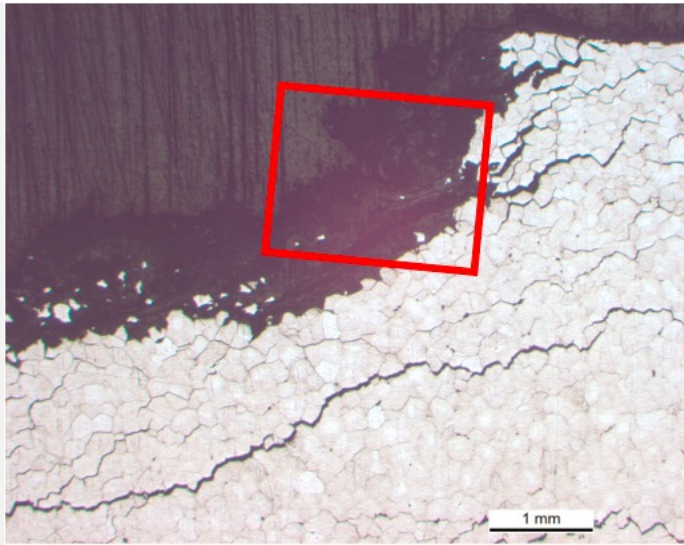
The remaining metal is an almost pure zinc alloy (Table 1). The oxygen content is not from the original alloy, but is due to secondary corrosion. The metal grains are visible without etching and present a polygonal structure (Figs. 5 and 6). The structure is recrystallised after annealing. The recrystallization of zinc alloys begins at room temperature.

Fig. 5: Micrograph of the metal sample from Fig. 3 (reversed picture, detail), unetched, bright field. Extensive intergranular corrosion is visible. The rectangle marks Fig. 7,

Extended intergranular corrosion has developed in the metal structure (Figs. 5, 6). The metal is covered by a corrosion crust that is hardly visible in bright field and which contains remnant metal (Fig. 5). On most of the sample the corrosion crust is uniform. In areas we see cracks (Fig. 7) appearing as brown lines separating the corrosion crust (Fig. 8). In bright field the corrosion crust appears grey containing dark-grey zones (Fig. 7). Under polarized light, the corrosion crust appears white with darker parts including remnant metal (Fig. 8). It contains Zn and O as well as S along some cracks (Table 2 and Fig. 9).

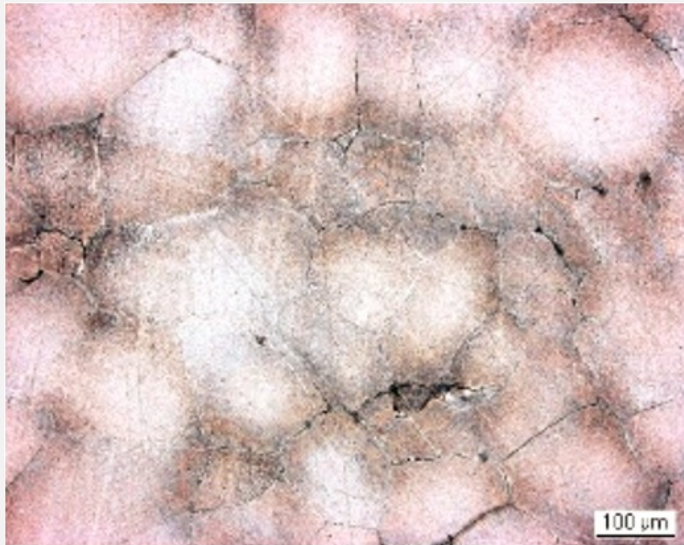
Fig. 6: Micrograph of the metal sample from Fig. 3 (detail), etched,

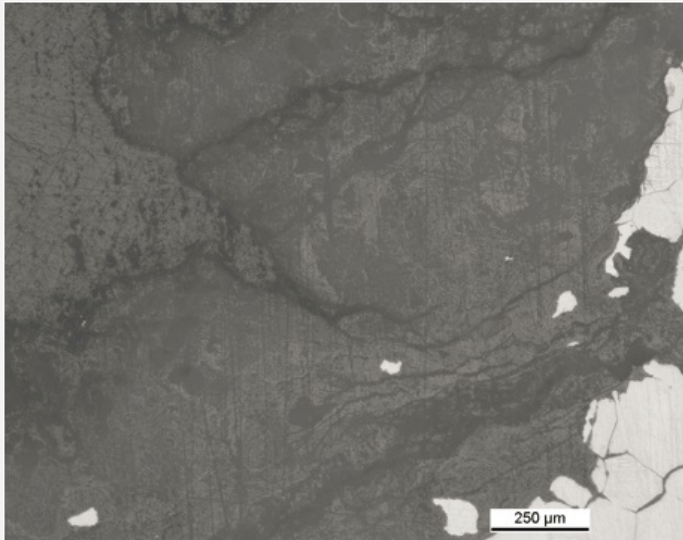
Table 2. Chemical composition (mass %) of the corrosion layer from Figs. 7 and 9. Method of analysis: SEM/EDS, Laboratory of Analytical Chemistry, Empa.

Fig. 7: Micrograph showing the metal - corrosion products interface from Fig. 5 (detail), unetched, bright field,

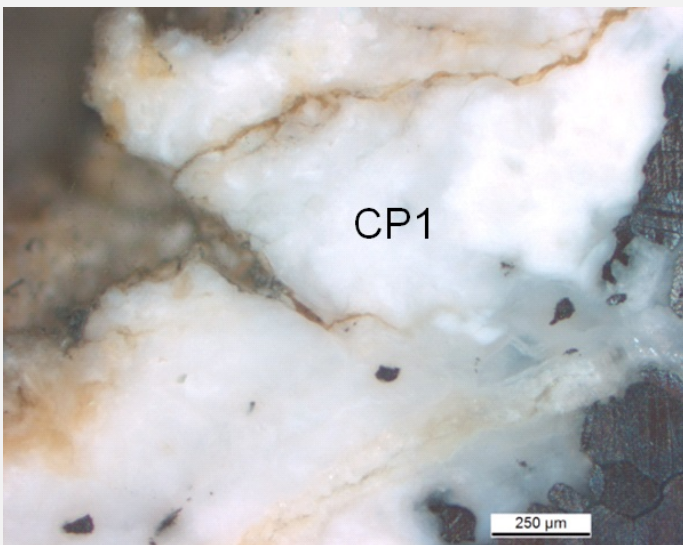
Fig. 8: Micrograph (same as Fig. 7) corresponding to the stratigraphy of Fig. 4, unetched, polarised light. We observe in dark-grey the metal, in white the corrosion crust separated by brown cracks including remnant metal,

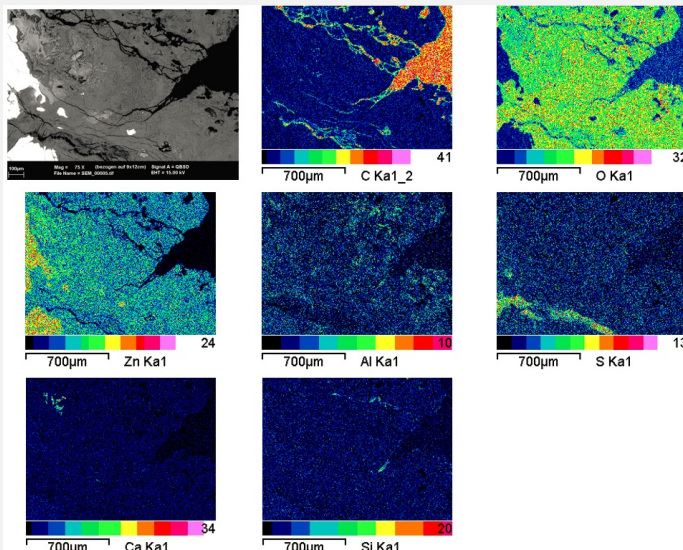
Fig. 9: SEM image, BSE-mode, and elemental chemical distribution of most of the area of Fig. 7 (reversed picture). Method of examination: SEM/EDS, Laboratory of Analytical Chemistry, Empa,
