# SACRIFICIAL ANODE VHS-8339 – ZN ALLOY – MODERN TIMES

**Artefact name** Sacrificial anode VHS-8339

**Authors** Marianne. Senn (EMPA, Dübendorf, Zurich, Switzerland) & Christian. Degryny (HE-Arc CR, Neuchâtel, Neuchâtel, Switzerland)

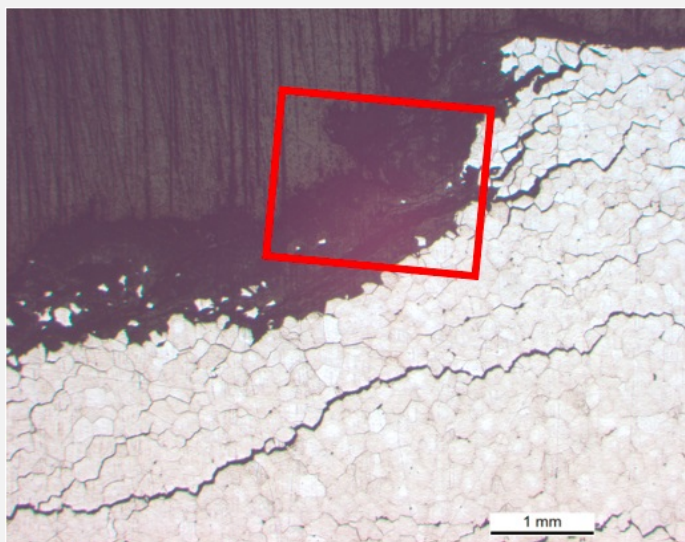
The remaining metal is an almost pure zinc alloy (Table 1). The oxygen content is not from the original alloy, but is due to secondary corrosion. The metal grains are visible without etching and present a polygonal structure (Figs. 5 and 6). The structure is recrystallised after annealing. The recrystallization of zinc alloys begins at room temperature.

Fig. 5: Micrograph of the metal sample from Fig. 3 (reversed picture, detail), unetched, bright field. Extensive intergranular corrosion is visible. The rectangle marks Fig. 7,

Extended intergranular corrosion has developed in the metal structure (Figs. 5, 6). The metal is covered by a corrosion crust that is hardly visible in bright field and which contains remnant metal (Fig. 5). On most of the sample the corrosion crust is uniform. In areas we see cracks (Fig. 7) appearing as brown lines separating the corrosion crust (Fig. 8). In bright field the corrosion crust appears grey containing dark-grey zones (Fig. 7). Under polarized light, the corrosion crust appears white with darker parts including remnant metal (Fig. 8). It contains Zn and O as well as S along some cracks (Table 2 and Fig. 9).

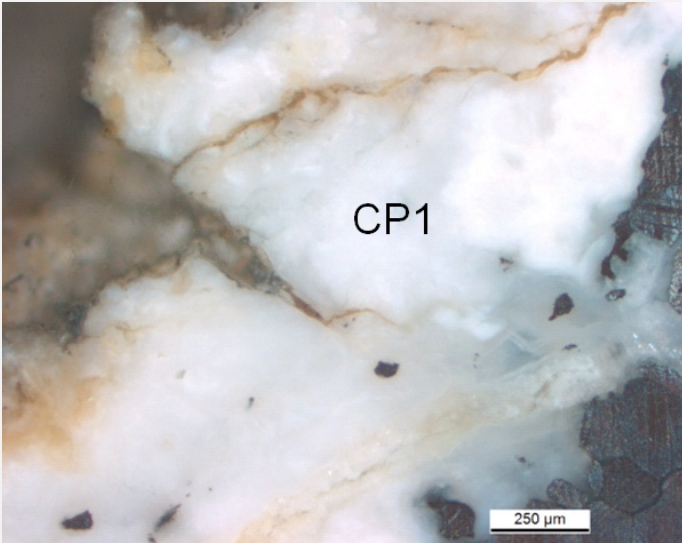
Fig. 8: Micrograph (same as Fig. 7) corresponding to the stratigraphy of Fig. 4, unetched, polarised light. We observe in dark-grey the metal, in white the corrosion crust separated by brown cracks including remnant metal,
