COFFEE FILTER – AL ALLOY – MODERN TIMES – FRANCE

Artefact name Coffee filter

Authors Christian. Degriigny (HE-Arc CR, Neuchâtel, Neuchâtel, Switzerland)

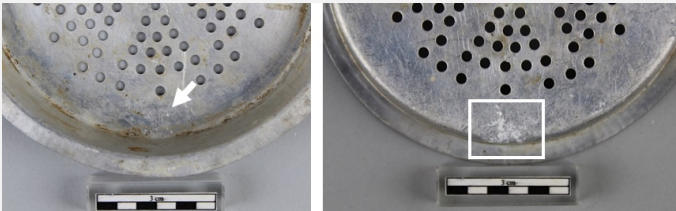
Fig. 2: Detail of the front and back sides of the coffee filter showing the location of Fig. 3,

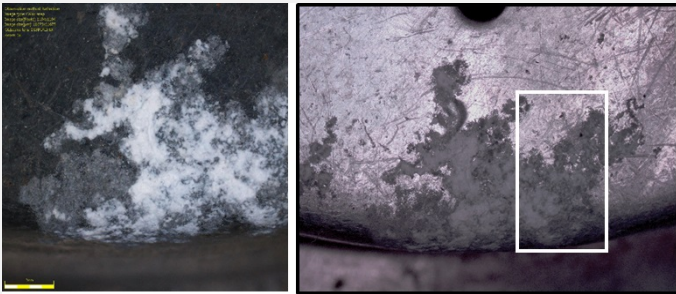
Fig. 3: Detail of the back side of the coffee filter showing the location of the sampling area,

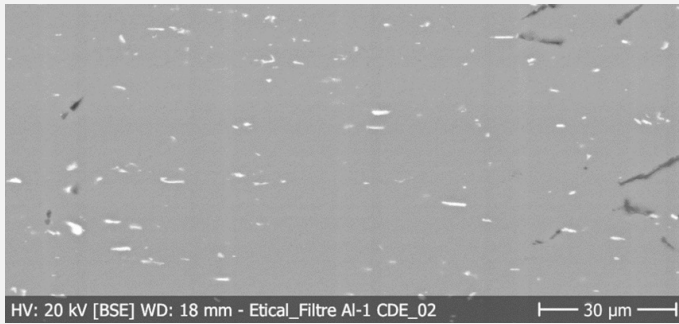
The metal is a relatively pure aluminium alloy with numerous elongated inclusions (Fig. 6). From their chemical composition they can be interpreted as Al_3Fe intermetallic compounds (Fig. 7). Inter- and transgranular corrosion has

Fig. 6: SEM image of the metal sample from Fig. 4 (detail), BSE-mode. We observe the presence of numerous elongated inclusions,

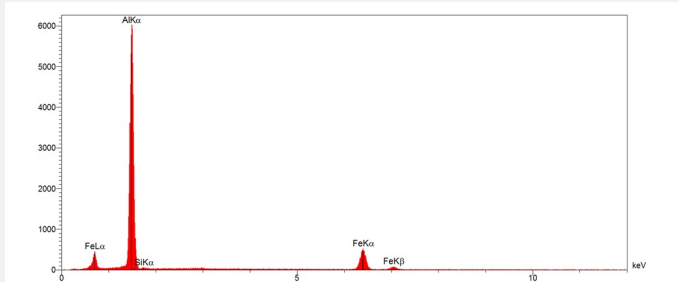
Fig. 7: EDS spectrum of the elongated inclusions of Fig. 6,

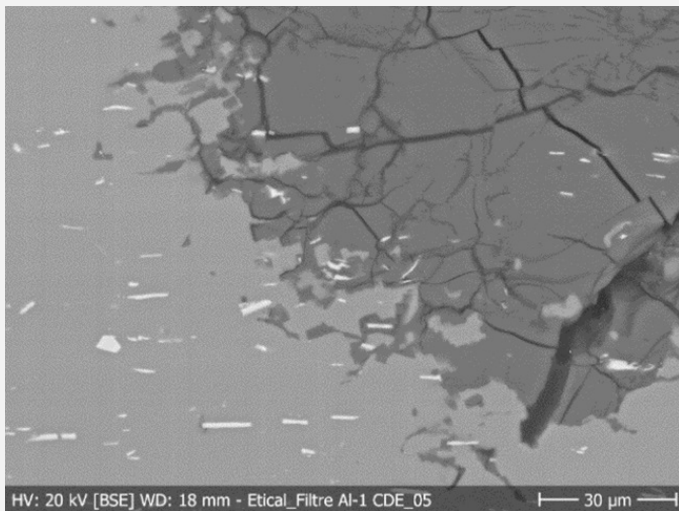
developed so extensively that some grains (not elongated) are outlined (Fig. 8).

Fig. 8: SEM image of the metal sample from Fig. 4 (detail), BSE-mode. Extensive inter- and transgranular corrosion has developed within the metal,

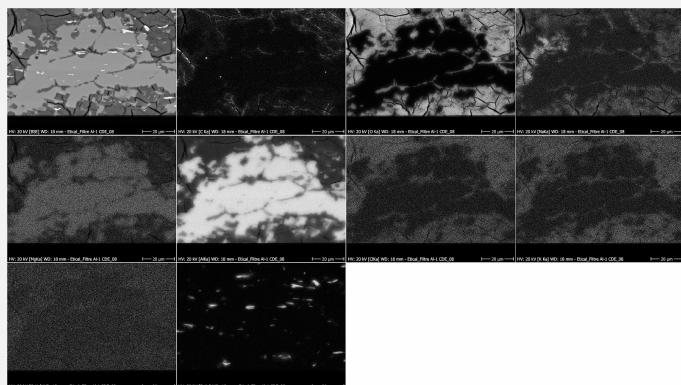
indicates that the metal is, as expected, covered by an Al and O-rich layer containing chlorides (red spots on Fig. 9) and surprisingly Na (Figs. 10 and 11). Chlorides do not seem to form active corrosion. A new examination carried out after 4 months (Fig. 12) shows new forms of alteration with a local enrichment of Na, C and O (Na₂CO₃?).

Fig. 12: SEM image, BSE-mode, and elemental chemical distribution of the selected area of Fig. 9 after 4 months. Method of examination: SEM-EDS, Lab of Electronic Microscopy and Microanalysis, IMA (Néode), HEI Arc,

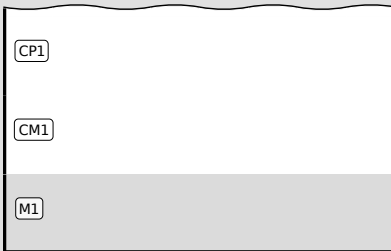
Fig. 5: Stratigraphic representation of the object in cross-section using the MiCorr application. The characteristics of the strata are only accessible by clicking on the drawing that redirects you to the search tool by stratigraphy representation. This representation can be compared to Fig. 9, Credit HE-Arc CR, C.Degrigny.
